**Subject: Amherst Island Wind Project  
Culvert Protection Measures**

**Reference: Culvert Inspection and Summary Report**  
**Project ID #1421 Amherst Island Wind Farm – Culvert Inspection, Collection System on the Island**

## AMHERST ISLAND WIND FARM CULVERT INSPECTION FORM

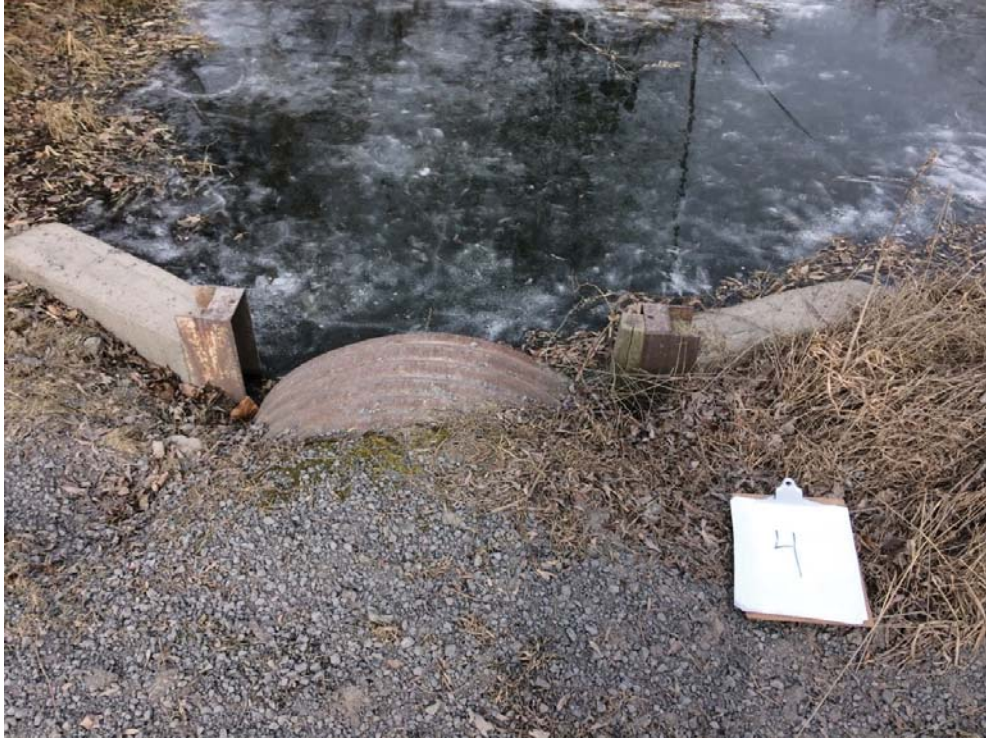
**INLET LOOKING WEST**

- Spring fed pond empties into sluice gate opening at 1000mm CSP location
- 1200 diameter CSP pipe extends 3.0 meters into 1200 x 1200 deteriorated box culvert which empties into Lake Ontario.

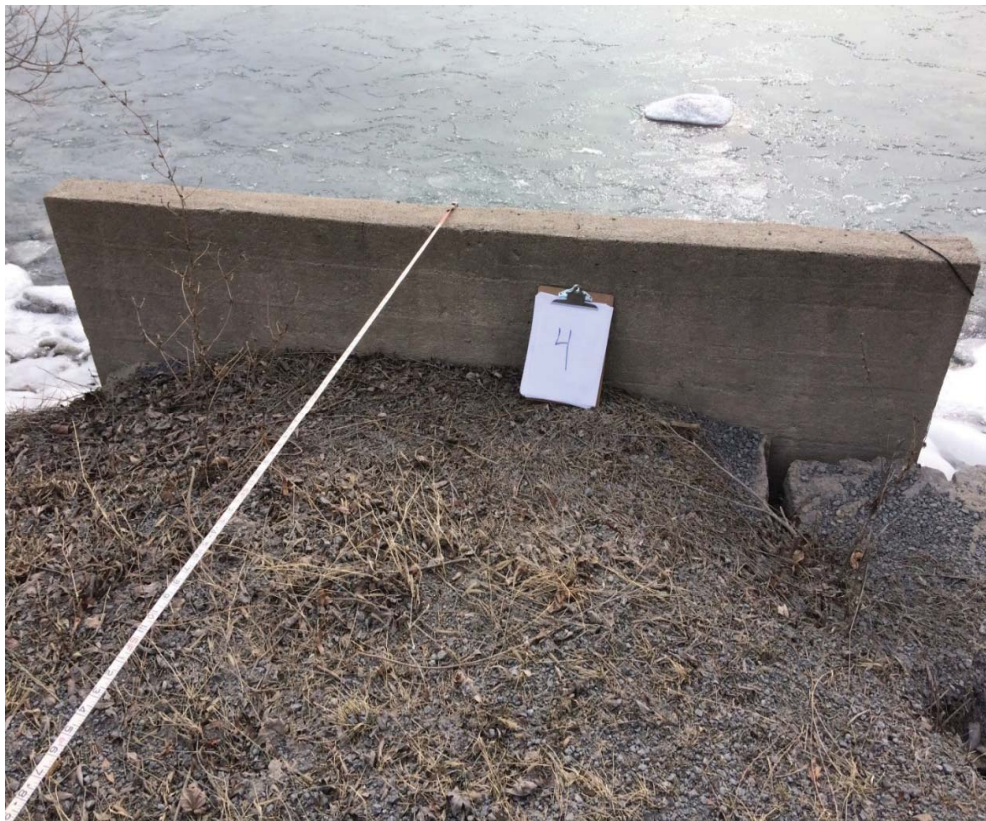
- Outlet has deteriorating, separated culvert walls and headwall. Flow of water is emptied into Lake Ontario. Walls are founded on bedrock.

**OUTLET LOOKING EAST, CRACKING AND EROSION AT HEADWALL**

- This culvert has experienced several structural defects and failures, especially if subject to future traffic overloading more consequential effects will be realized. Remove and replace existing concrete culvert with similar or larger sectional area structure or CSP.

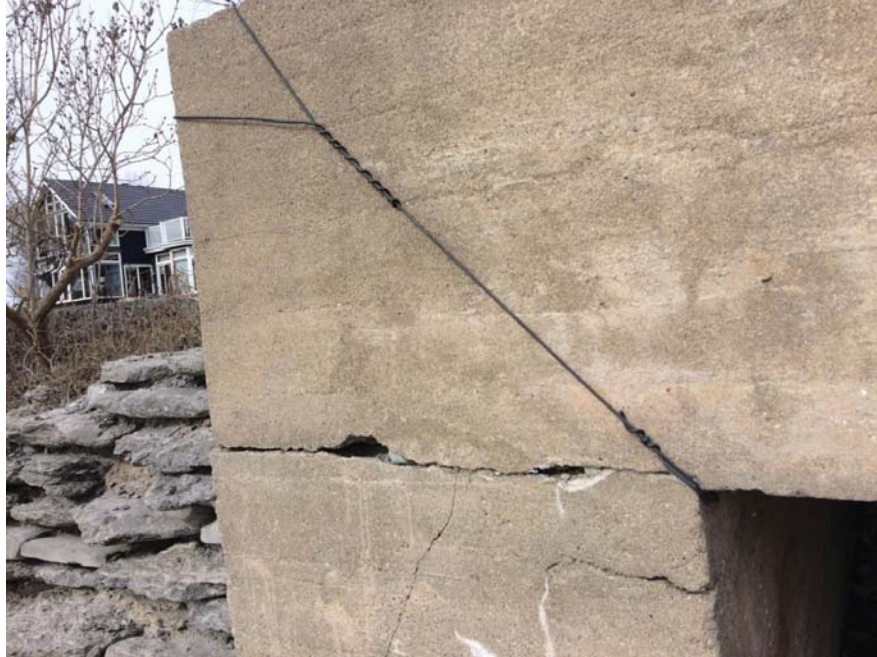
**EAST HEADWALL / SOUTH WALL, WEST ELEVATION,  
CRACKING AND SEPARATION OF HEADWALL**

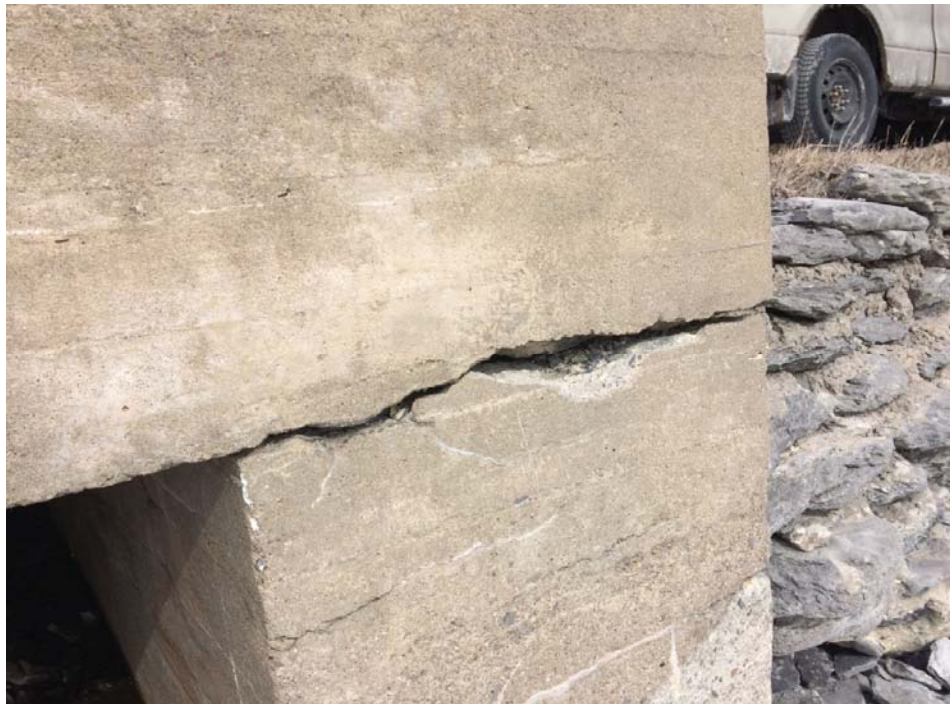
**EAST HEADWALL / NORTH WALL, WEST ELEVATION  
CRACKING AND SEPARATION OF HEADWALL**

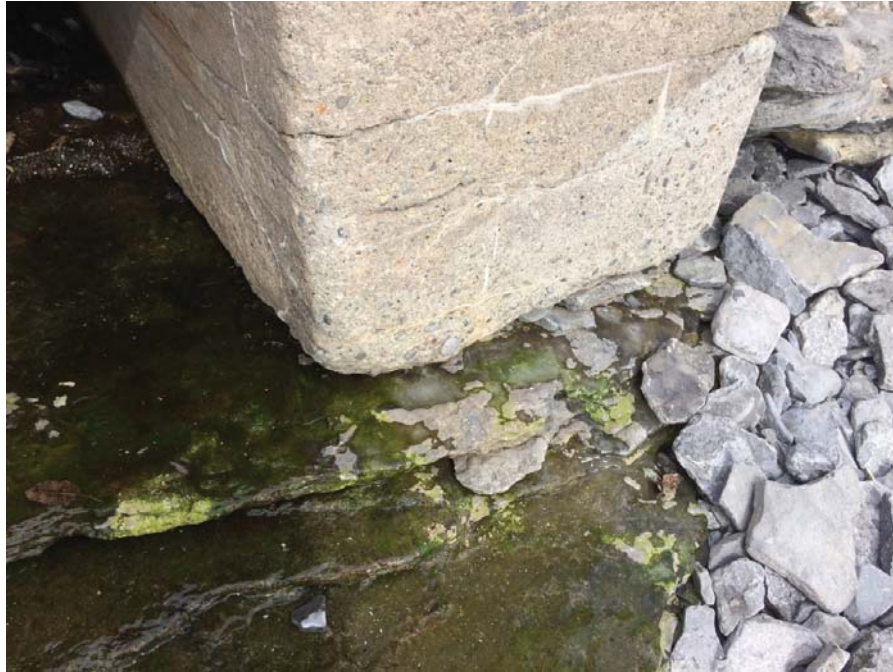
- Concrete is unsound, cracked and deteriorating beyond any heavy vehicular traffic load.
- Severe cracking in walls and disintegration and lack of foundation supporting culvert walls.
- Leaking through WIDE cracks along pour lines of culvert barrel walls

**NORTH WALL BASE, WEST ELEVATION  
EROSION AND LACK OF FOUNDATION BOND**

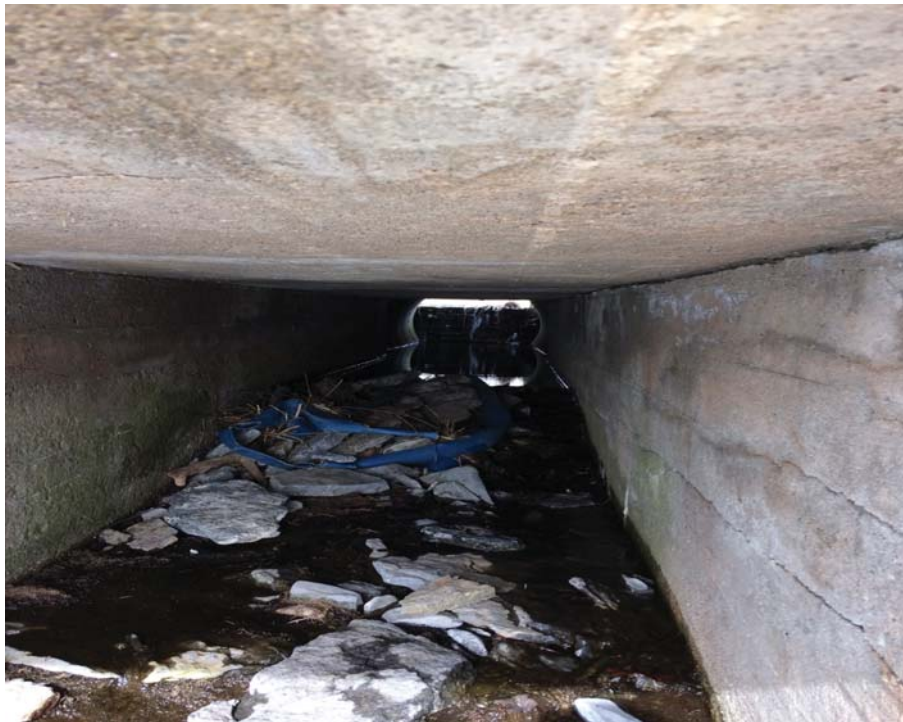
**WEST ELEVATION, CULVERT BARREL  
LEAKING OF WIDE CRACKS**

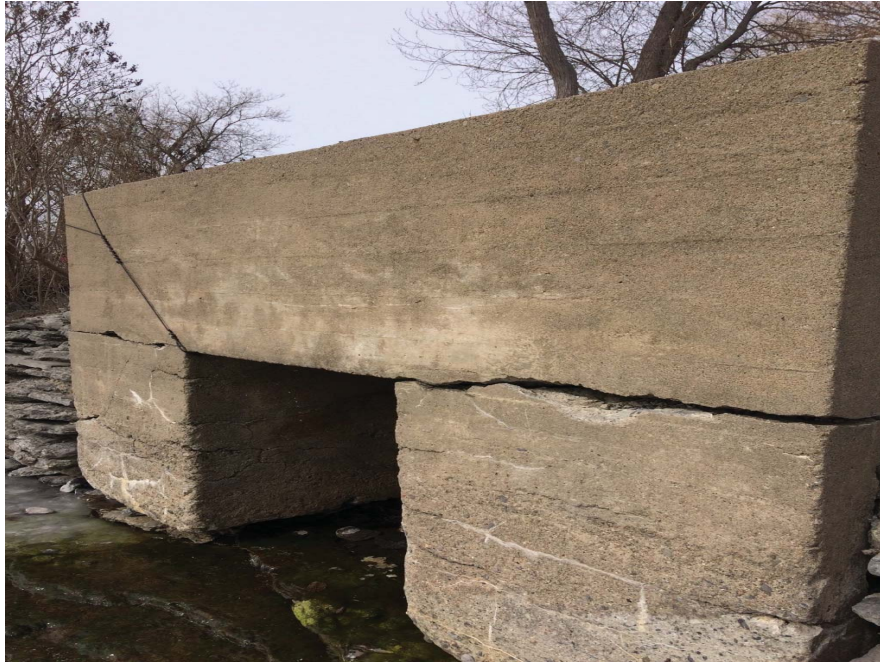
**SOUTHWEST ELEVATION  
SEPARATION OF HEADWALL AND DETERIORATED CONCRETE WALLS**

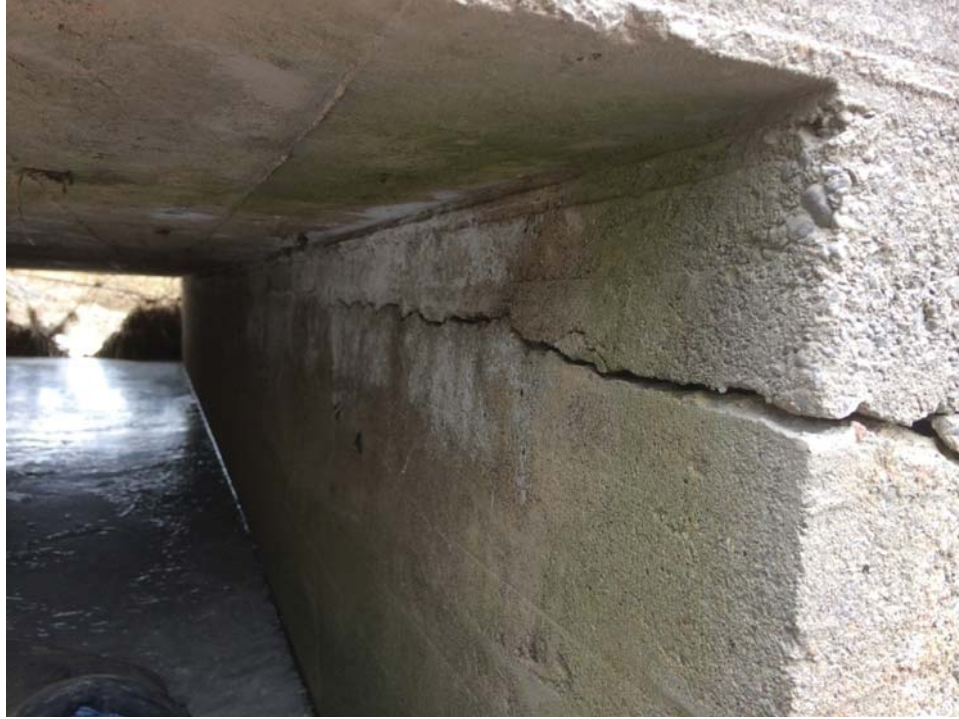
- Culvert is in poor condition. Severe diagonal cracking, full height along east wall, at 1.35m from North end of culvert.
- Wall to slab 25mm gap separation along east wall for 5.2 meters from east end of culvert.
- Severe cracking for 2.0 meters on West wall, around to Northwest wingwall.
- Broken slab on North East corner.
- Footings, if any were inaccessible at time of inspection

**SOUTH WEST ELEVATION, WEST WALL  
SEVERE CRACKING AND SEPARATION**

- This culvert has experienced several structural defects and failures, especially if subject to future traffic overloading more consequential effects will be realized. Remove and replace existing concrete culvert with similar or larger sectional area structure or CSP.

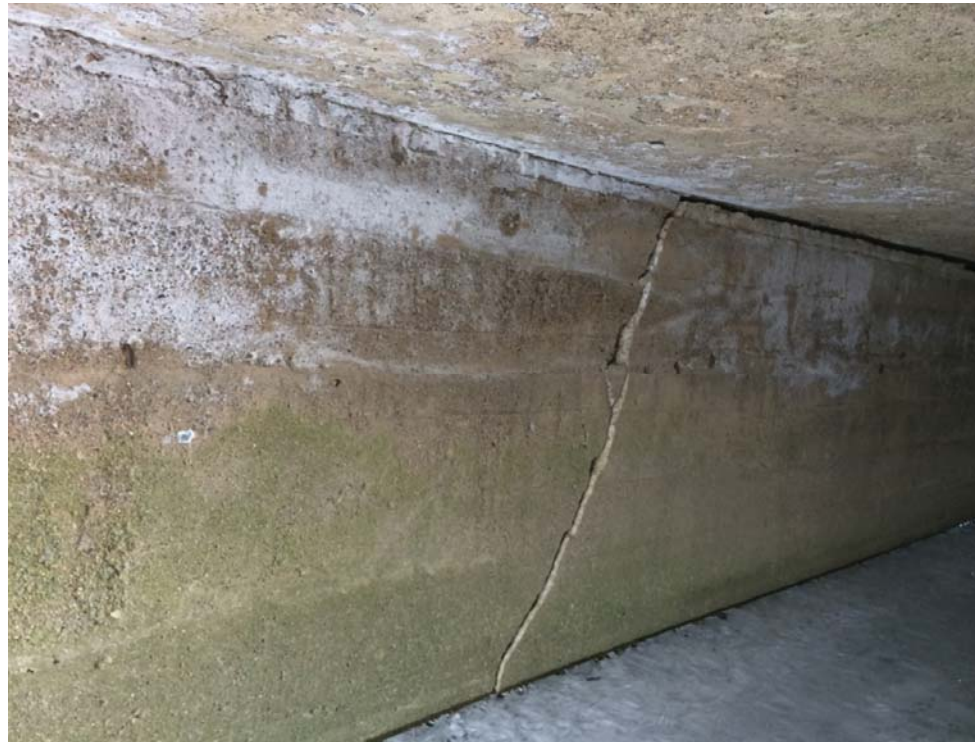
**EAST ELEVATION, EAST WALL  
SEVERE DIAGONAL CRACKING, NORTH CRACK**

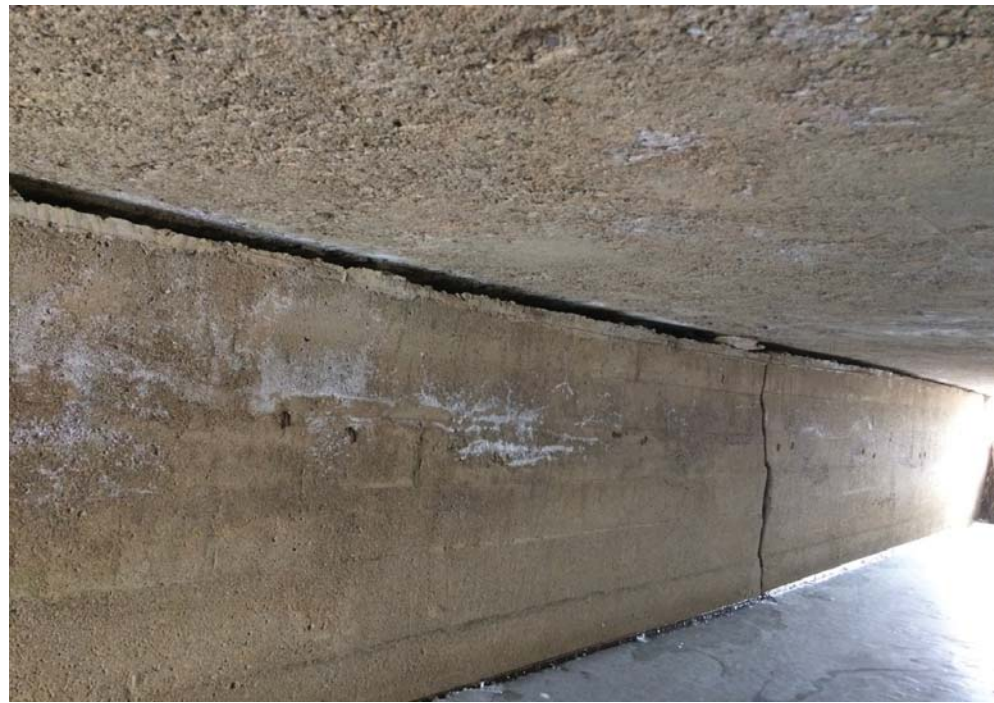
**EAST WALL,  
SOUTH CRACK, AND WALL TO SLAB SEPARATION**

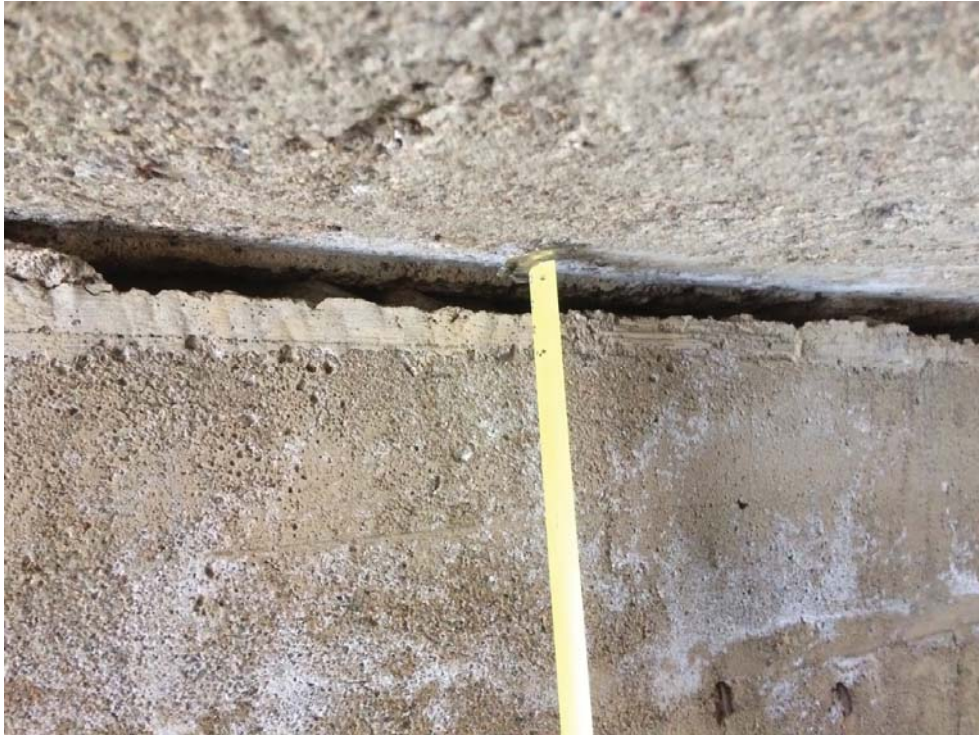
**EAST WALL, 25mm ROOF SLAB TO WALL SEPARATION**

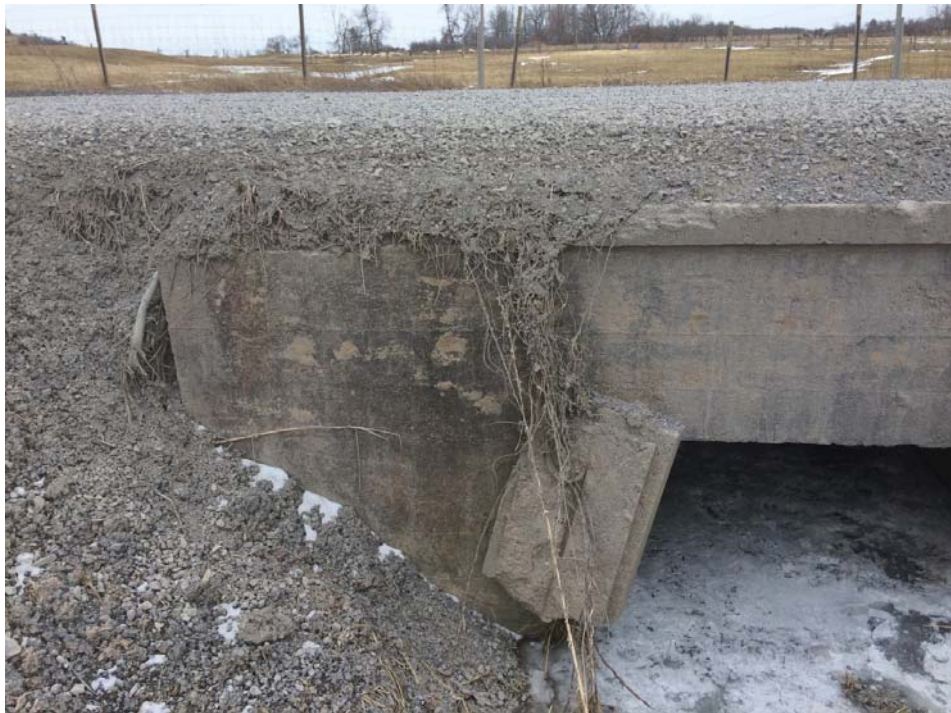
**EAST ELEVATION, SOUTHEAST WALL  
DISINTEGRATION OF SMALL HEADWALL**

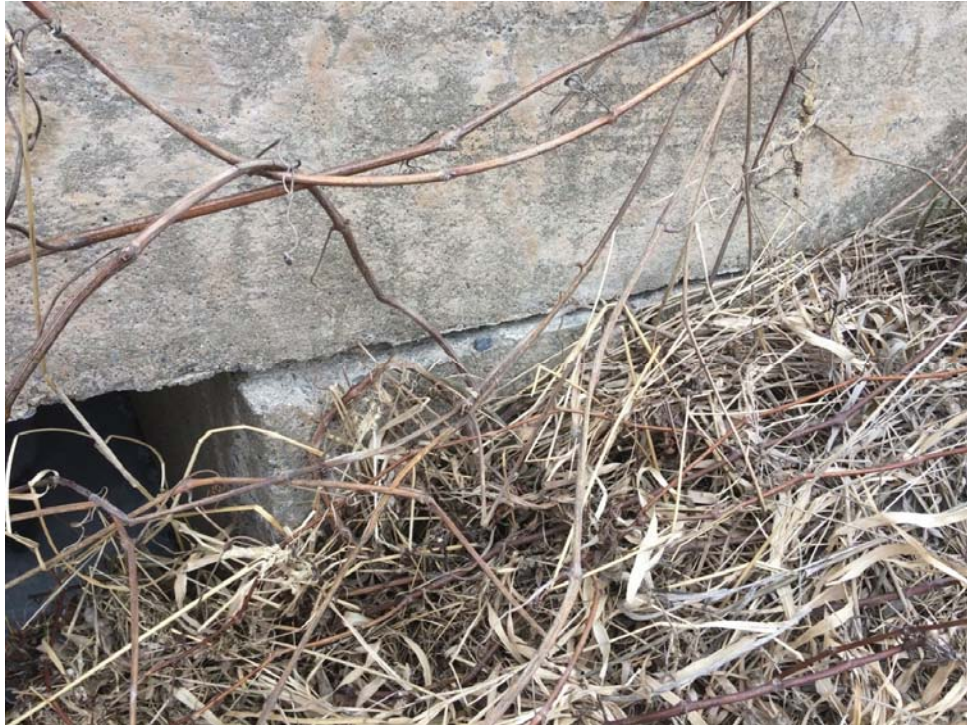
**WEST ELEVATION, SOUTHEAST WALL  
ROOF SLAB TO WALL SEPARTION,**

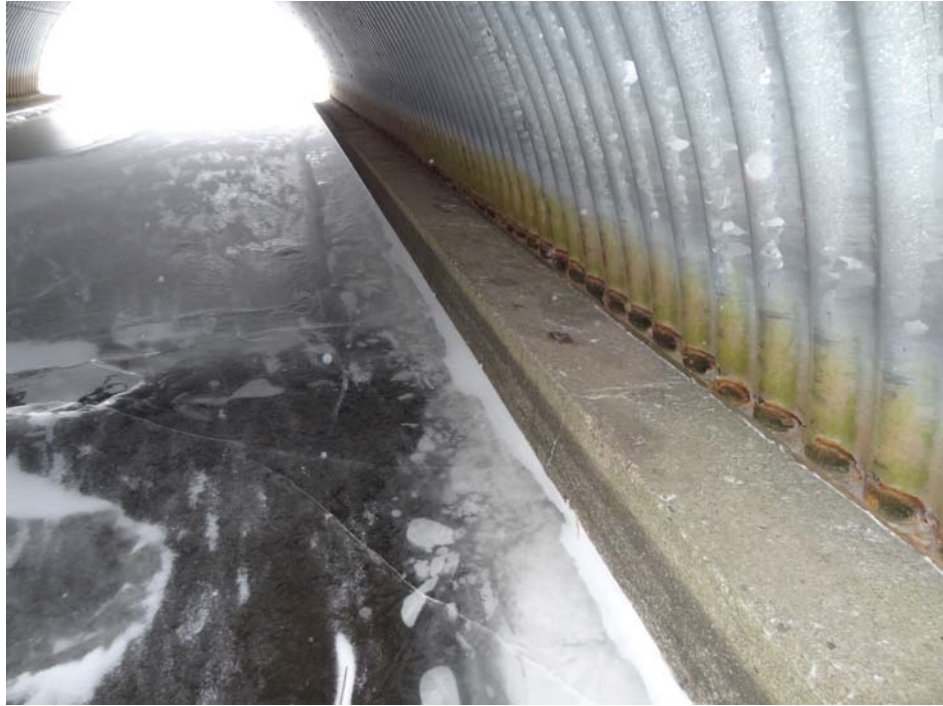
**CONCRETE FOOTING AND CONNECTION POINTS**

- Pipe is in good condition. No defects observed. Culvert bolts are dry and free of rust. There are no signs of cracking or leaking of steel structure. There is minor vegetative staining along bottom 400mm of the culvert arch. The connecting arch plate to the concrete footing appears to be non-galvanized / welded steel plate. As such, there is a light rust staining along this steel plate connection. The culvert still appears to maintain its original arch shape which indicates that no deformation has occurred to date.
- Concrete footing free of defects. Two (2) Very narrow cracks < 0.2mm in width observed along south footing. These appear to be shrinkage cracks resulting from lack of concrete curing procedures at time of footing pour.

- There were no defects found during time of inspection and structure is in good condition. No repairs are required.

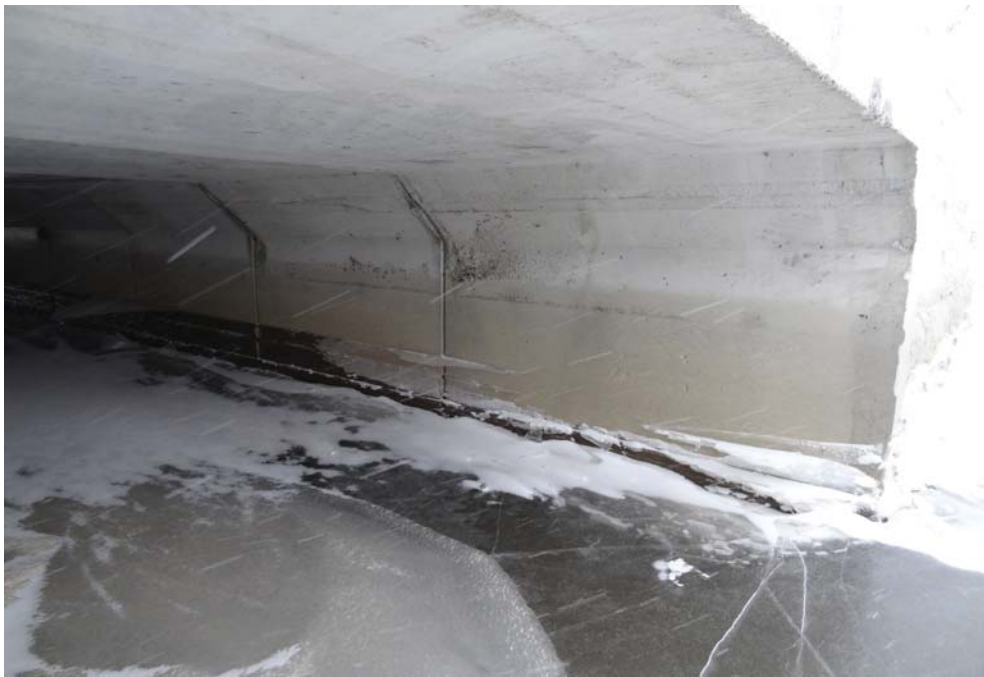
**SOUTH WEST END SECTION OF PRE-CAST CULVERT BARREL**

- No defects present.
- Pre-cast roof slab sections at west end are differential in horizontal plane, but this appears to be a product of either improper orientation during installation or a manufacturing defect.
- There are no signs of settlement, cracking or deflection during inspection. Culvert faces were dry and no
- signs of leaking or moisture at joint locations.
