**Subject: Amherst Island Wind Project
Culvert Protection Measures**

**Reference: Culvert Inspection and Summary Report
Project ID #1421 Amherst Island Wind Farm – Culvert Inspection, Collection System on
the Island**

AMHERST ISLAND WIND FARM CULVERT INSPECTION FORM

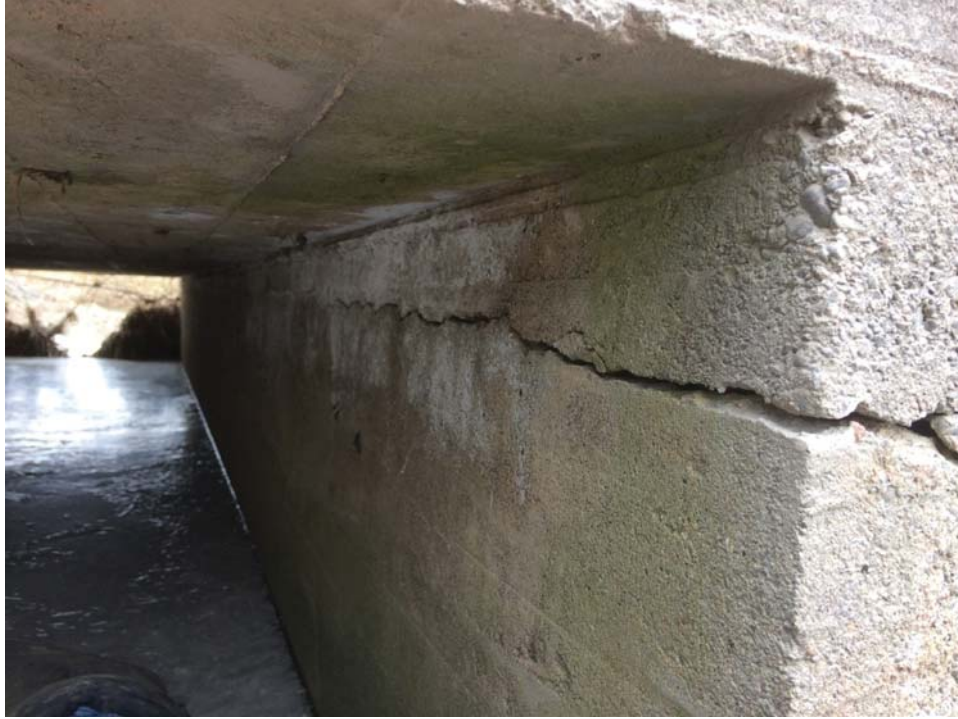
**SOUTH WEST ELEVATION, WEST WALL
SEVERE CRACKING AND SEPARATION**

- This culvert has experienced several structural defects and failures, especially if subject to future traffic overloading more consequential effects will be realized. Remove and replace existing concrete culvert with similar or larger sectional area structure or CSP.

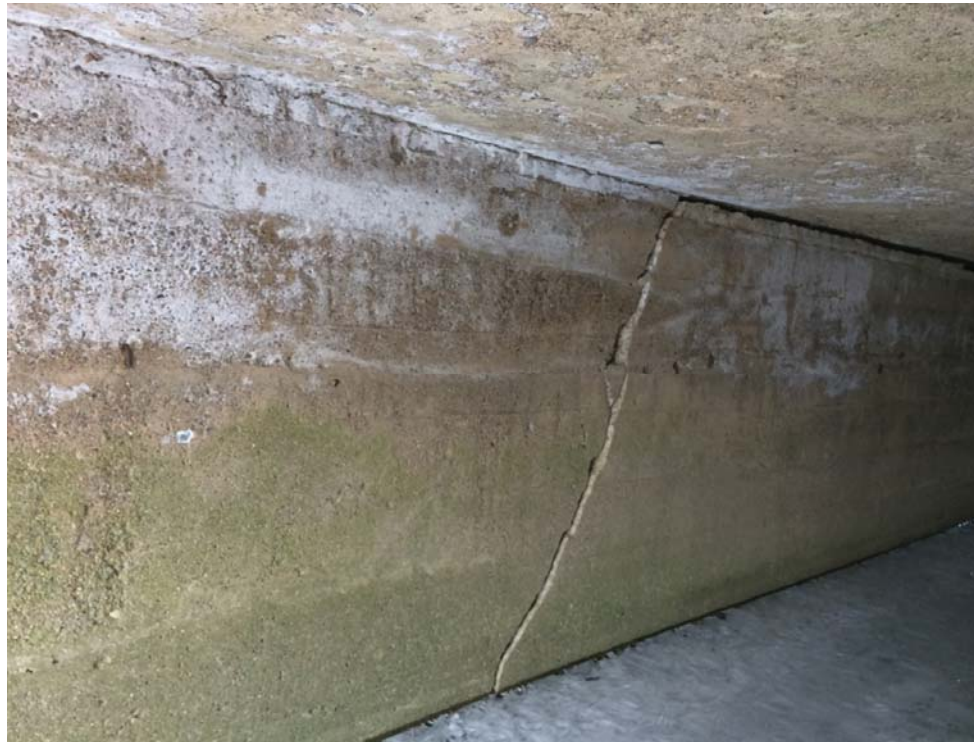
- Culvert is in poor condition. Severe diagonal cracking, full height along east wall, at 1.35m from North end of culvert.
- Wall to slab 25mm gap separation along east wall for 5.2 meters from east end of culvert.
- Severe cracking for 2.0 meters on West wall, around to Northwest wingwall.
- Broken slab on North East corner.
- Footings, if any were inaccessible at time of inspection

**EAST ELEVATION, EAST WALL
SEVERE DIAGONAL CRACKING, NORTH CRACK**

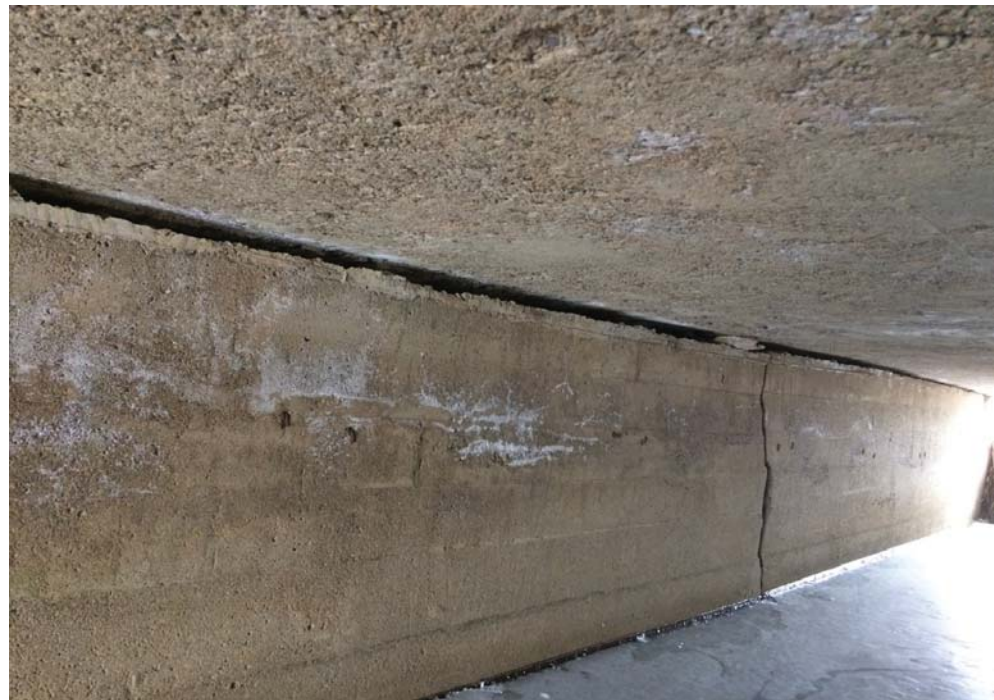
**EAST WALL,
SOUTH CRACK, AND WALL TO SLAB SEPARATION**
