**Amherst Island Wind Energy Project
Irish Stone Fence Detailed Review**

File No. 160960595

December 6, 2016

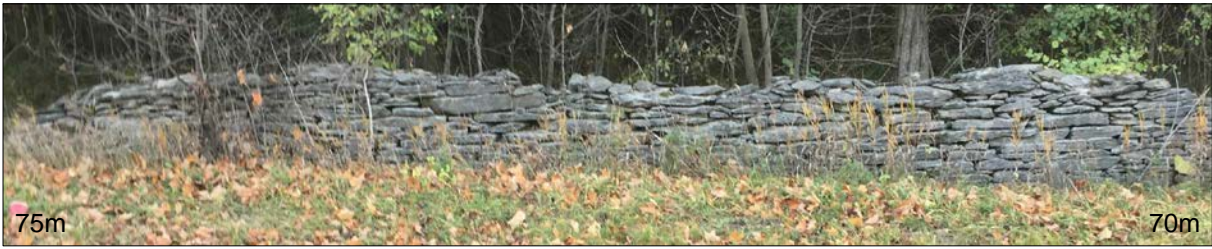
Dry Stone Fence Photo - 70m to 75m

This portion was constructed in a traditional manner with even and tight joints, but the small stones on top of wall appear to be placed at random.

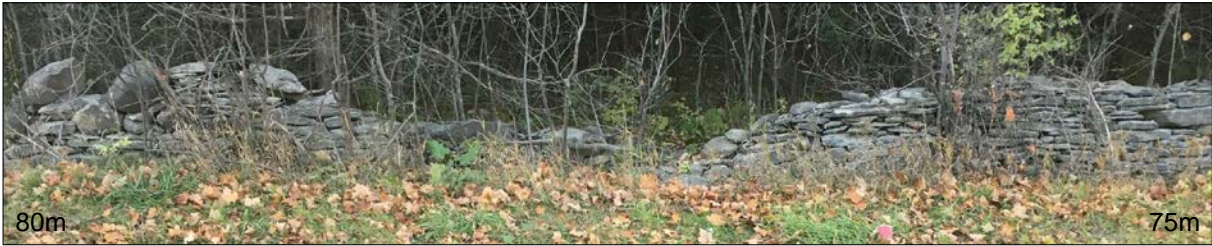
Dry Stone Fence Photo - 75m to 80m

75-77m continues from previous section with decent even bedding plane and joints, there is a missing part at the middle section and also adjacent to 80m, note the round rubble on top in this area.

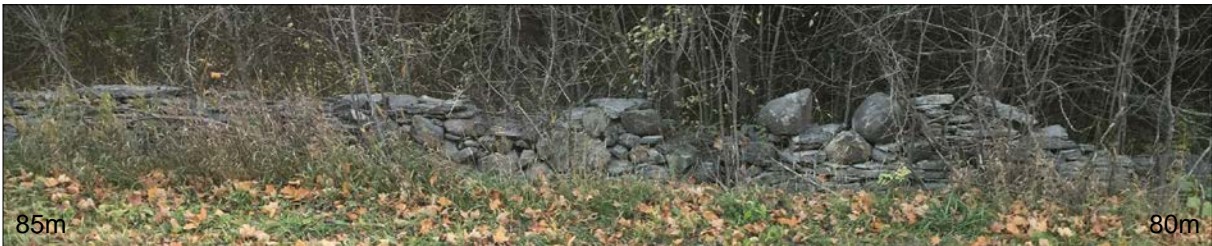
Dry Stone Fence Photo - 80m to 85m

The bottom of the portion at 82-85m appears to be constructed in traditional manner, but areas between 80-82m appears to be a reconstruct, as indicated by the loosely packed smaller size rubble stones.

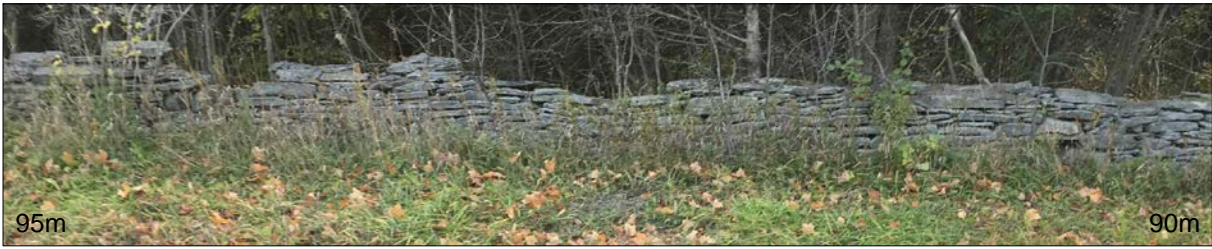
Dry Stone Fence Photo - 90m to 95m

Similar to section 85-90m with missing top layer and additional pieces on the top too.

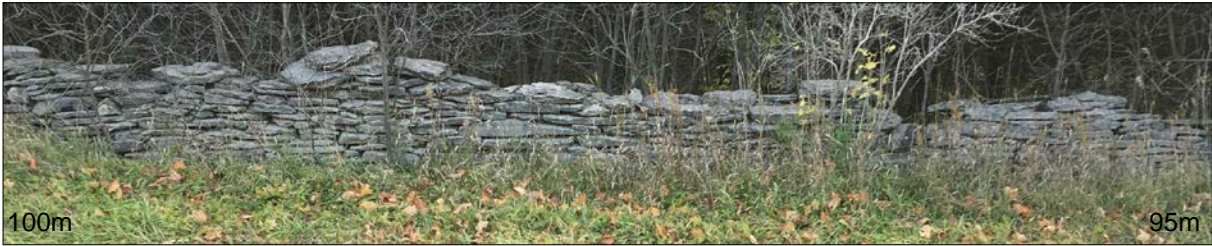
Dry Stone Fence Photo - 95m to 100m

Similar to section 90-95m with missing top layer and additional pieces on the top, also some gaps in joints.

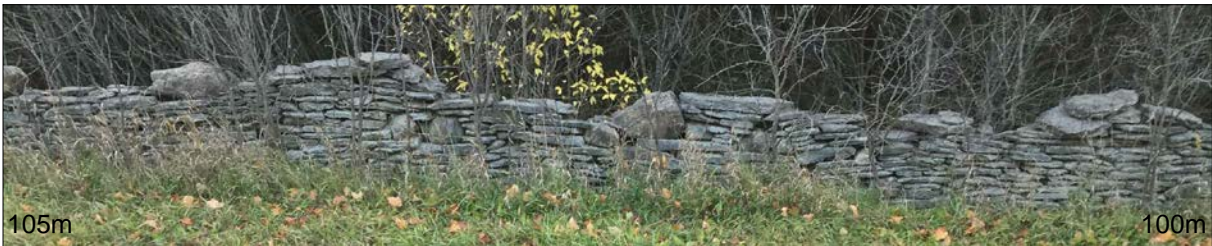
Dry Stone Fence Photo - 100m to 105m

Similar to section 95-100 with missing top layer and additional pieces on the top.

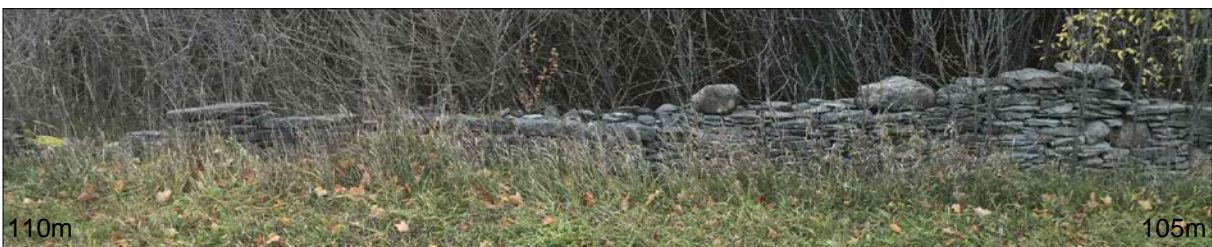
Dry Stone Fence Photo - 105m to 110m

Similar to section 100-105 with missing top layer and additional pieces on the top, as well as a gradual reduced height.

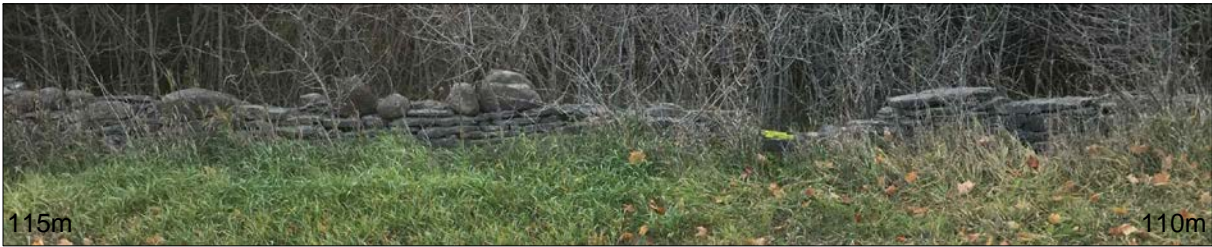
Dry Stone Fence Photo - 110m to 115m

Where the stone is laid in traditional manner, the joint is decently tight and the bedding line is even, but is missing top layers at various locations. Random round stone pieces are on top.

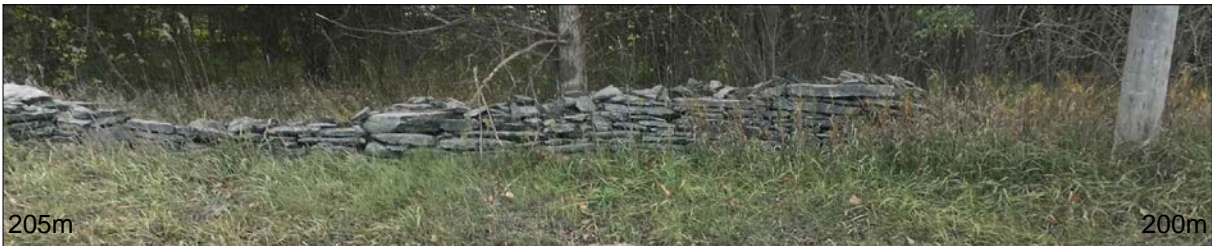
Dry Stone Fence Photo - 200m to 205m

This section is visible and low, with less tight joints and less regular bedding than the portion at the right, note the random loose pieces on top of wall.

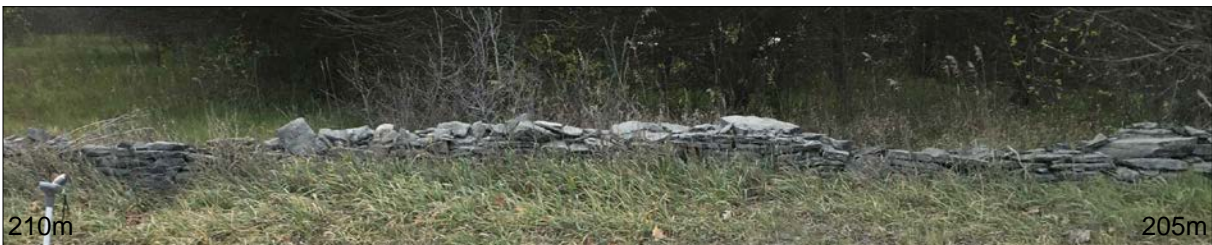
Dry Stone Fence Photo - 205m to 210m

Low wall with decent tightness and even joint even less visible. Note loose random pieces on top of wall.

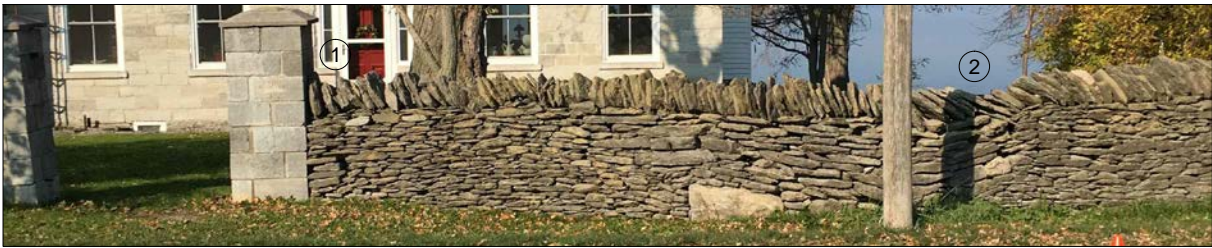
Dry Stone Fence Photo - 0m to 5m

Consists of limestone, laid in traditional manner with tight joints and well distributed sizes and level bedding plane, with the exception of discontinuities noted here.

- 1) Area butting the pillar has different pattern, size of stones and tightness, apparently a reconstructed area.
- 2) Un-even bedding plane, less joint tightness and size of stone is different from adjacent areas, indicating reconstruction, note the large boulder at bottom.

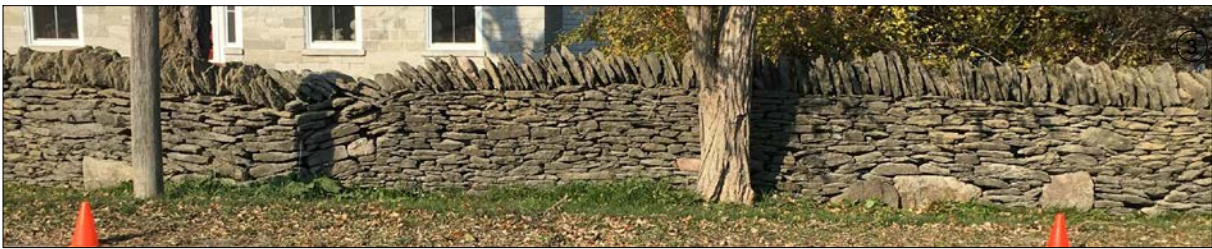
Dry Stone Fence Photo - 5m to 10m

Constructed in traditional manner with limestone, with tight joints and well distributed sizes and level bedding plane, with the exception of discontinuities noted.

- 3) A change in placement pattern and sizes of stone is noted in this area, note the large boulders at bottom of wall.

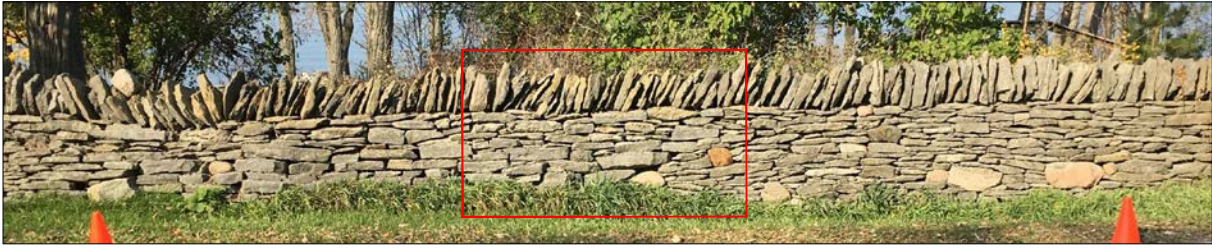
Dry Stone Fence Photo - 30m to 35m

Constructed in traditional manner with limestone, with tight joints and well distributed sizes and level bedding plane, with the exception of a change in stone sizes, joint tightness and levelness indicated above.

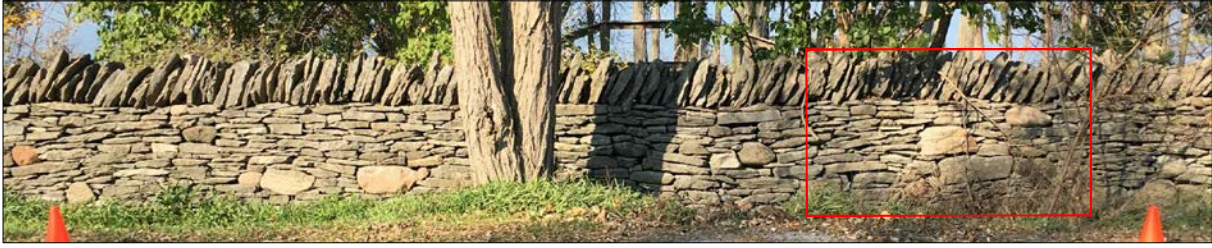
Dry Stone Fence Photo - 35m to 40m

Constructed in traditional manner with limestone, with tight joints and well distributed sizes and level bedding plane, with the exception of a change in joint tightness and bedding levelness, indicated above. Note the large pieces at isolated locations.

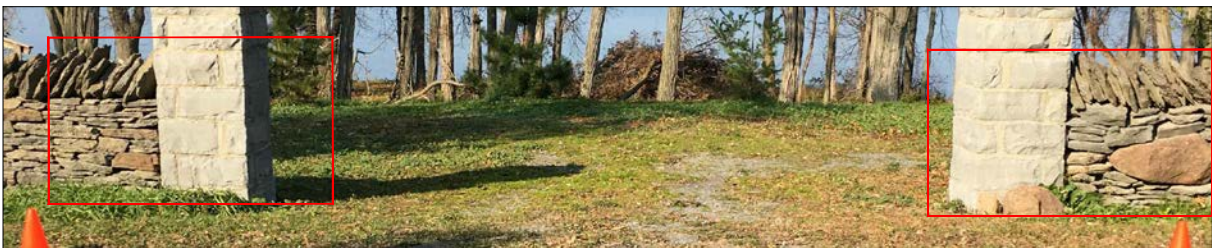
Dry Stone Fence Photo - 45m to 50m

Constructed in traditional manner with limestone, with tight joints and well distributed sizes and level bedding plane, with the exception of discontinuities noted above. First, a slight change in pattern where butting with the left pillar, and second where butting with the right pillar the stone was laid in less tightly, note the large piece of boulder.

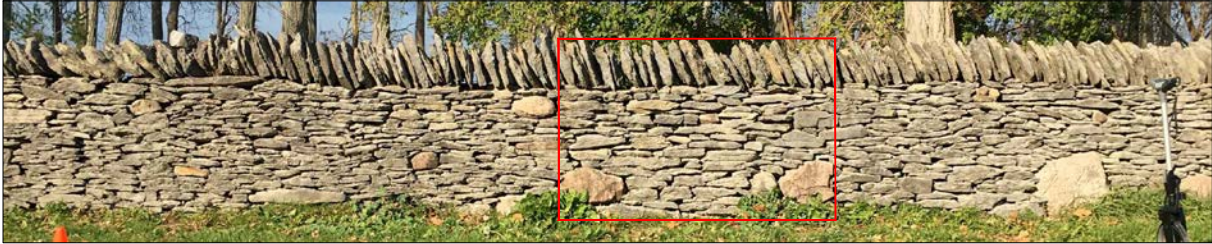
Dry Stone Fence Photo - 55m to 60m

Constructed in traditional manner with limestone, with tight joints and well distributed sizes and level bedding plane, with the exception of a slight change in joint tightness noted above.

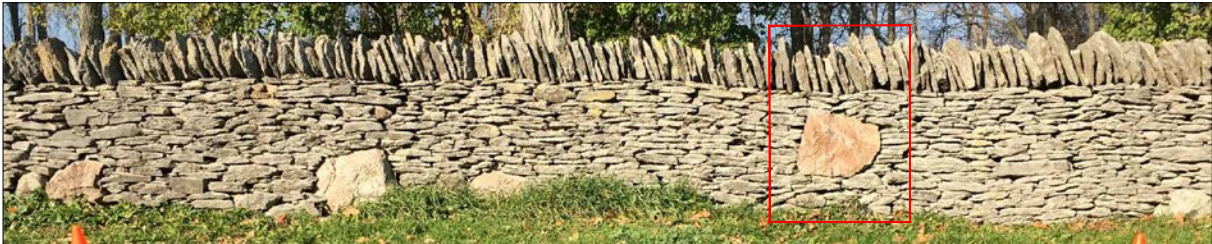
Dry Stone Fence Photo - 60m to 65m

Constructed in traditional manner with limestone, with tight joints and well distributed sizes and level bedding plane, with the exception of a large piece in between noted above.

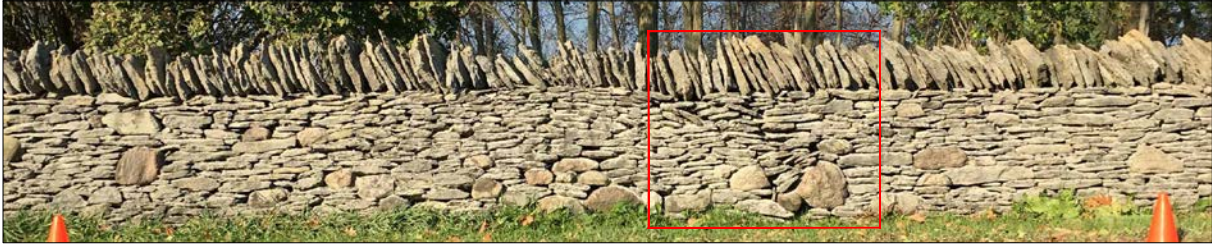
Dry Stone Fence Photo - 75m to 80m

Constructed in traditional manner with limestone, with tight joints and well distributed sizes and level bedding plane, with the exception of a change in pattern, joint tightness, and likely reconstructed area, noted above .

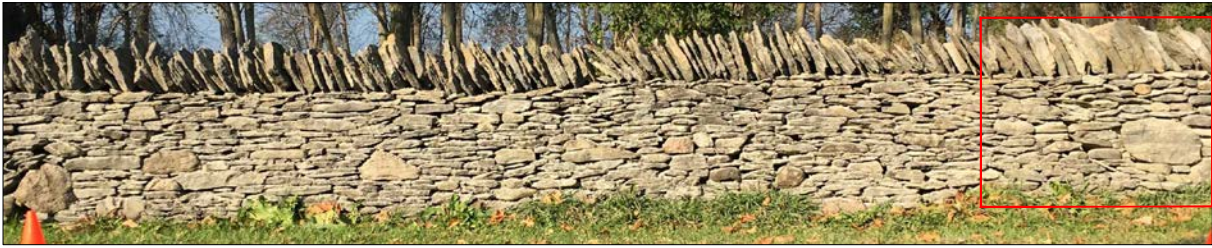
Dry Stone Fence Photo - 80m to 85m

Constructed in traditional manner with limestone, with tight joints and well distributed sizes and level bedding plane, with the exception of a change in pattern and joint tightness, noted above .

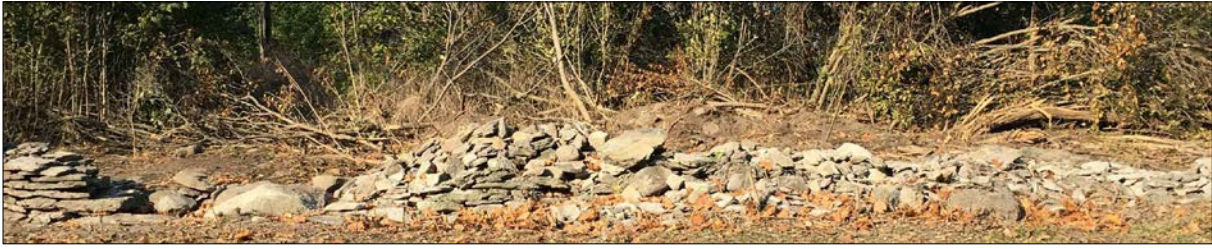
Dry Stone Fence Photo - 110m to 115m

Wall diminished in this area, tire tracks in the vicinity, indicating recent construction activities.

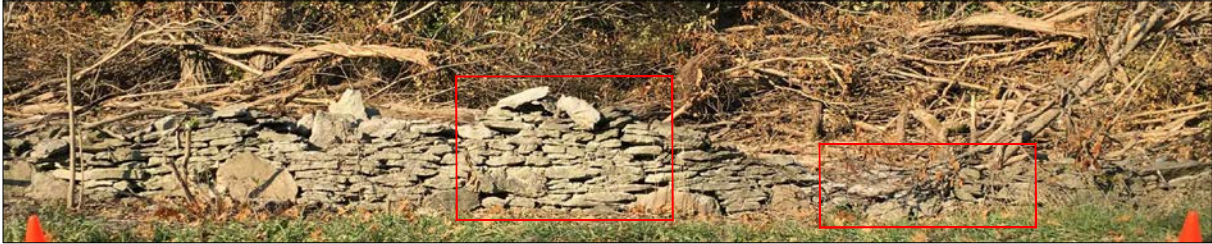
Dry Stone Fence Photo - 135m to 140m

Where wall remains it is constructed in a traditional manner, but top layers have disappeared. Note that top layers disappeared and stones are loose, as well as the wall diminishing from here.

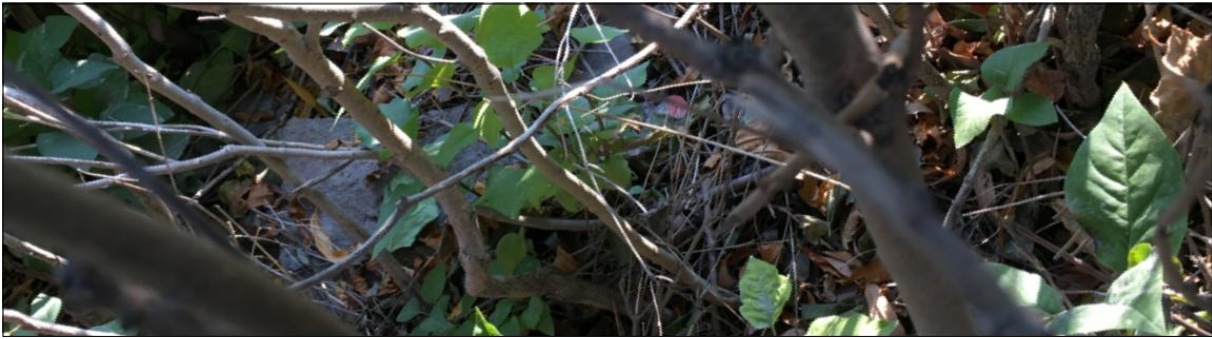
Dry Stone Fence Photo - 0m to 5m
Stones scattered under bush in front of 12515.

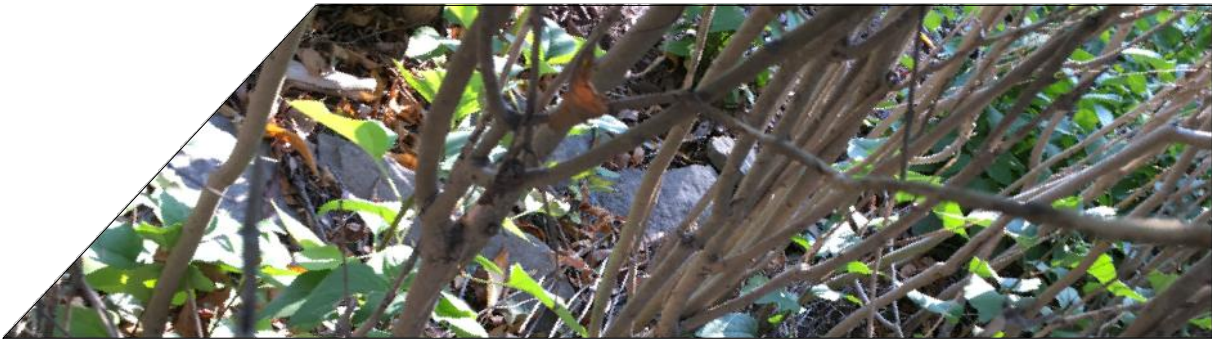
Dry Stone Fence Photo - 5m to 10m
Stones scattered under bush in front of 12515.

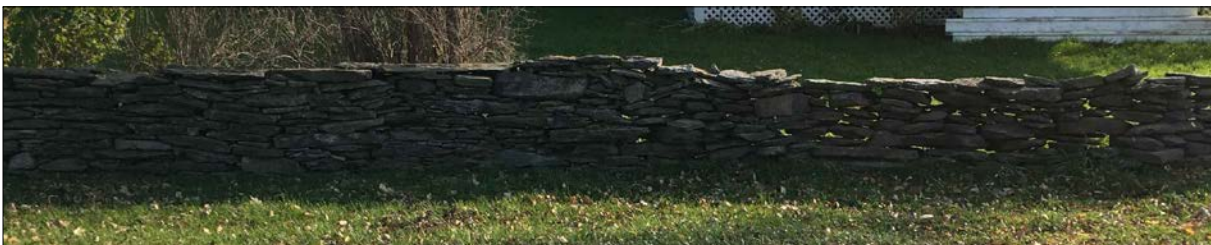
Dry Stone Fence Photo - Section 1 - 5m to 10m

Similar pattern continuous from previous section but change to loosely stacked pieces with big voids and uneven bedding.

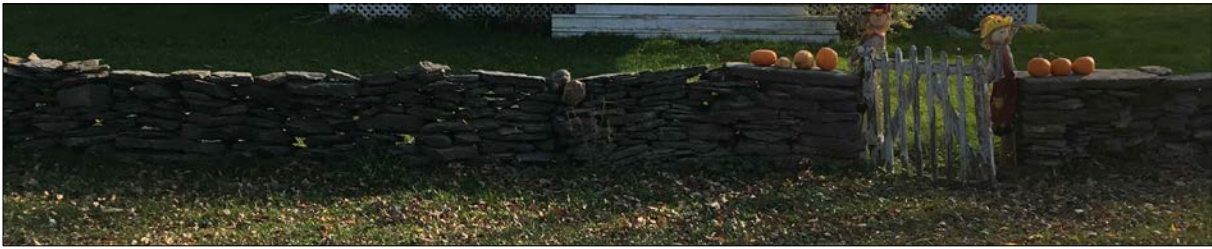
Dry Stone Fence Photo - Section 1 - 10m to 15m

Loosely stacked continuous from previous section up to about 12m and then changed to a tighter joint towards the wooden gate.

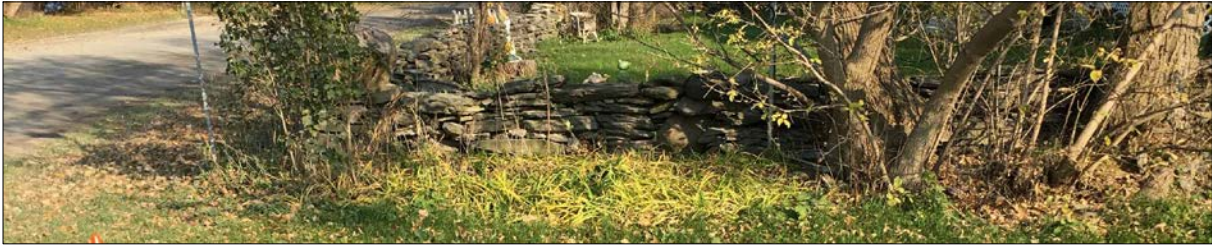
Dry Stone Fence Photo - Section 2 - 0m to 5m

Section 2 is perpendicular to the front wall shown in section 1. The stone was laid in loose pattern, lacks even bedding, tightness, has apparent voids and integrated with one round piece.
