**Subject: Amherst Island Wind Project  
Culvert Protection Measures**

**Reference: Culvert Inspection and Summary Report**  
**Project ID #1421 Amherst Island Wind Farm – Culvert Inspection, Collection System on the Island**

## AMHERST ISLAND WIND FARM CULVERT INSPECTION FORM

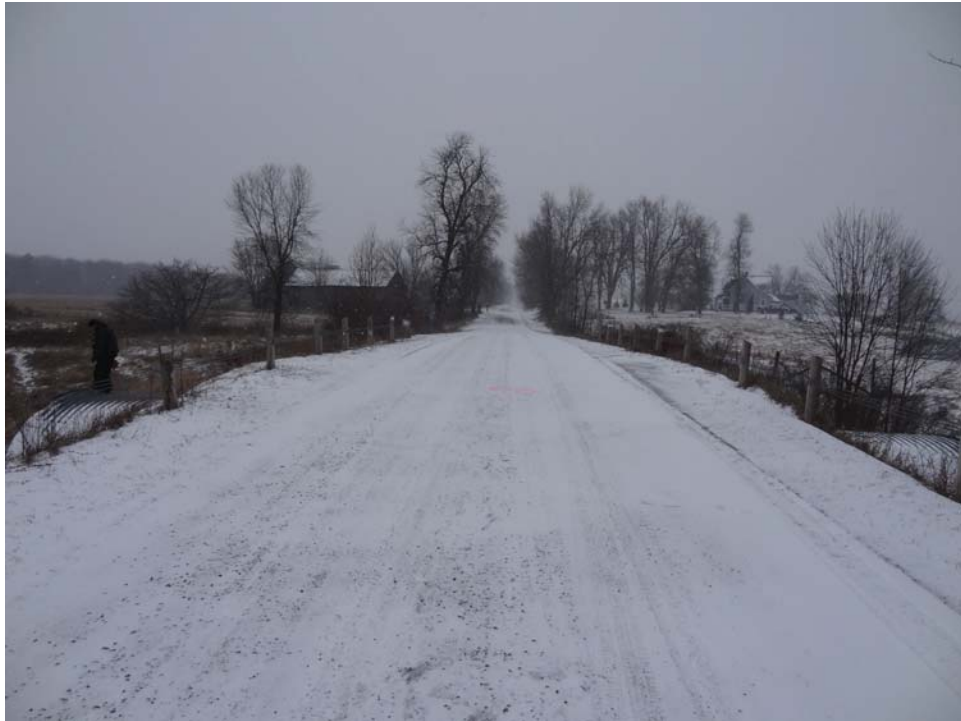
**LOOKING SOUTH**

- Pipe is in good condition. No defects observed. Culvert bolts are dry and free of rust. There are no signs of cracking or leaking of steel structure. There is minor vegetative staining along bottom 400mm of the culvert arch. The connecting arch plate to the concrete footing appears to be non-galvanized / welded steel plate. As such, there is a light rust staining along this steel plate connection. The culvert still appears to maintain its original arch shape which indicates that no deformation has occurred to date.
- Concrete footing free of defects. Two (2) Very narrow cracks < 0.2mm in width observed along south footing. These appear to be shrinkage cracks resulting from lack of concrete curing procedures at time of footing pour.

- There were no defects found during time of inspection and structure is in good condition. No repairs are required.

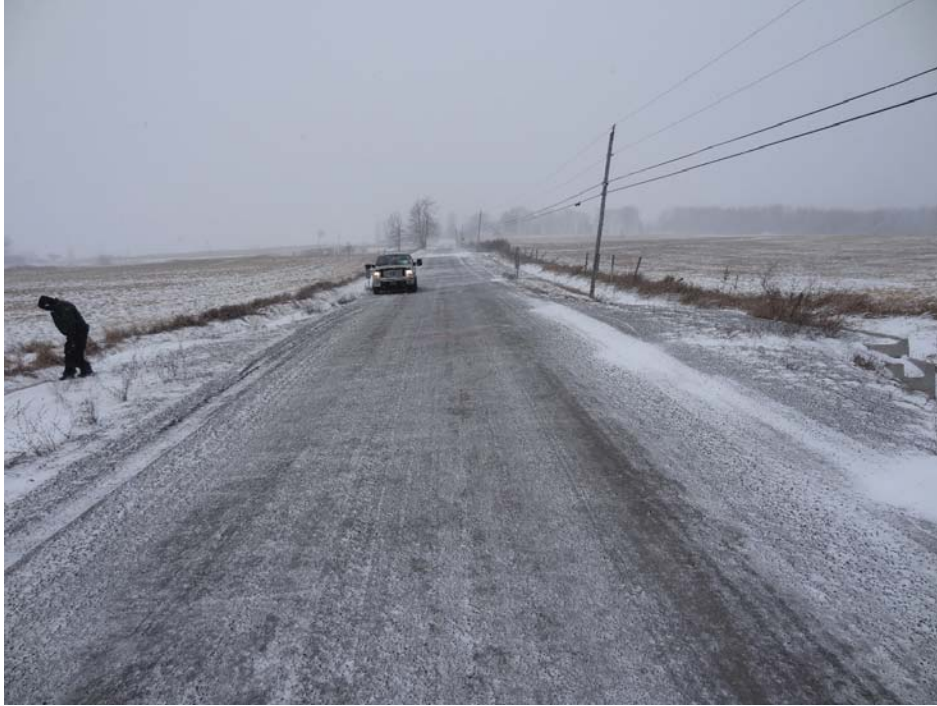
**LOOKING SOUTH**

- No defects present.
- Pre-cast roof slab sections at west end are differential in horizontal plane, but this appears to be a product of either improper orientation during installation or a manufacturing defect.
- There are no signs of settlement, cracking or deflection during inspection. Culvert faces were dry and no
- signs of leaking or moisture at joint locations.

- There were no defects found during time of inspection and structure is in good condition. No repairs are required.
