**Subject: Amherst Island Wind Project
Culvert Protection Measures**

**Reference: Culvert Inspection and Summary Report
Project ID #1421 Amherst Island Wind Farm – Culvert Inspection, Collection System on
the Island**

AMHERST ISLAND WIND FARM CULVERT INSPECTION FORM

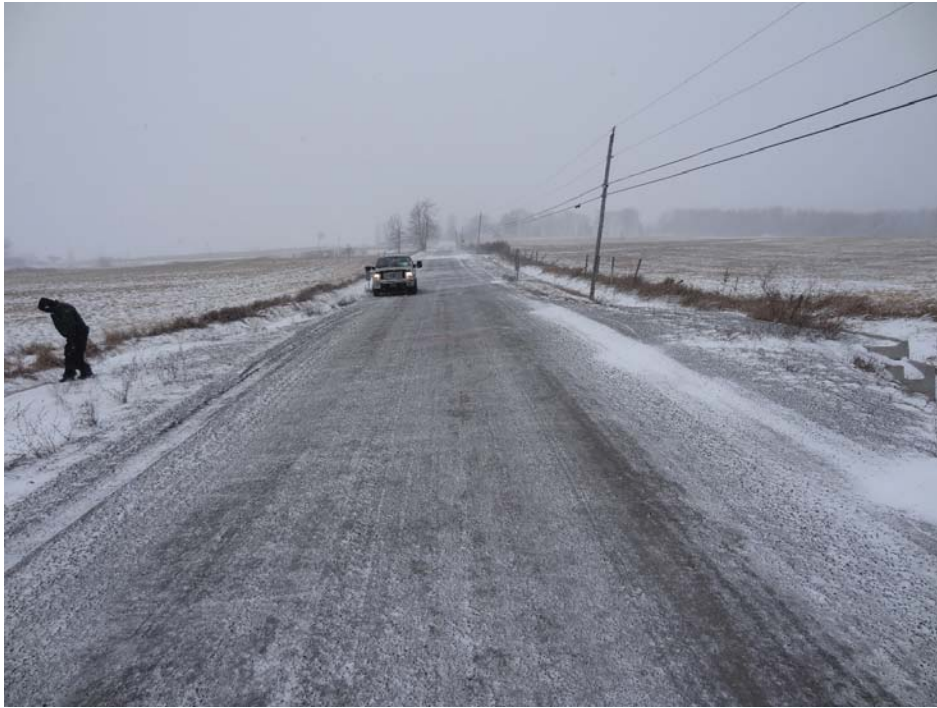
LOOKING SOUTH

- No defects present.
- Pre-cast roof slab sections at west end are differential in horizontal plane, but this appears to be a product of either improper orientation during installation or a manufacturing defect.
- There are no signs of settlement, cracking or deflection during inspection. Culvert faces were dry and no
- signs of leaking or moisture at joint locations.

- There were no defects found during time of inspection and structure is in good condition. No repairs are required.
