**Amherst Island Wind Energy Project
Irish Stone Fence Detailed Review**

File No. 160960595

December 6, 2016

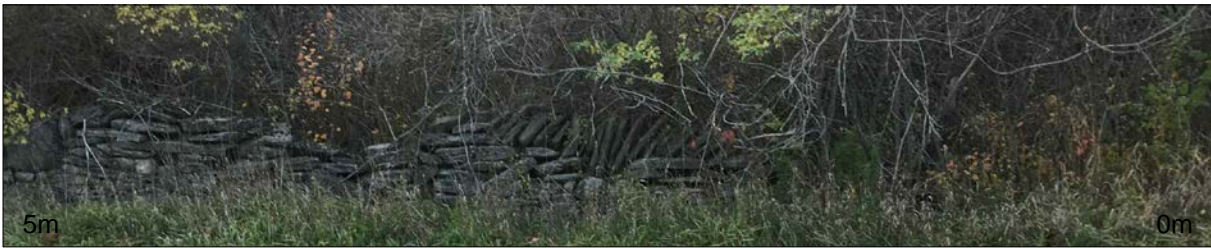
Dry Stone Fence Photo - 0m to 5m

North end starting point of the fence, west side of Emerald 40 Foot Road, 0.8 km south of Front street, consists of limestone, at 4-5m, the stones were placed tighter than the rest of this section.

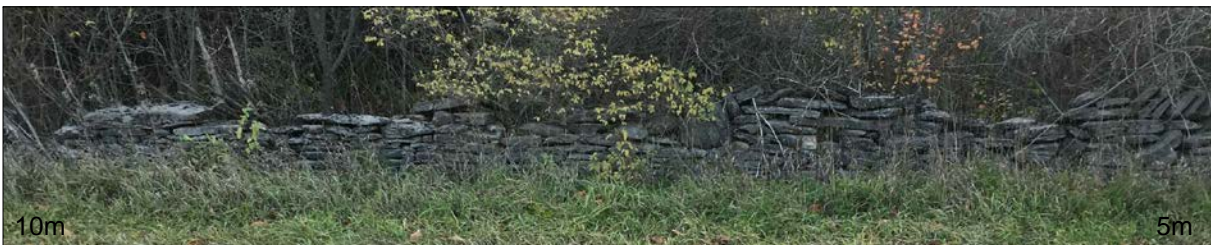
Dry Stone Fence Photo - 5m to 10m

Consists of limestone, the lower portion at left (7.5m-10m) appears to be lined more evenly and tight than the right portion(5m-7.5m).

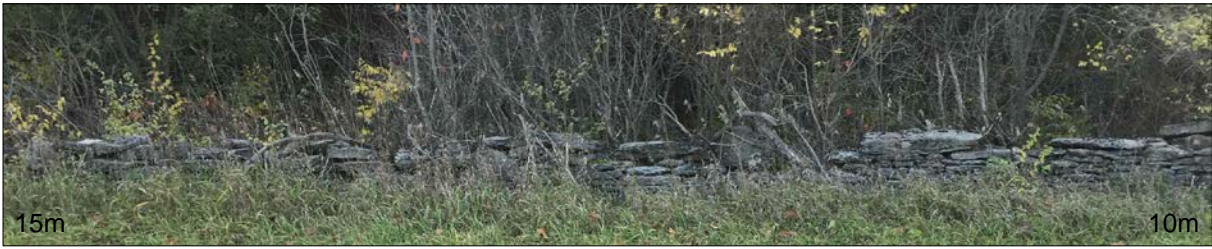
Dry Stone Fence Photo - 10m to 15m

Consists of limestone, the portion at 10-12m appears to be lined more evenly and tight than the right portion(12-15m).

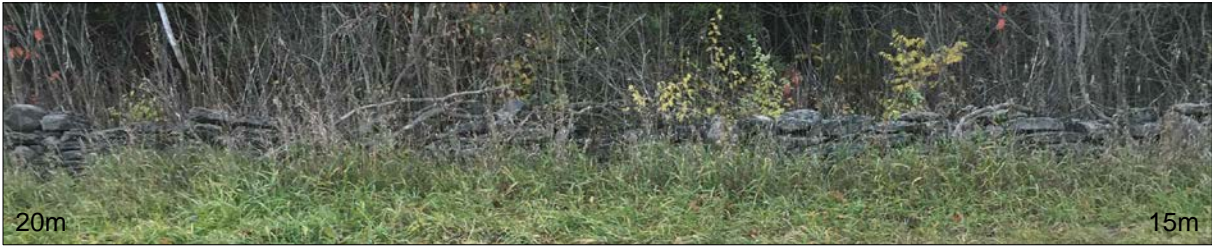
Dry Stone Fence Photo - 15m to 20m

Consists of limestone, this portion was placed with various alignment and tightness.

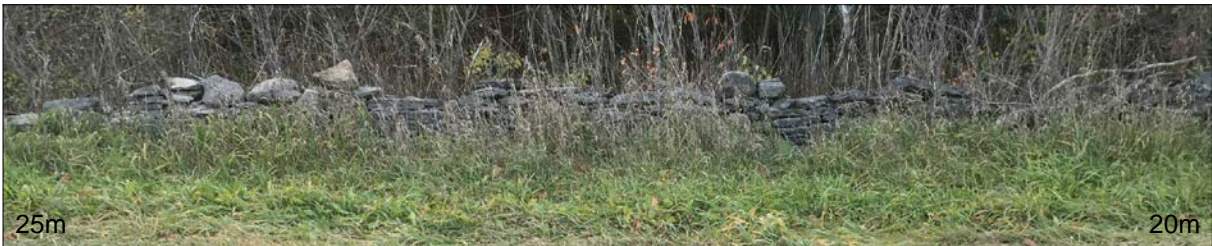
Dry Stone Fence Photo - 20m to 25m

Consists of limestone, this portion was placed with various alignment and tightness, note the round pieces on top of wall.

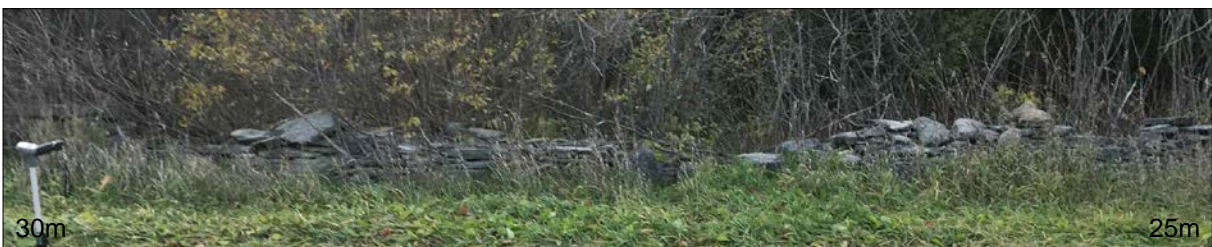
Dry Stone Fence Photo - 25m to 30m

Consists of limestone, this portion was placed with various alignment and tightness.

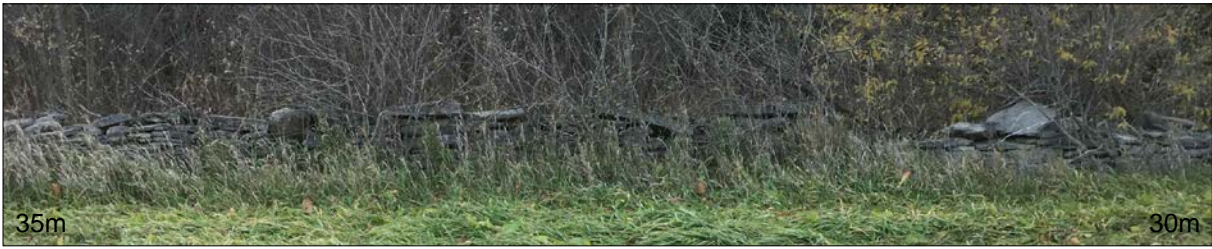
Dry Stone Fence Photo - 30m to 35m

Consists of limestone, this portion was placed at various alignment and tightness, the lower portion at middle appears to be laid more evenly than the rest of this section.

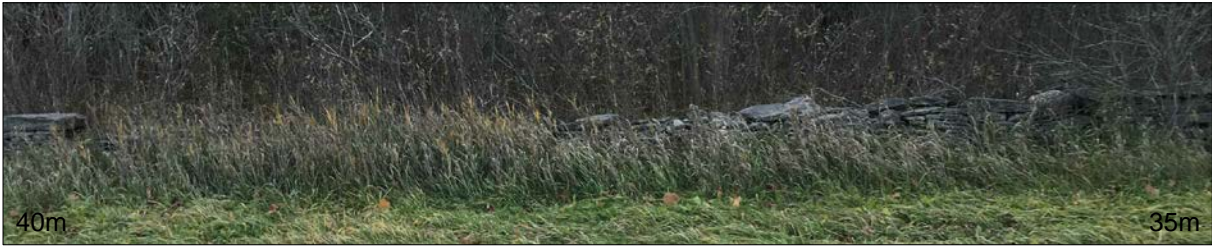
Dry Stone Fence Photo - 35m to 40m

Consists of limestone, the 35-37m portion was placed at more evenly and tightly than the rest.

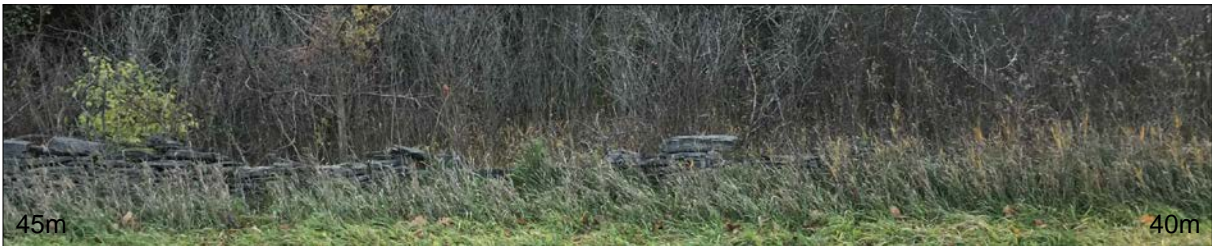
Dry Stone Fence Photo - 40m to 45m

Consists of limestone, this portion was placed with various alignment and tightness.

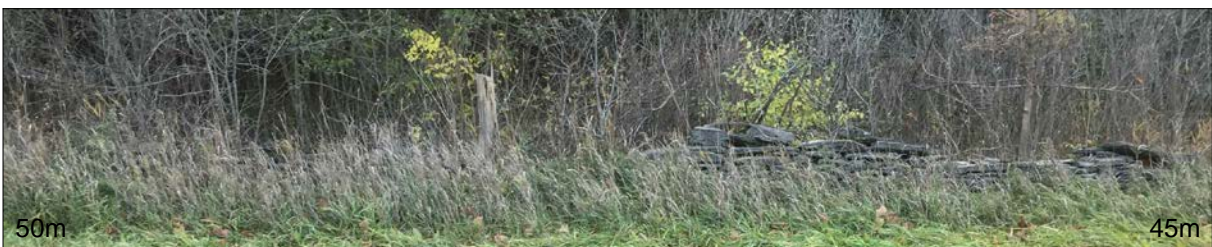
Dry Stone Fence Photo - 45m to 50m

Consists of limestone, this portion was placed with various alignment and tightness.

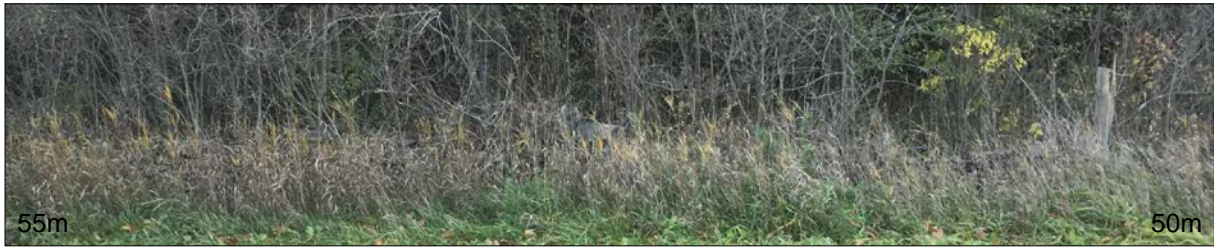
Dry Stone Fence Photo - 50m to 55m

Consists of limestone, barely visible, this portion was placed with various alignment and tightness.

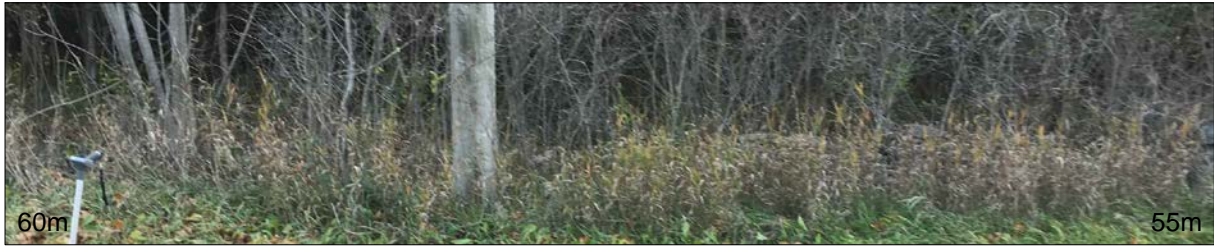
Dry Stone Fence Photo - 55m to 60m

Barely visible, consists of limestone, this portion was placed with various alignment and tightness.

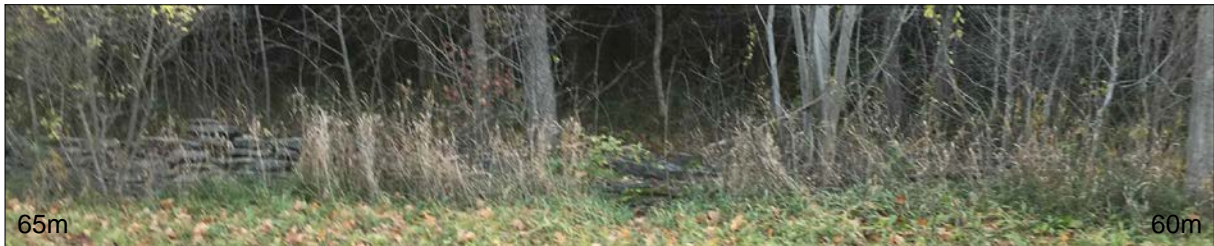
Dry Stone Fence Photo - 60m to 65m

Consists of limestone, this portion was placed with various alignment and tightness.

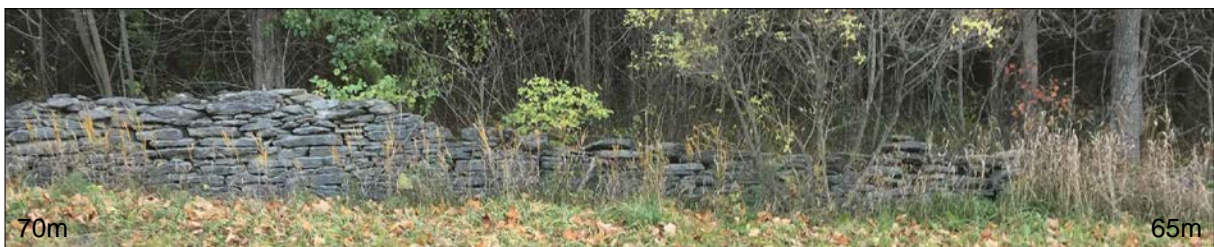
Dry Stone Fence Photo - 65m to 70m

Consists of limestone, the 67-70m portion is more even and tight than the remaining, indicating a modification at 65-67m portion.

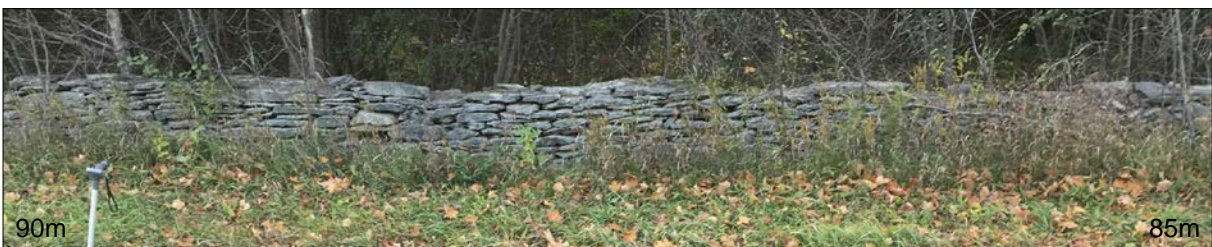
Dry Stone Fence Photo - 85m to 90m

This section appears to be placed in the traditional manner with even bedding and decent tight joints, some gaps are present.

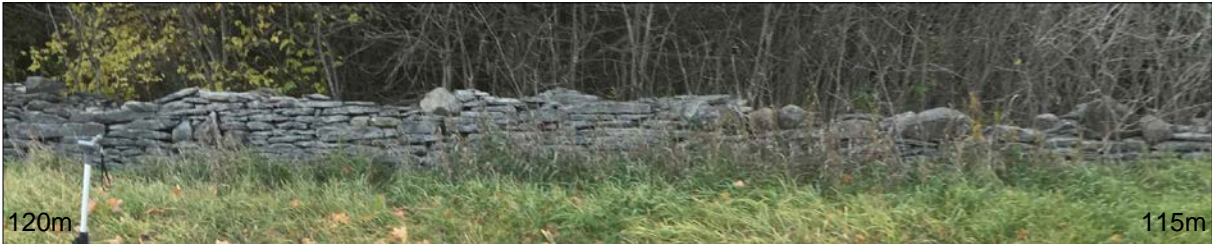
Dry Stone Fence Photo - 115m to 120m

Area between 117 -120m appears to have more tight joints and even bedding line than the area between 115-117, note the change texture and pattern at about 120m which indicates reconstruction at some point in time.

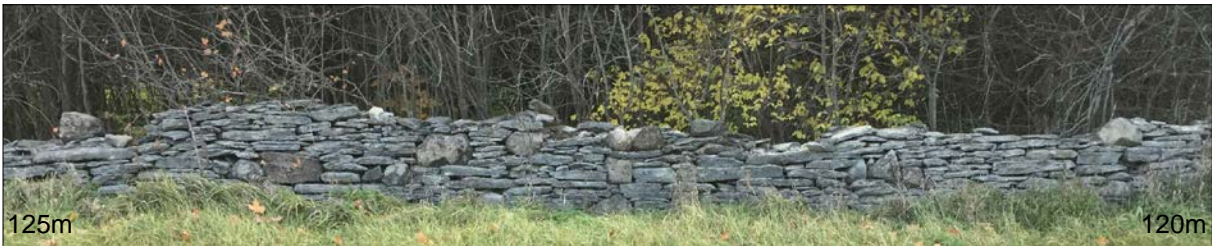
Dry Stone Fence Photo - 120m to 125m

Area between 120-124m appears to be constructed in the traditional manner, but the height is reduced towards the 125m mark. Note the big round rubble pieces sandwiched in between the long flat pieces.

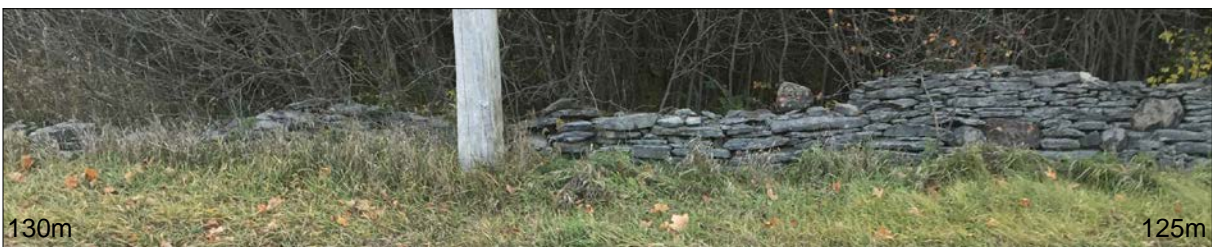
Dry Stone Fence Photo - 125m to 130m

The first half (right side of photo) of wall is more traditionally placed than the second half (left side of photo) which is reduced in height to barely visible.

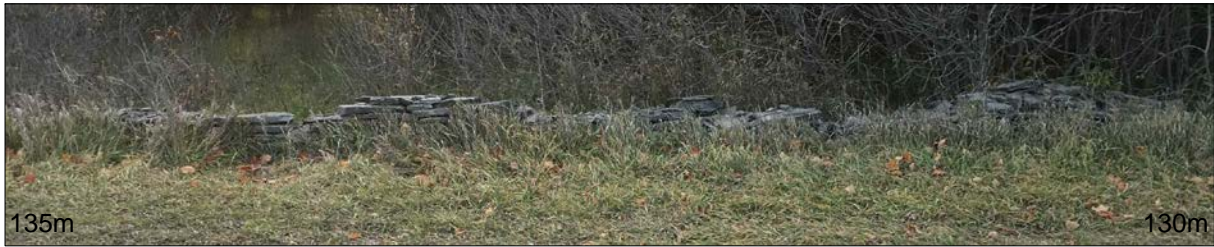
Dry Stone Fence Photo - 130m to 135m

The portion on the left appears to be randomly placed stone pieces, the portion on the right is placed in a systematic manner, the height varies.

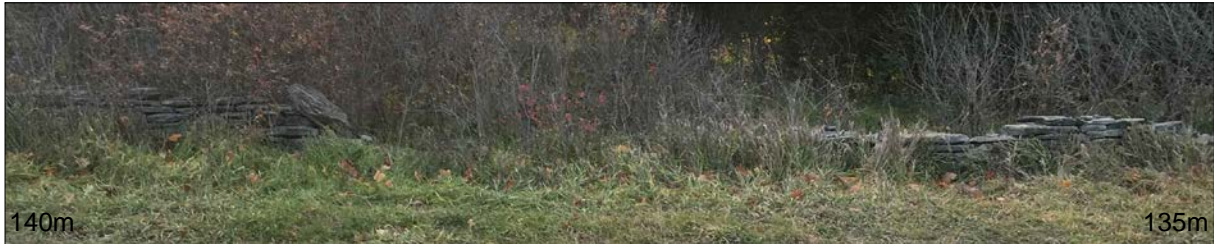
Dry Stone Fence Photo - 135m to 140m

The height varies from non-existence of fence at middle section to traditionally stacked low wall, some top pieces appears to be placed randomly.

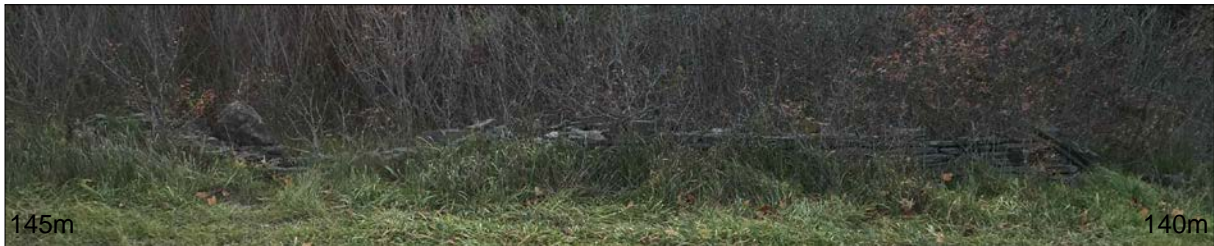
Dry Stone Fence Photo - 140m to 145m

The height varies significantly, sections of traditionally stacked low wall, some top pieces appear to be placed randomly.

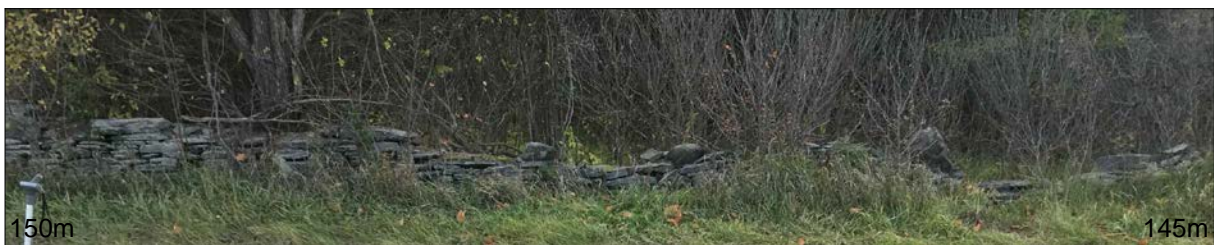
Dry Stone Fence Photo - 145m to 150m

The height varies significantly, sections of traditionally stacked low wall, some top pieces appear to be placed randomly.

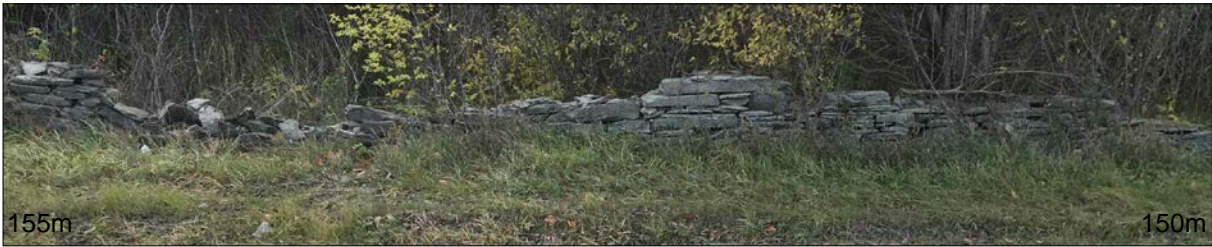
Dry Stone Fence Photo - 150m to 155m

The height varies significantly, sections of traditionally stacked low wall, some top pieces appear to be placed randomly.

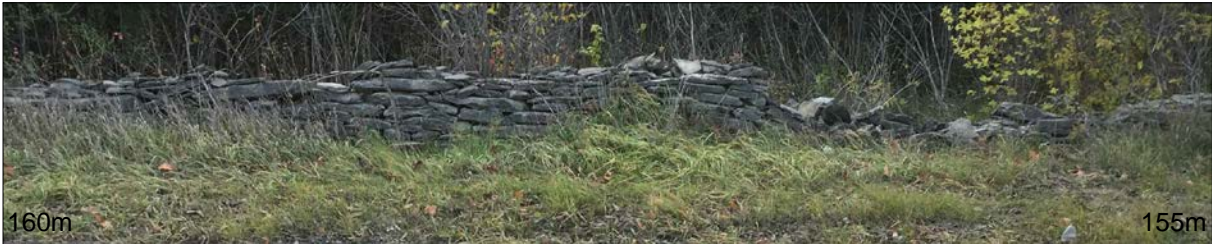
Dry Stone Fence Photo - 155m to 160m

Height reduces to barely visible towards left, the portion at right appears to be built in traditional way, with medium tight joints and decent level of bedding, note random round piece at top and one round piece at the left end.

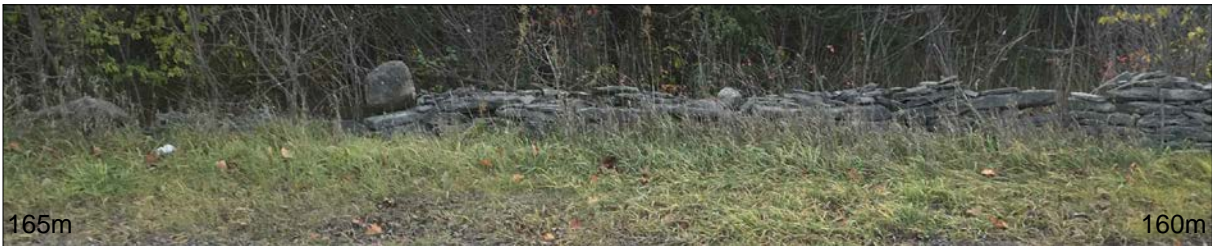
Dry Stone Fence Photo - 160m to 165m

The height varies significantly, sections of traditionally stacked low wall, some top pieces appear to be placed randomly.

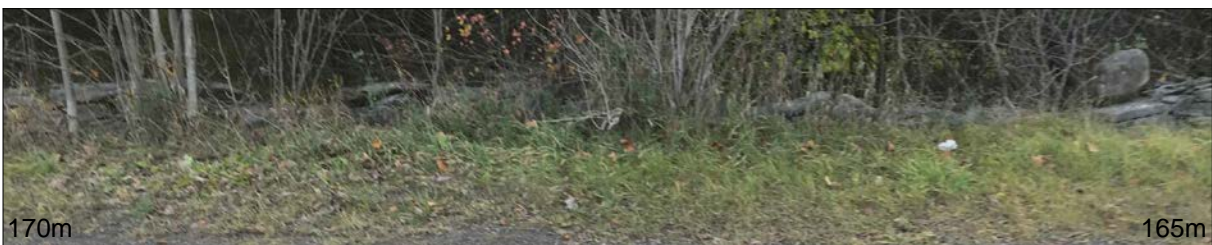
Dry Stone Fence Photo - 165m to 170m

Barely visible with one to two layers hidden in grass, appears to be randomly placed.

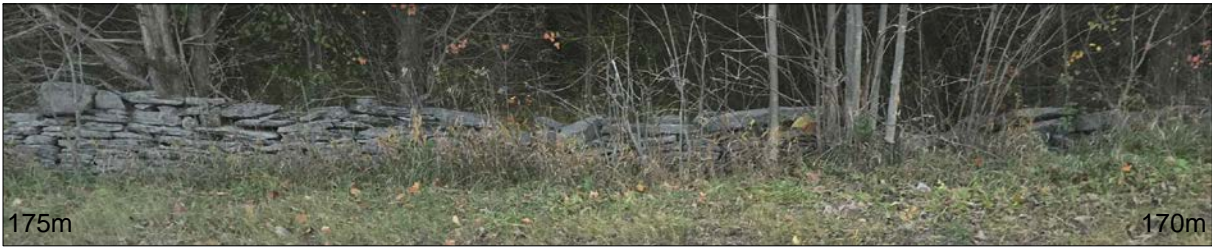
Dry Stone Fence Photo - 170m to 175m

Laid in traditional manner and medium uniform height, bedding plane and medium tight joints .

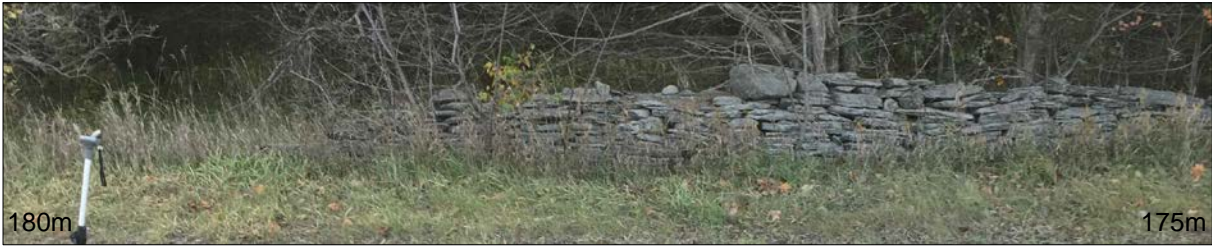
Dry Stone Fence Photo - 175m to 180m

Height diminished from right to left, the visible portion appears to be built in traditional manner with medium uniform bedding plane and medium tight joints.

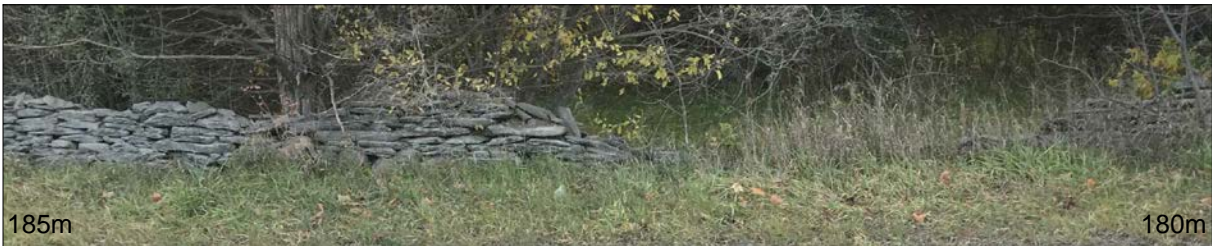
Dry Stone Fence Photo - 180m to 185m

Wall height rises towards left portion, built in traditional manner, the bedding plane appears to be even and joints medium tight.

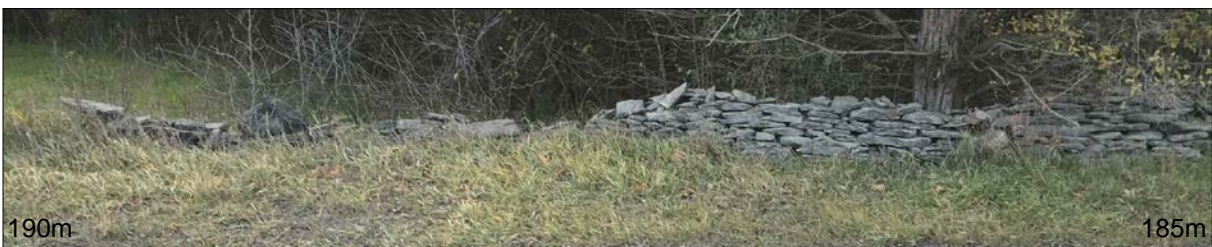
Dry Stone Fence Photo - 185m to 190m

The wall height reduces towards the left where stones become barely visible, the placement pattern is less systematic.

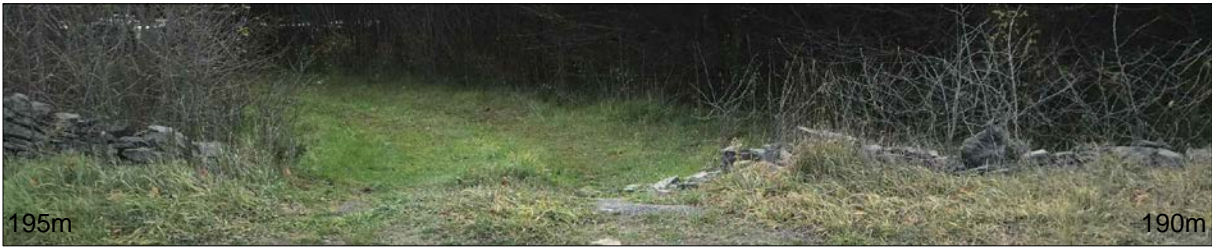
Dry Stone Fence Photo - 190m to 195m

Stone wall height diminishes to a few random stones embedded in the ground at a pathway into the forest, and rises again, the small section of wall is laid in traditional manner with similar fashion to other sections.

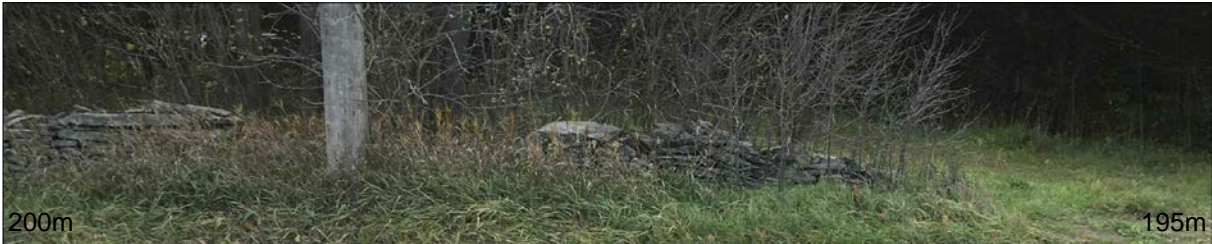
Dry Stone Fence Photo - 195m to 200m

Stone fence is barely visible in the middle of the section, the visible low wall at left has decent tight joints and evenness of bedding plane.

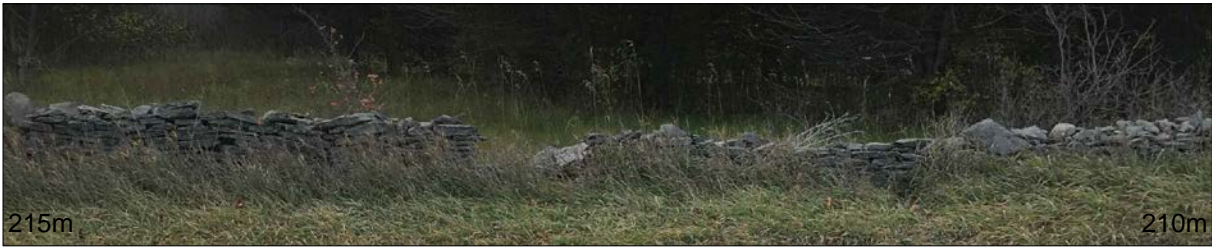
Dry Stone Fence Photo - 210m to 215m

Low wall slightly increases towards left portion, but the tightness and evenness of wall reduces as compare to the portion at the right.

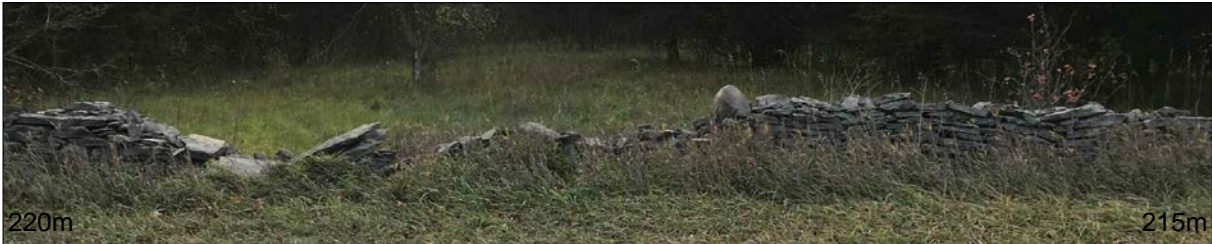
Dry Stone Fence Photo - 215m to 220m

Again the wall height reduces to barely visible and rises again towards left, stones and mid portion appears to be laid randomly.

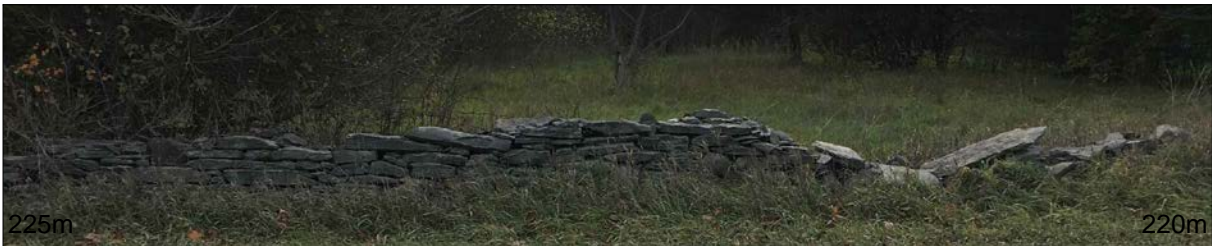
Dry Stone Fence Photo - 220m to 225m

This portion of the wall has medium tight joints and even bedding plane appearing to be constructed in traditional manner, though the change in size and thickness of stone may indicate a reconstruction of a portion of it.

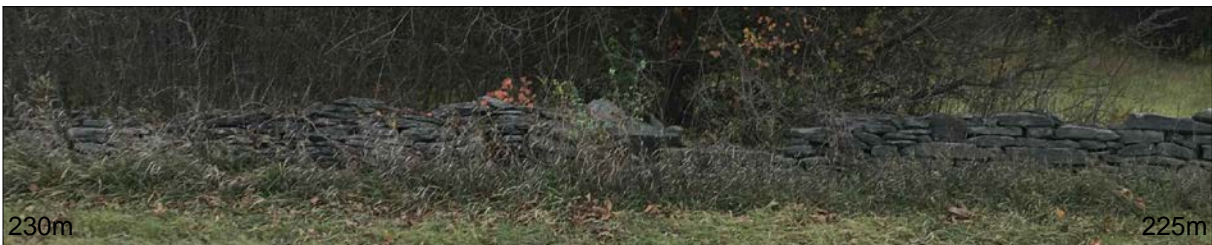
Dry Stone Fence Photo - 225m to 230m

Less visible due to grass but appears to be laid in traditional way. The left portion also appears to have smaller stones and tighter joints than the portion at the right.

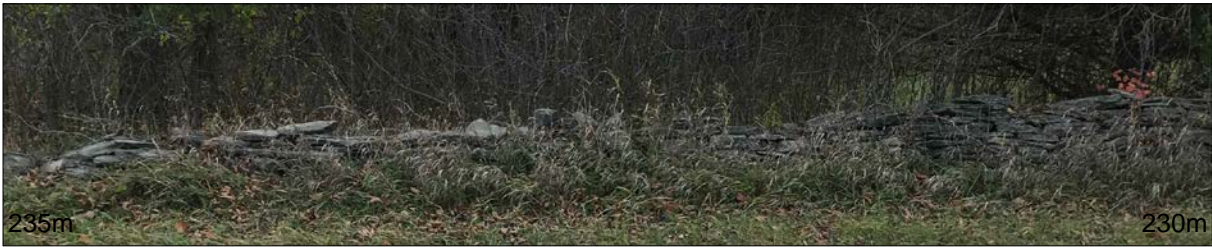
Dry Stone Fence Photo - 230m to 235m

The wall height reduces to even less visible due to grass and appears to diminish at the left end.

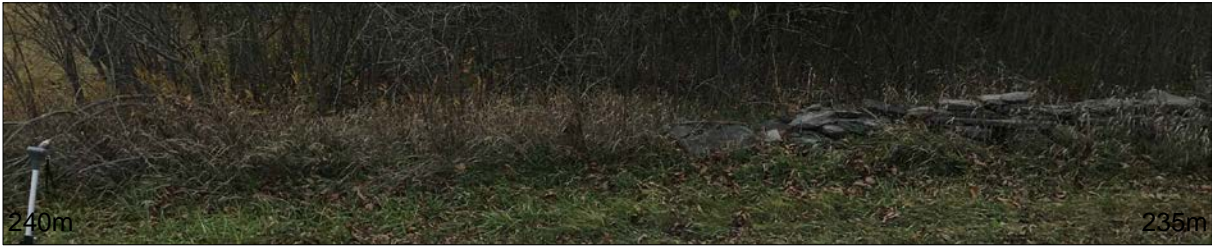
Dry Stone Fence Photo - 235m to 240m

Not visible except portion at the right.

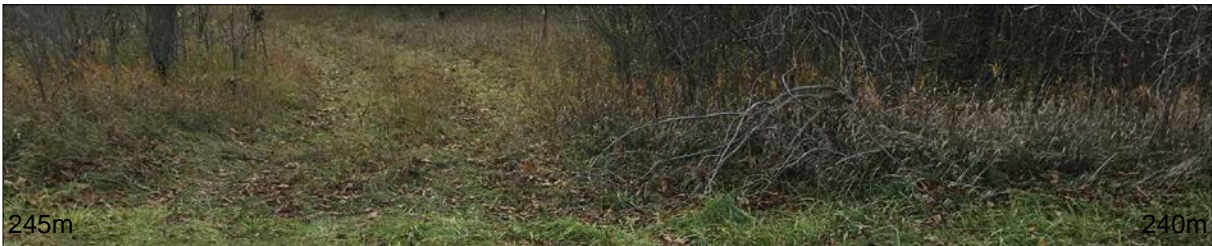
Dry Stone Fence Photo - 240m to 245m

Not visible.

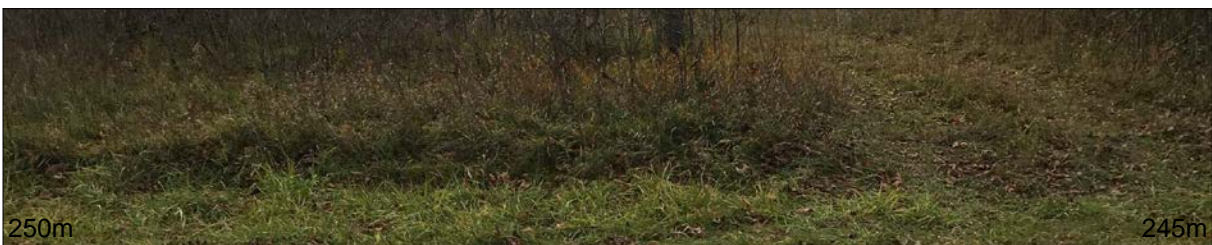
Dry Stone Fence Photo - 245m to 250m

Not visible.

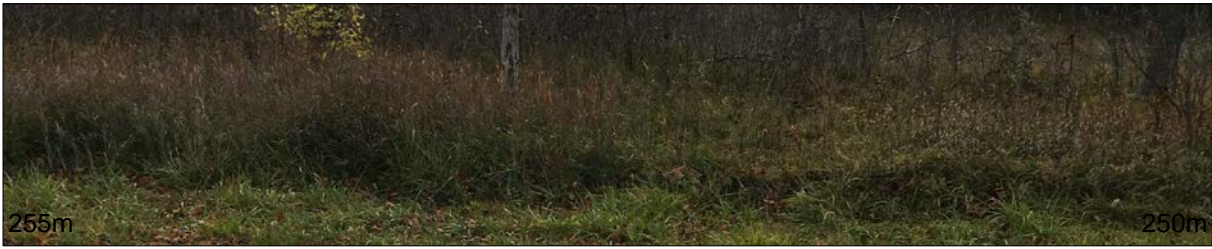
Dry Stone Fence Photo - 250m to 255m

Not visible.

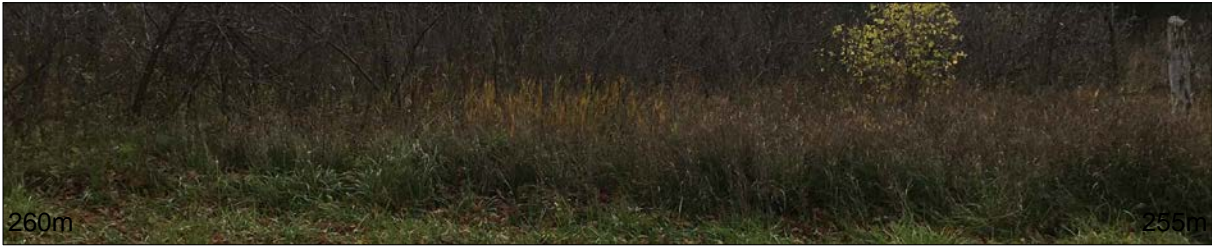
Dry Stone Fence Photo - 255m to 260m

Not visible.

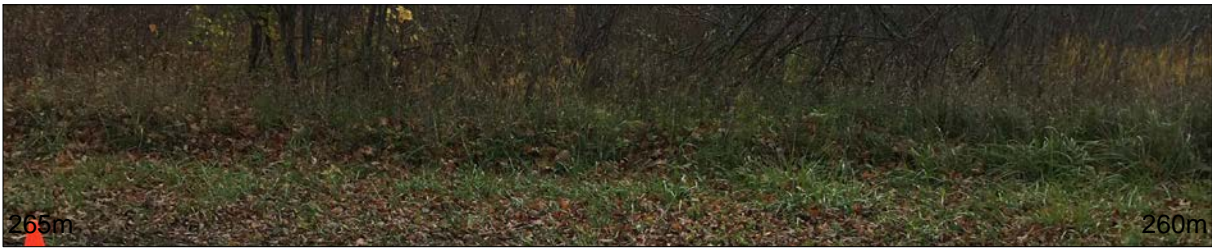
Dry Stone Fence Photo - 260m to 265m

Not visible.

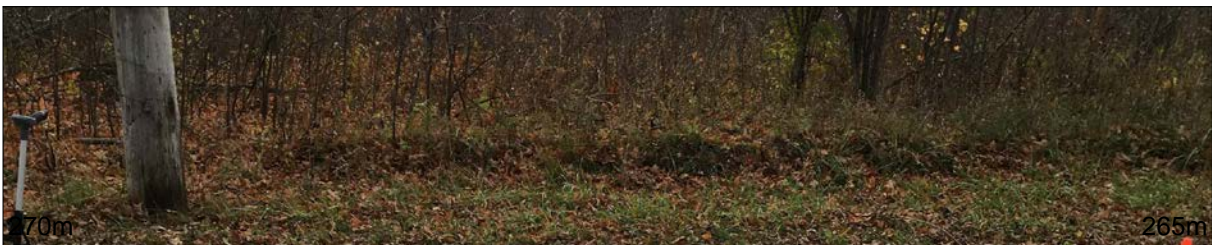
Dry Stone Fence Photo - 265m to 270m

Not visible.

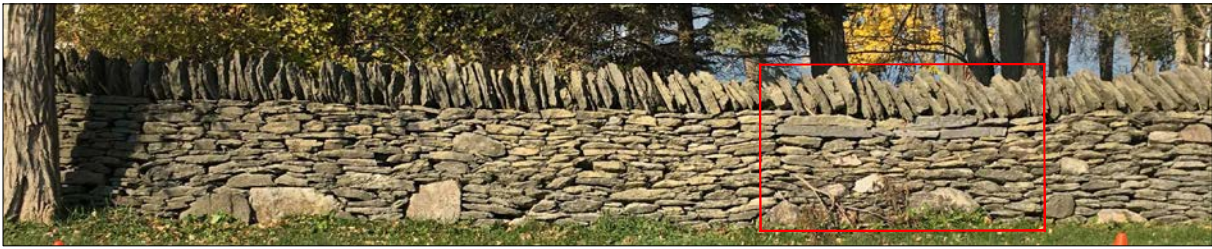
Dry Stone Fence Photo - 10m to 15m

Constructed in traditional manner with limestone, with tight joints and well distributed sizes and level bedding plane, with the exception of change in stone sizes and slight pattern change, likely reconstruction, indicated above.

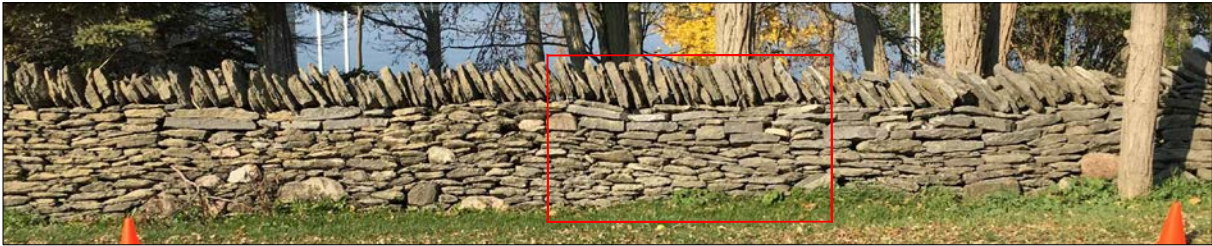
Dry Stone Fence Photo - 15m to 20m

Constructed in traditional manner with limestone, with tight joints and well distributed sizes and level bedding plane, with the exception of change in stone sizes and slight pattern change, likely reconstruction, indicated above.

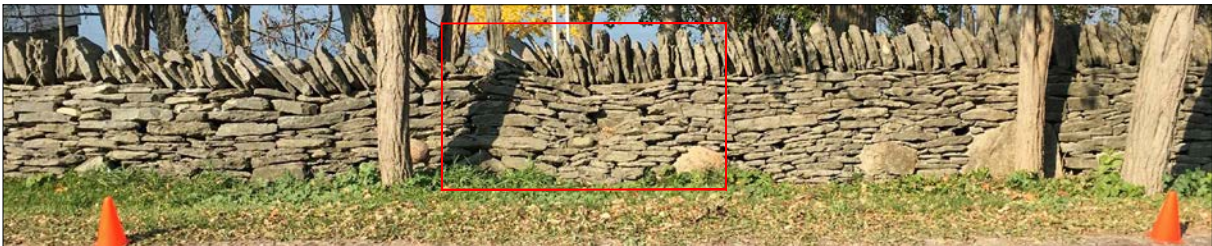
Dry Stone Fence Photo - 20m to 25m

Constructed in traditional manner with limestone, with tight joints and well distributed sizes and level bedding plane, with the exception of change in stone sizes and slight pattern change, likely reconstruction, indicated above.

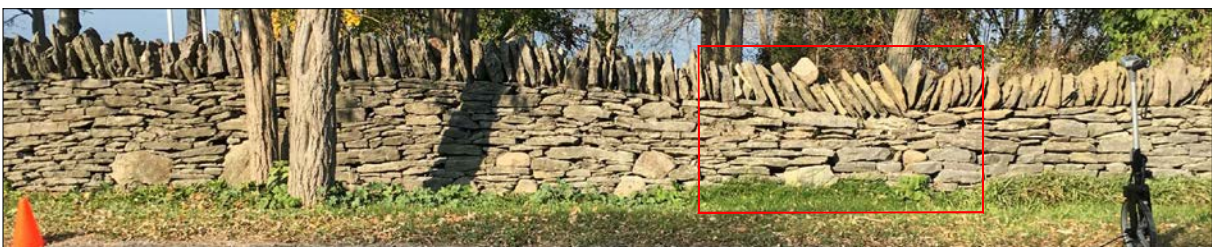
Dry Stone Fence Photo - 25m to 30m

Constructed in traditional manner with limestone, with tight joints and well distributed sizes and level bedding plane, with the exception of change in stone sizes and slight pattern change, likely reconstruction, indicated above.

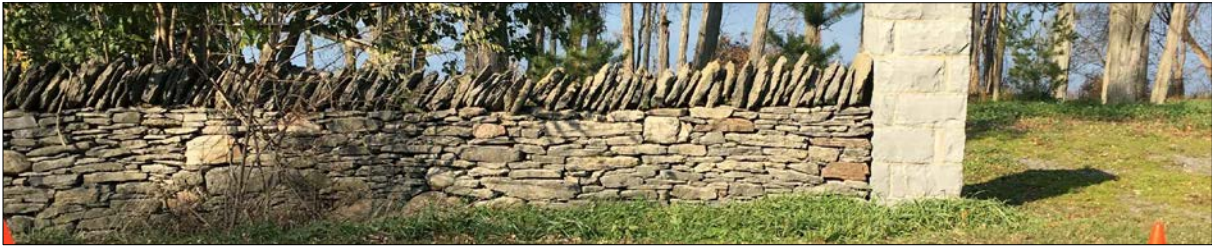
Dry Stone Fence Photo - 40m to 45m

Constructed in traditional manner with limestone, with tight joints and well distributed sizes and level bedding plane.

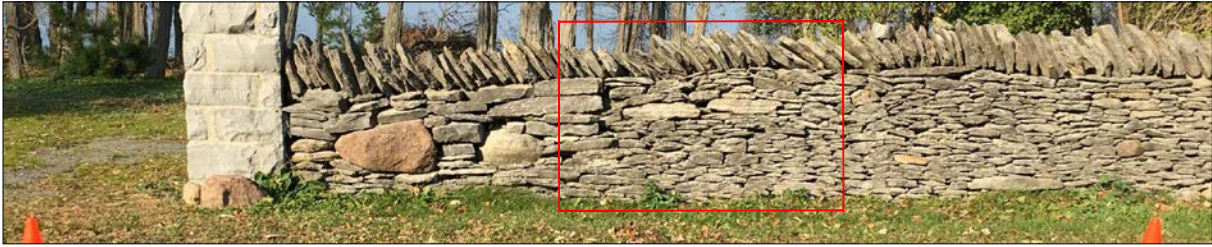
Dry Stone Fence Photo - 50m to 55m

Constructed in traditional manner with limestone, with tight joints and well distributed sizes and level bedding plane, with the exception of the placement pattern, stone sizes and tightness is less than the adjacent, indicated above.

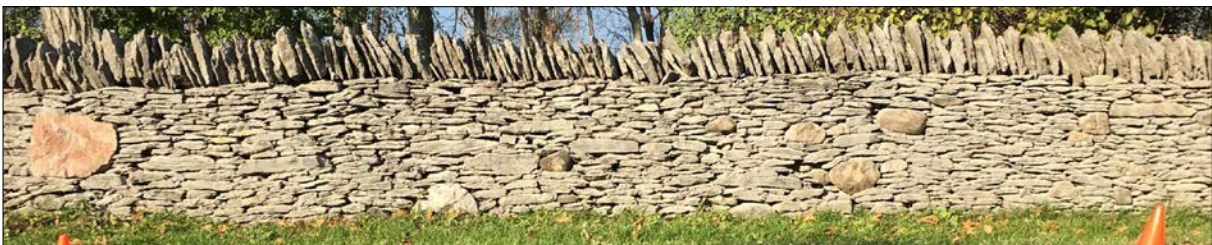
Dry Stone Fence Photo - 65m to 70m

Constructed in traditional manner with limestone, with tight joints and well distributed sizes and level bedding plane.

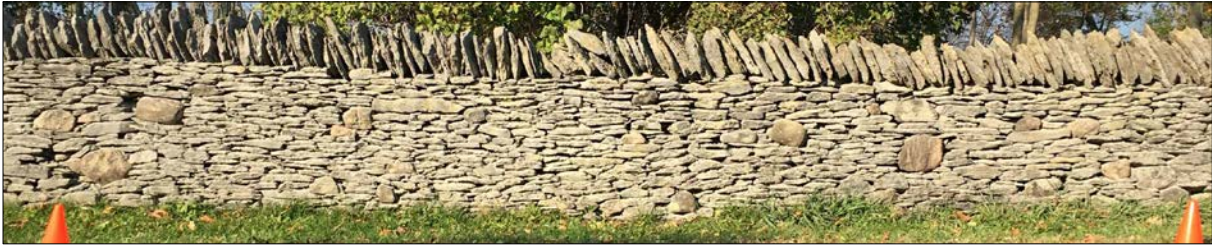
Dry Stone Fence Photo - 70m to 75m

Constructed in traditional manner with limestone, with tight joints and well distributed sizes and level bedding plane.

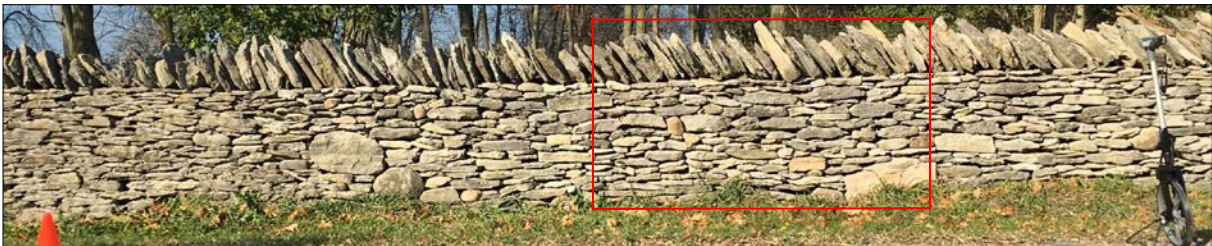
Dry Stone Fence Photo - 85m to 90m

Constructed in traditional manner with limestone, with tight joints and well distributed sizes and level bedding plane, with the exception of a slight change in pattern, stone sizes and joint tightness, possible a reconstructed area.

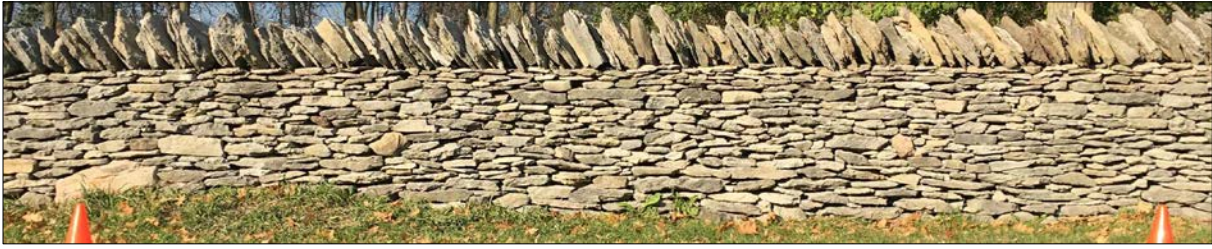
Dry Stone Fence Photo - 90m to 95m

Constructed in traditional manner with limestone, with tight joints and well distributed sizes and level bedding plane.

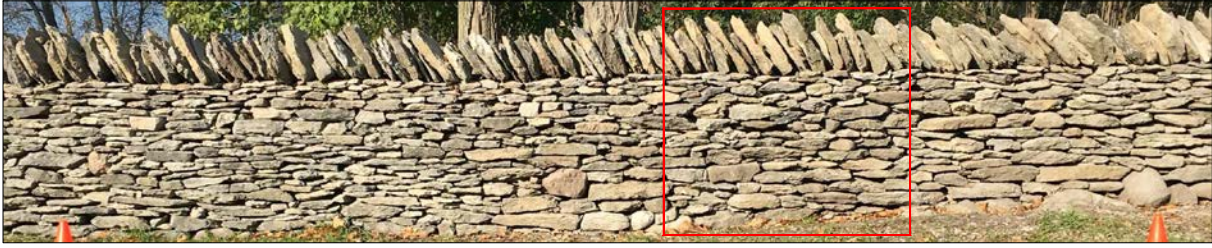
Dry Stone Fence Photo - 95m to 100m

Constructed in traditional manner with limestone, with tight joints and well distributed sizes and level bedding plane, with the exception of a slight change in pattern, stone sizes and joint tightness.

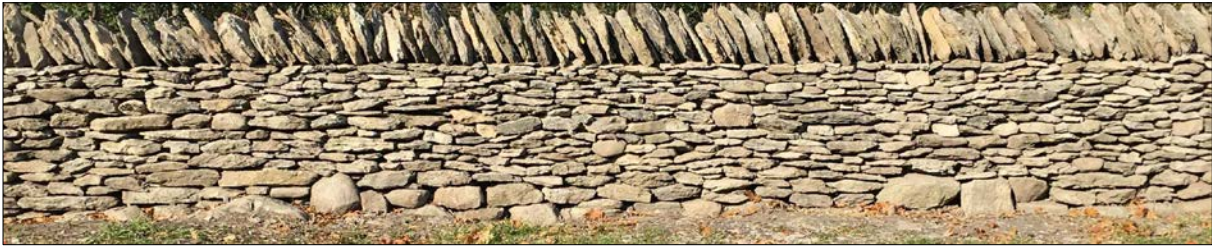
Dry Stone Fence Photo - 100m to 105m

Constructed in traditional manner with limestone, with tight joints and well distributed sizes and level bedding plane, note several large stones at the bottom of wall.

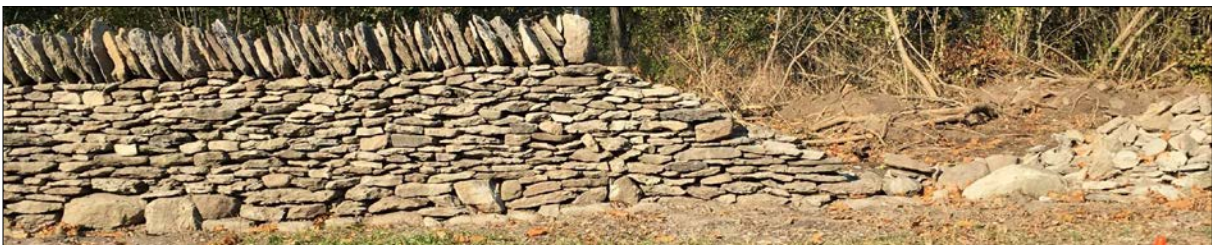
Dry Stone Fence Photo - 105m to 110m

Constructed in traditional manner with limestone, with tight joints and well distributed sizes and level bedding plane, with an exception at about 107 m from the west end, wall diminished, tire tracks in the vicinity, indicating recent construction activities.

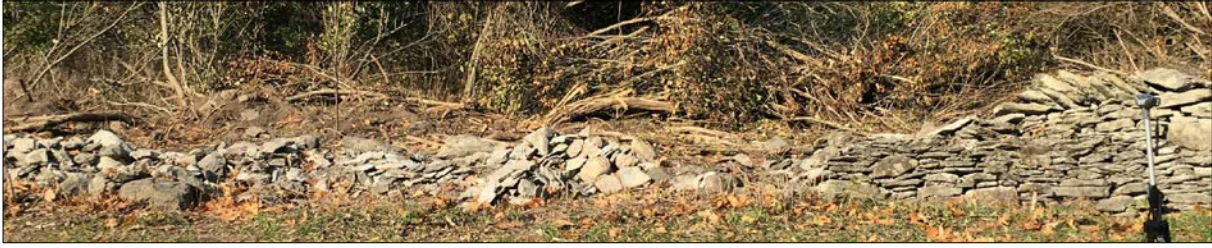
Dry Stone Fence Photo - 115m to 120m

Wall diminished in this area with some remaining at the east end of this section, tire tracks in the vicinity, indicating recent construction activities.

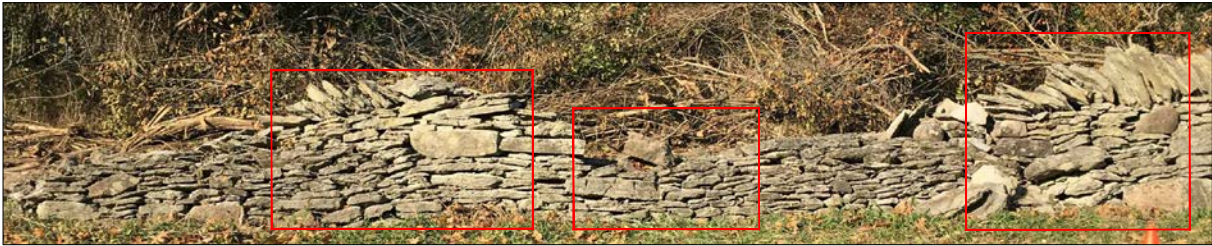
Dry Stone Fence Photo - 120m to 125m

The section that remains is constructed in traditional manner but there is apparent changes in pattern, tightness and levelness, indicating reconstruction activities

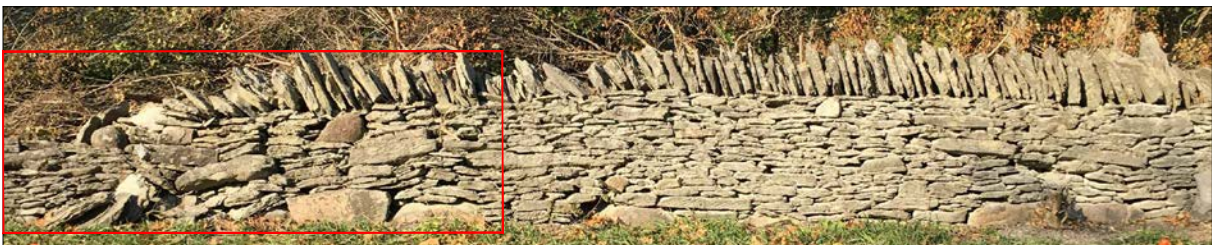
Dry Stone Fence Photo - 125m to 130m

Constructed in traditional manner with limestone, with tight joints and well distributed sizes and level bedding plane, with the exception of a change in size of stone, joint tightness, levelness and color indicating reconstruction area.

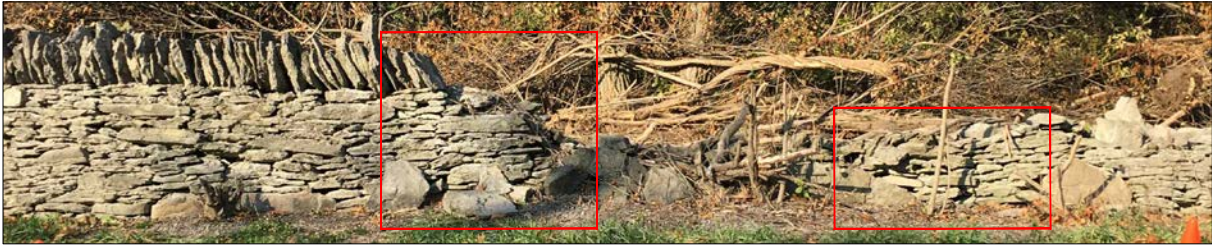
Dry Stone Fence Photo - 130m to 135m

Constructed in traditional manner with limestone, with tight joints and well distributed sizes and level bedding plane, with the exception of the fence diminishing and then reappearing again with lower height and without vertical coping stones.

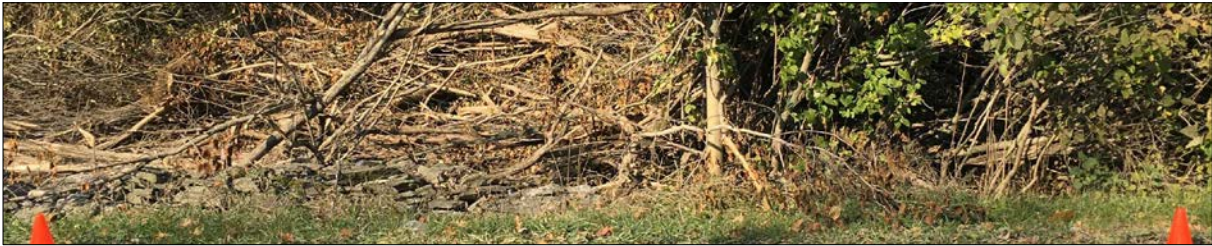
Dry Stone Fence Photo - 140m to 145m

Barely visible, with lower portion of the wall remaining and scattered.

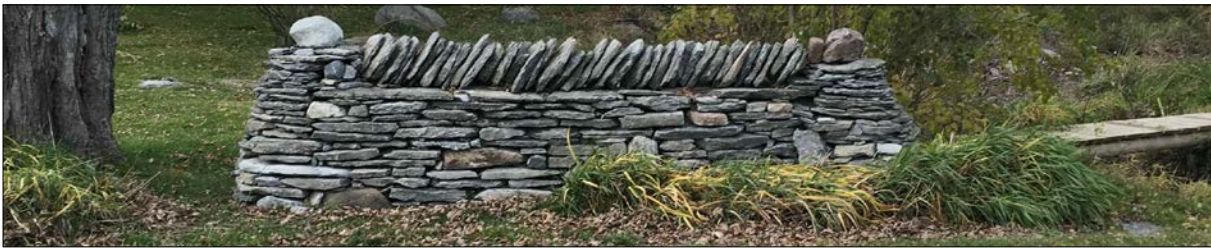
Dry Stone Fence Photo - Section 1 - 0m to 4.75m

Mostly limestone with a few granitic rounder pieces at random locations. Well built with level bedding planes, tight joints, well distributed sizes and shapes.

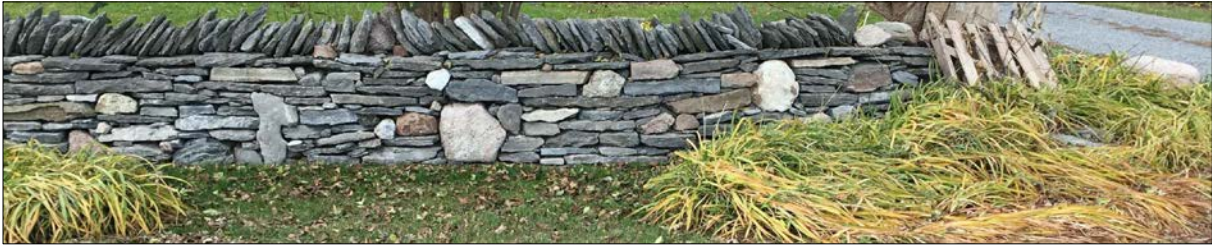
Dry Stone Fence Photo - Section 2 - 0m to 5m

Mostly limestone with a few granitic rounder pieces at random locations. Well built with level bedding planes, tight joints, well distributed sizes and shapes.

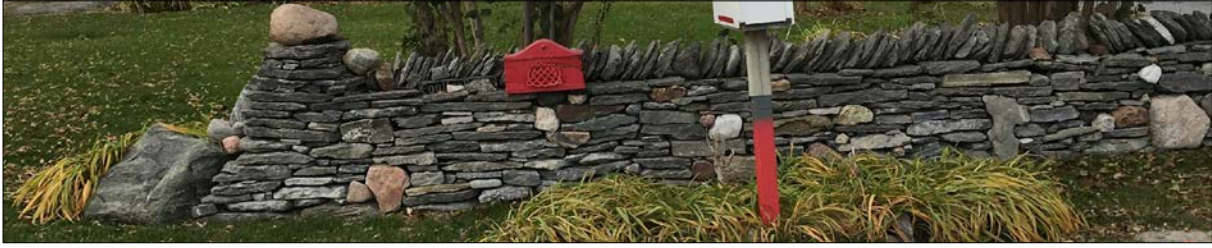
Dry Stone Fence Photo - Section 2 - 5m to 9.4m

Mostly limestone with a few granitic rounder pieces at random locations. Well built with level bedding planes, tight joints, well distributed sizes and shapes.

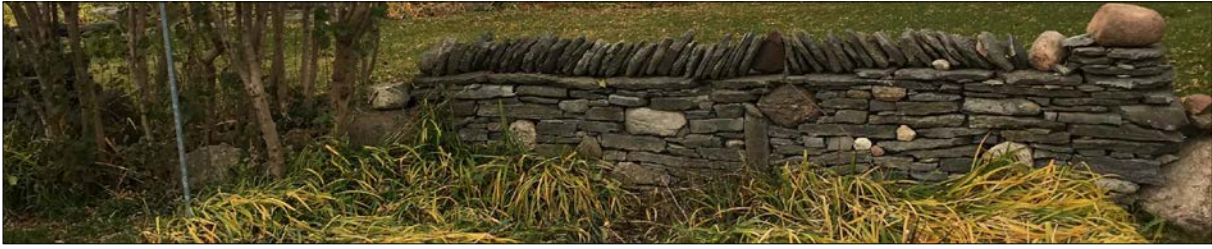
Dry Stone Fence Photo - Section 3 - 0m to 5m

Mostly limestone with a few granitic rounder pieces at random locations. Well built with level bedding planes, tight joints, well distributed sizes and shapes.
