**Amherst Island Wind Energy Project
Irish Stone Fence Detailed Review**

File No. 160960595

December 6, 2016

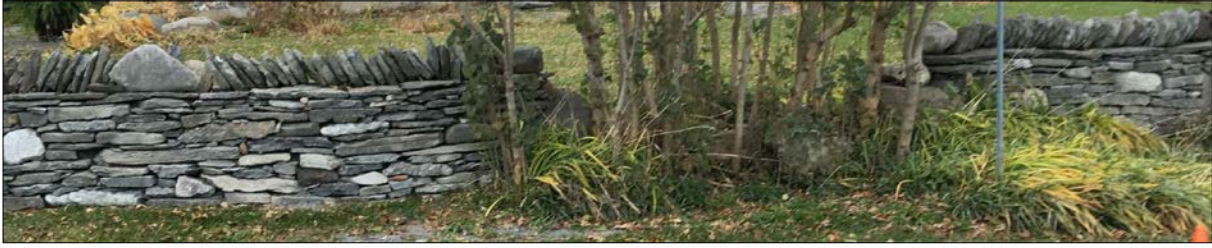
Dry Stone Fence Photo - Section 3 - 5m to 10m

Mostly limestone with a few granitic rounder pieces at random locations. Well built with level bedding planes, tight joints, well distributed sizes and shapes.

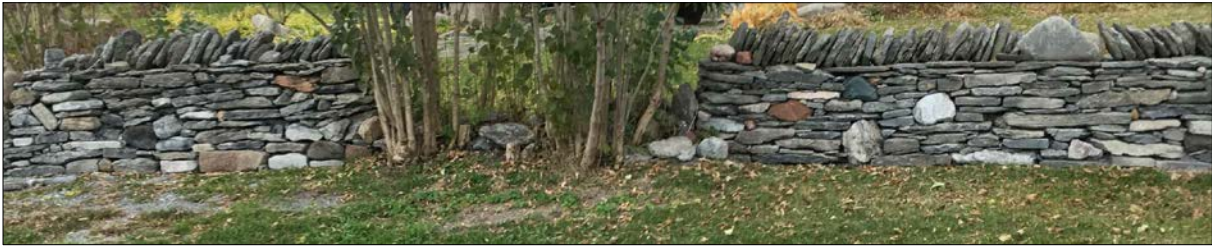
Dry Stone Fence Photo - Section 3 - 10m to 15m

Mostly limestone with a few granitic rounder pieces at random locations. Well built with level bedding planes, tight joints, well distributed sizes and shapes.

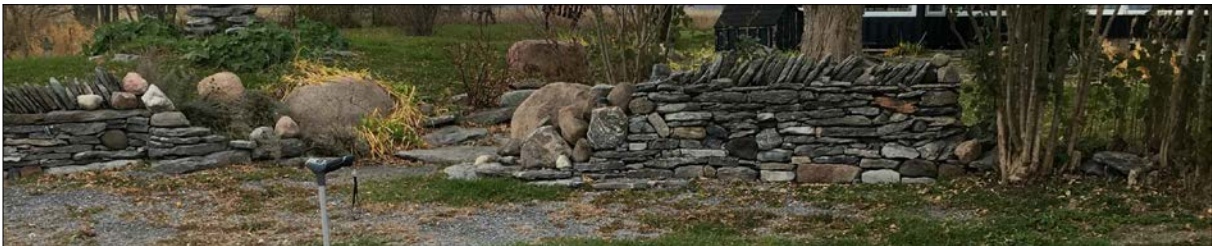
Dry Stone Fence Photo - Section 3 - 15m to 17.5m

Mostly limestone with a few granitic rounder pieces at random locations. Well built with level bedding planes, tight joints, well distributed sizes and shapes, some randomly placed round boulders at path way to the residence.

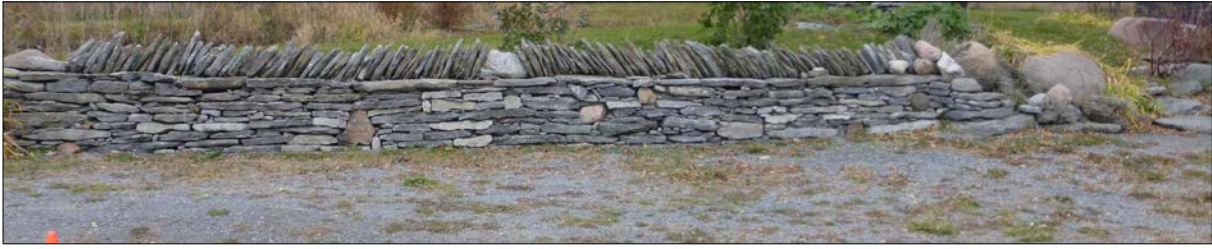
Dry Stone Fence Photo - Section 4 - 0m to 5m

Mostly limestone with a few granitic rounder pieces at random locations. Well built with level bedding planes, tight joints, well distributed sizes and shapes.

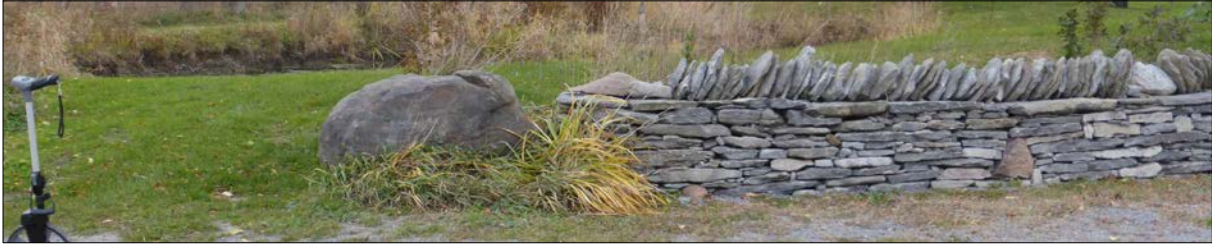
Dry Stone Fence Photo - Section 4 - 5m to 8.5m

Mostly limestone with a few granitic rounder pieces at random locations. Well built with level bedding planes, tight joints, well distributed sizes and shapes.

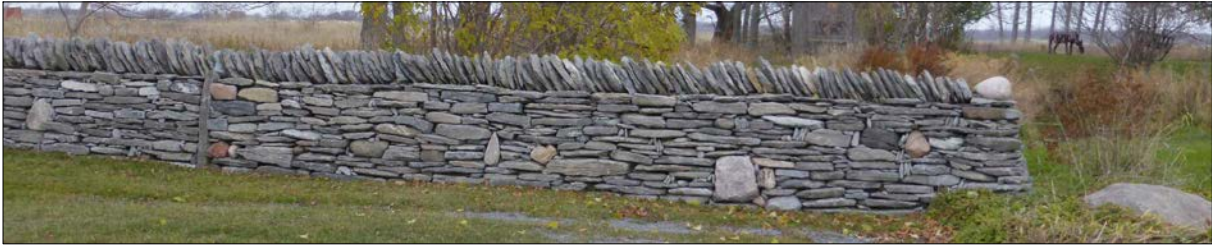
Dry Stone Fence Photo - Section 5 - 0m to 5m

Mostly limestone with a few granitic rounder pieces at random locations. Well built with level bedding planes, tight joints, well distributed sizes and shapes.

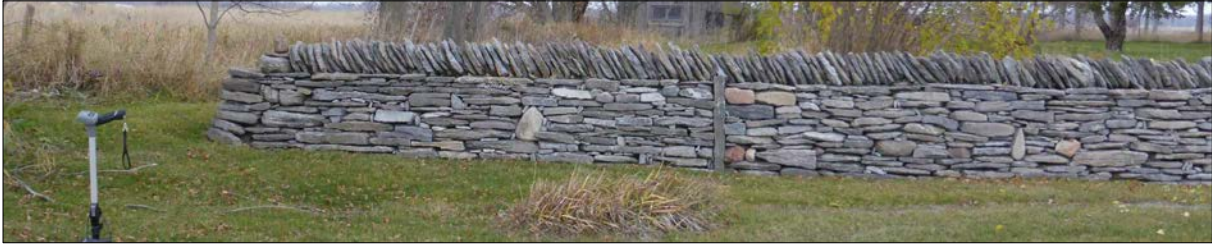
Dry Stone Fence Photo - Section 5 - 5m to 10m

Mostly limestone with a few granitic rounder pieces at random locations. Well built with level bedding planes, tight joints, well distributed sizes and shapes, slight change in pattern at the end which could be have been added after because it was not tied to the main portion.

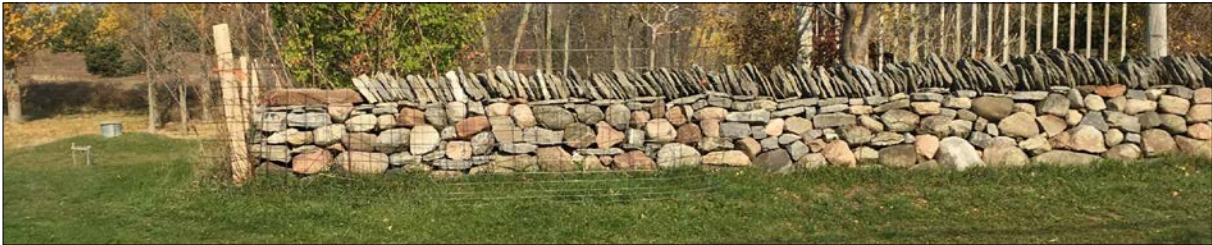
Dry Stone Fence Photo - 0m to 5m

Consists mostly granitic cobble stones, mixed with occasional limestone slab in between. The overall appearance is uniform, note the vertical coping consists of limestone except the end piece.

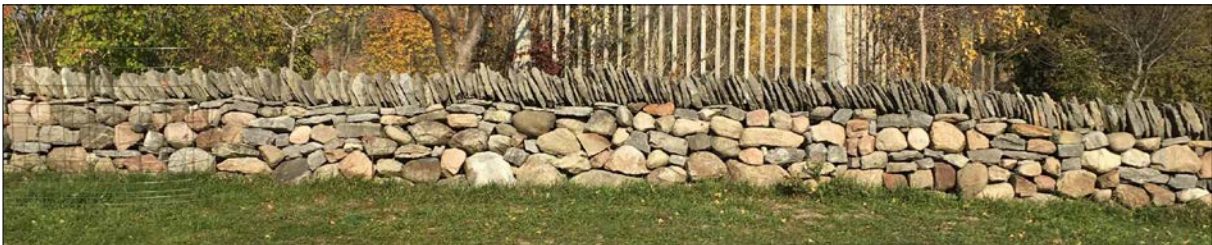
Dry Stone Fence Photo - 5m to 10m

Consists mostly granitic cobble stones, mixed with occasional limestone slab in between. The overall appearance is uniform, note the vertical coping consists of limestone.

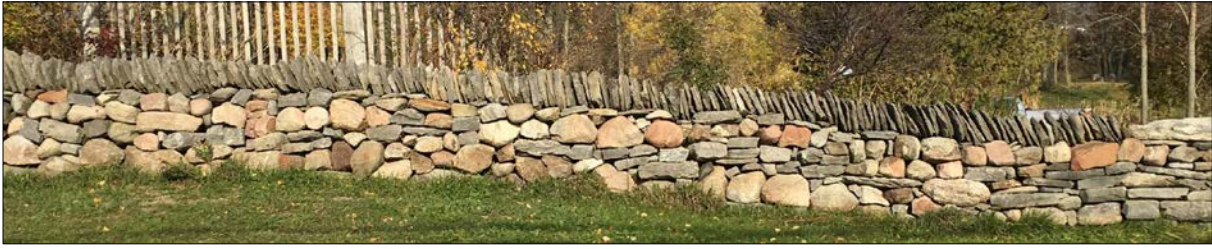
Dry Stone Fence Photo - 10m to 15m

Consists mostly granitic cobble stones, mixed with occasional limestone slab in between. The overall appearance is uniform, note the vertical coping consists of limestone.

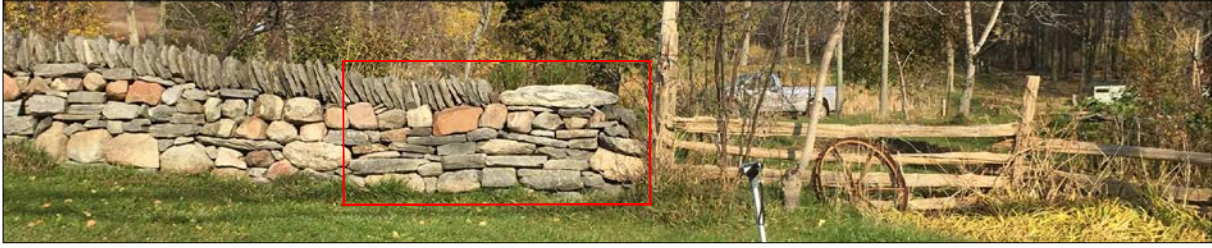
Dry Stone Fence Photo - 15m to 17.5m

Consists mostly granitic cobble stones, mixed with occasional limestone slab in between. The overall appearance is uniform, note the vertical coping consists of limestone except the end piece which contains more limestone than the rest of the wall.

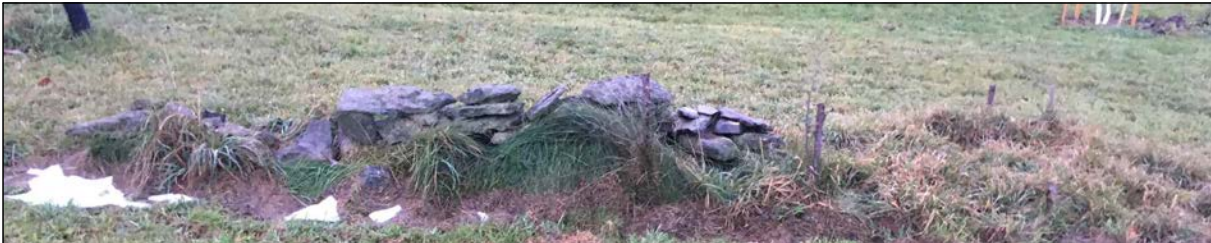
Dry Stone Fence Photo - Section 1

General Fence Information	
Municipal Address	2400 Front Road
Approximate Length	Wall Section 1: 7.0m, Section 2: 4.0m
Approximate Mean Height	
Estimated Age	25 Years
GPS Coordinates	
Condition Rating	2
Overall Observations	This fence was constructed from flat rocks and field boulders by the tenants in the recent 25 years. it is not constructed with any dry-stack style or skill. We do not even know that this is in a location where a fence stood or even on the correct property line.

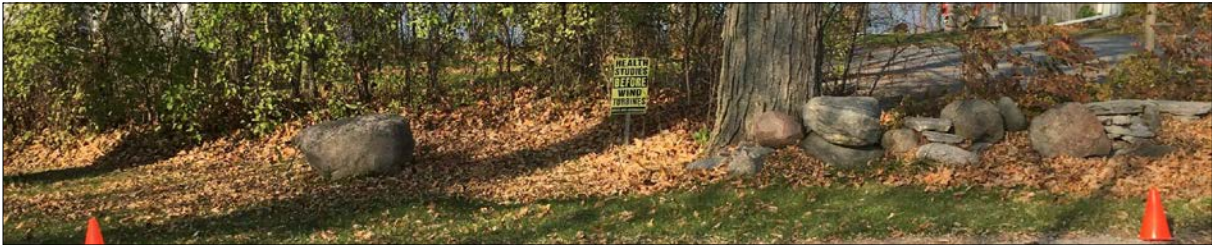
Dry Stone Fence Photo - 0m to 5m

A few pieces of granitic cobble stones randomly placed, not consistent with traditional dry stack stone fence.

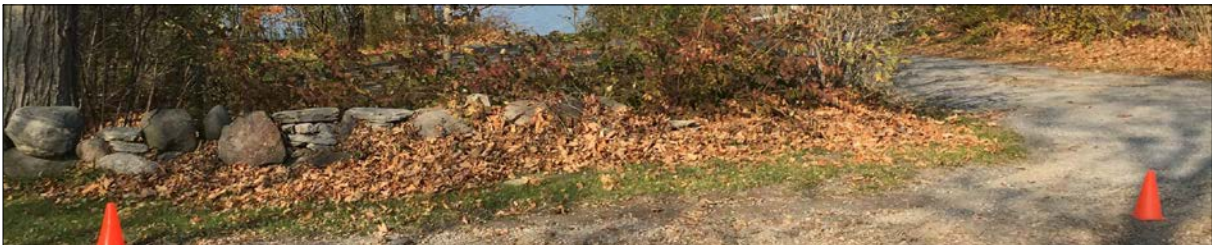
Dry Stone Fence Photo - 3m to 8m

a few pieces of granitic cobble stones and a few pieces of limestone slab, randomly placed, not consistent with traditional dry stack stone fence

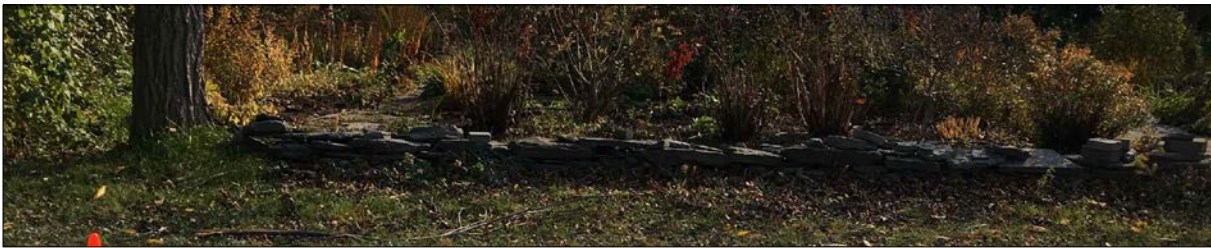
Dry Stone Fence Photo - 0m to 5m

Stone fence consists of limestones pieces with several bricks placed on top, appear to be laid in random manner, especially the top layer.

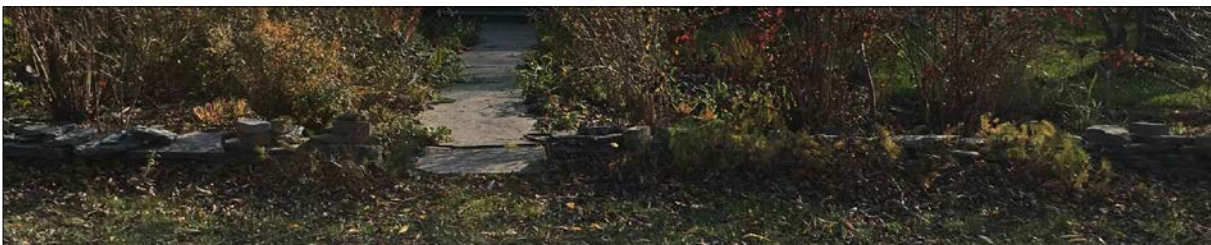
Dry Stone Fence Photo - 5m to 10m

Consists of limestones pieces with several bricks placed on top, appear to be laid in random manner, especially the top layer.

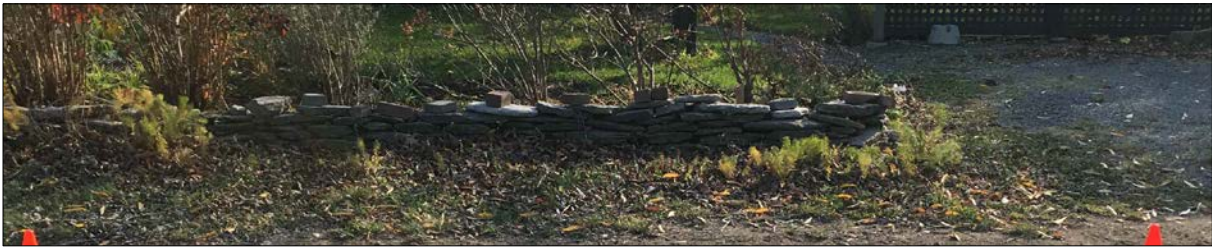
Dry Stone Fence Photo - 10m to 15m

Consists of limestones pieces with several bricks placed on top, appear to be laid in random manner, especially the top layer.

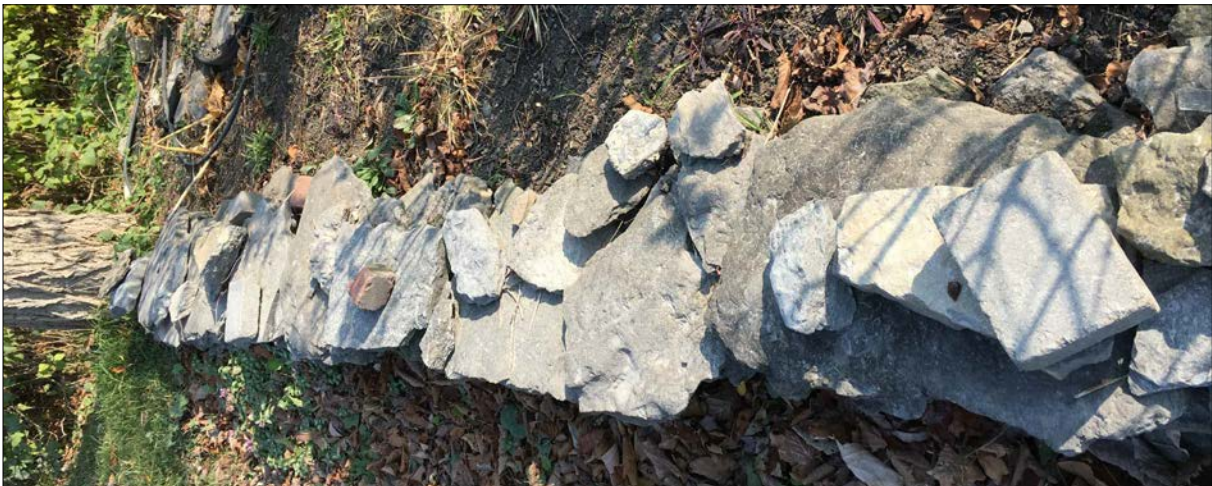
Dry Stone Fence Photo - 10m to 15m

This section of fence consists of limestone, but is not consistent with traditional manner.

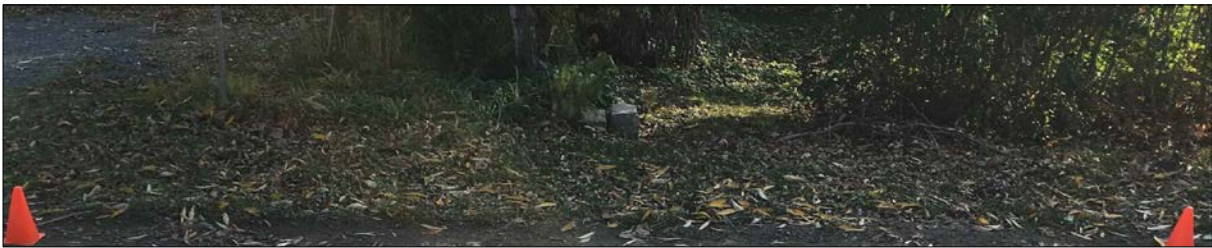
Dry Stone Fence Photo - 0m to 5m

Driveway of address 12485 at left and the start of address 12515 residence at mid point, stone fence is not visible, barely saw a few pieces if the leaves are removed.

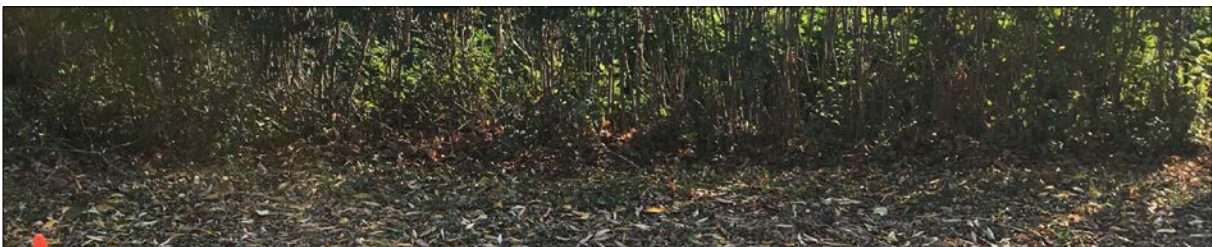
Dry Stone Fence Photo - 5m to 10m

Stone fence not visible, barely saw a few pieces if the leaves are removed.

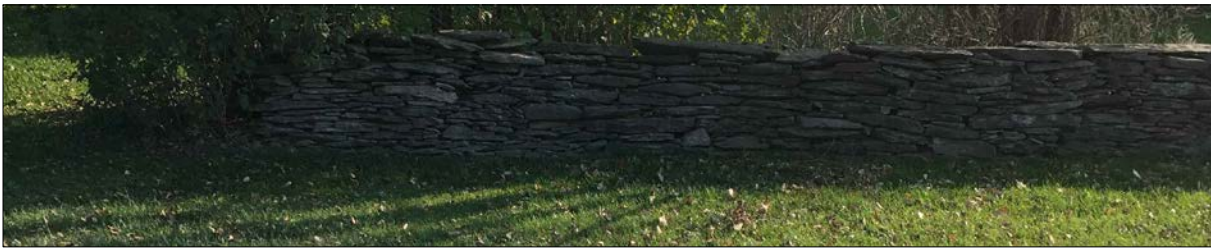
Dry Stone Fence Photo - Section 1 - 0m to 5m

Consists of limestone built in traditional manner, tight at east end(0-1.5 m) with smaller sizes and change to less tight large stone pieces, likely built in different times, apparent discontinuity at 4.5 m also.

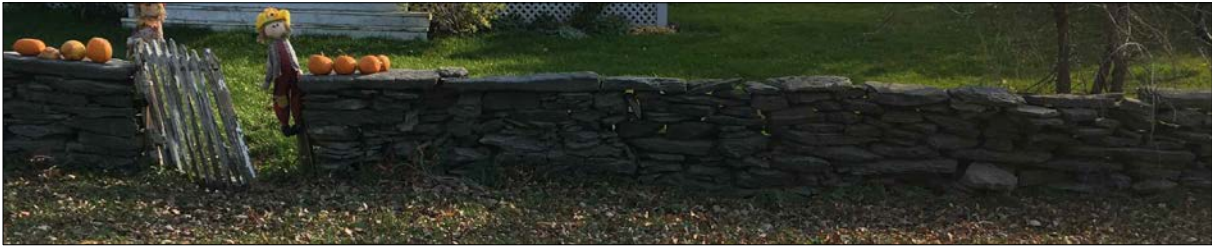
Dry Stone Fence Photo - Section 1 - 15m to 20m

The 1m adjacent to wooden gate was tighter but apparent disintegration westward, large voids apparent at transition

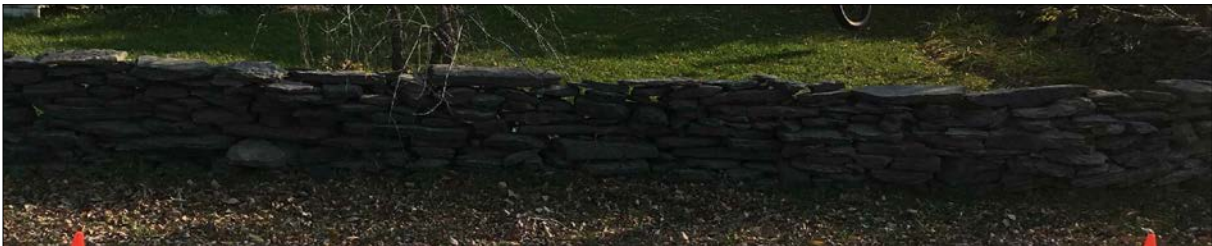
Dry Stone Fence Photo - Section 1 - 20m to 25m

Pattern continues from previous section.

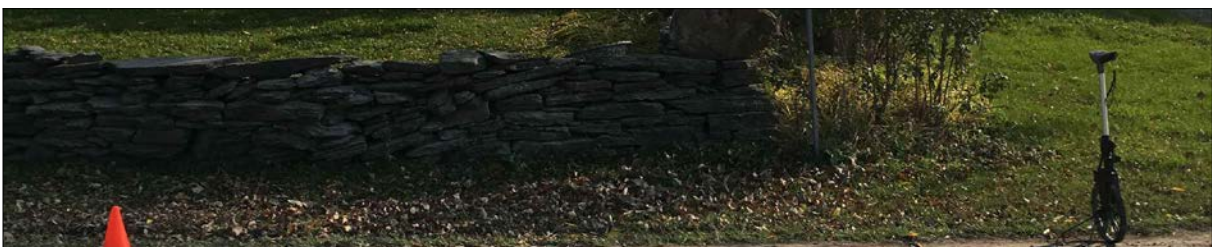
Dry Stone Fence Photo - Section 1 - 25m to 30m

Pattern continues from previous section in the first half but becomes tight and with more even bedding at the corner.

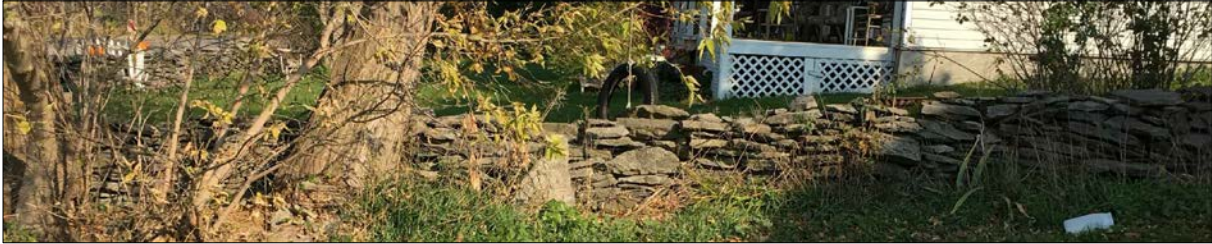
Dry Stone Fence Photo - Section 2 - 5m to 10m

Pattern continues from previous section, lack of even bedding plane and tightness.

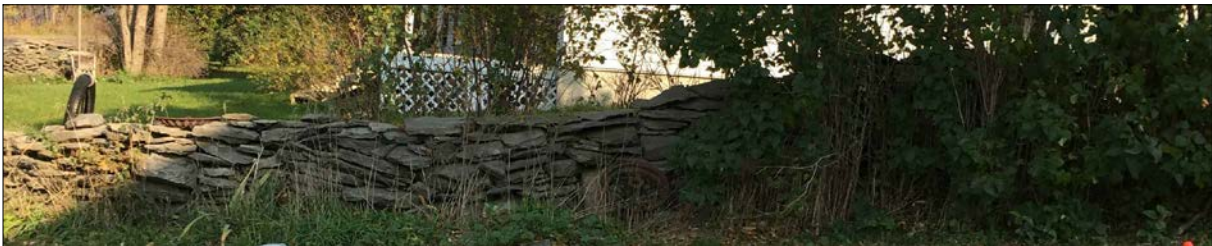
Dry Stone Fence Photo - Section 2 - 10m to 15m

Pattern continues from previous section, lack of even bedding plane and tightness.

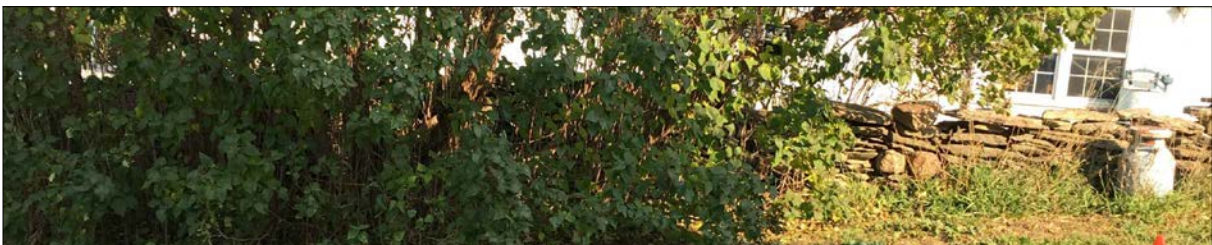
Dry Stone Fence Photo - Section 2 - 15m to 20m

Pattern continues from previous section, lack of even bedding plane and tightness.

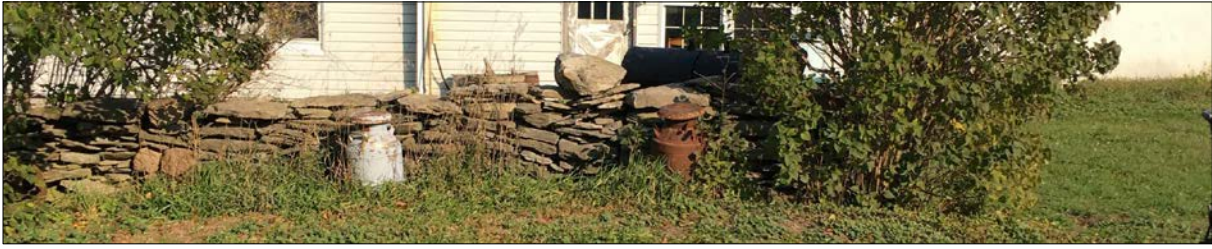
Dry Stone Fence Photo - Section 2 - 20m to 25m

Pattern continues from previous section, lack of even bedding plane and tightness.

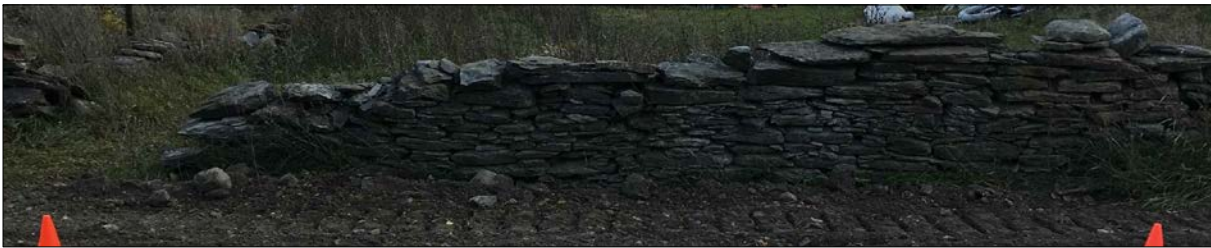
Dry Stone Fence Photo - 0m to 5m

Consists of limestone, built in traditional manner, mostly tight, apparent change in pattern at mid-section and towards east/west ends of the section, uneven bedding line.

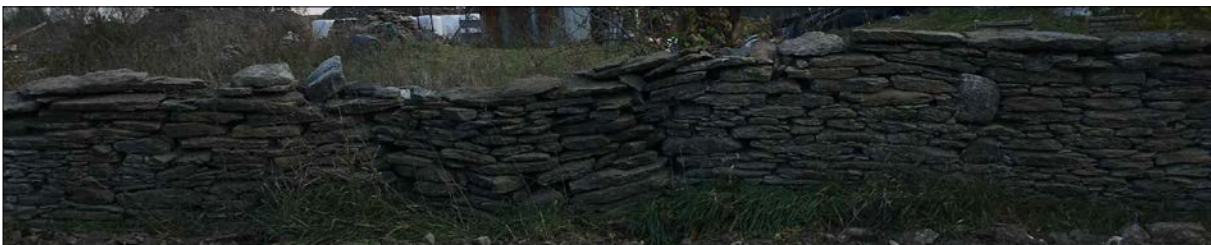
Dry Stone Fence Photo - 5m to 10m

Area 7.5m to 10m the stone was laid in traditional manner area with a large cobble stone infill, the area at approximately 5-7.5m, are laid with less tightness and inconsistent bedding line, apparently reconstructed at a later day.

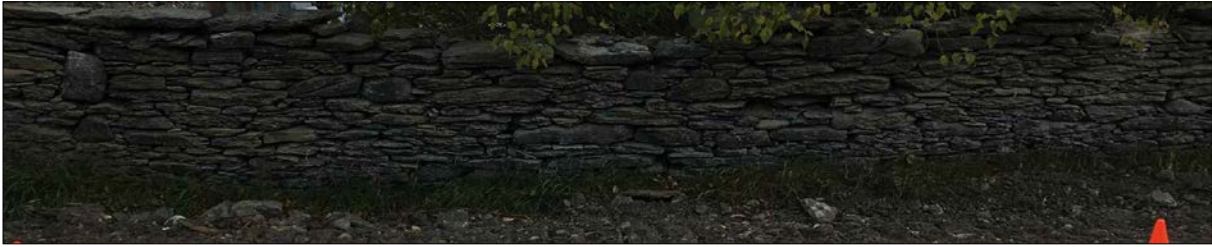
Dry Stone Fence Photo - 10m to 15m

Constructed in traditional manner with apparent modification in tightness at mid and upper portion, note the occasional larger and thicker stone pieces and voids at about 13m.

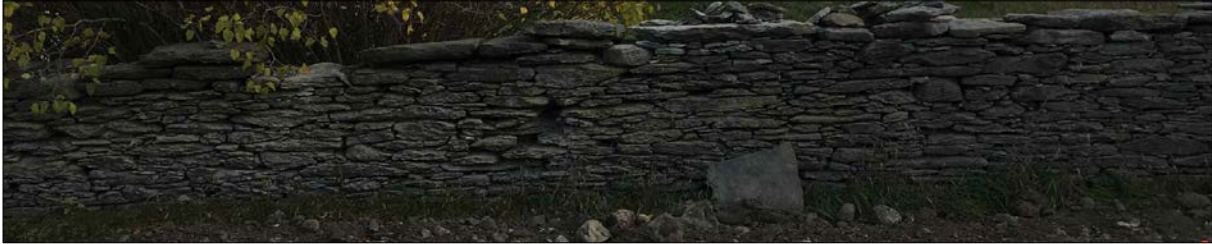
Dry Stone Fence Photo - 15m to 20m

Traditional manner, change in pattern at mid section and towards the 18m area, the different color of stones indicate the difference in age, thus possibly reconstructed afterwards. Also note occasional larger thick pieces at upper right.

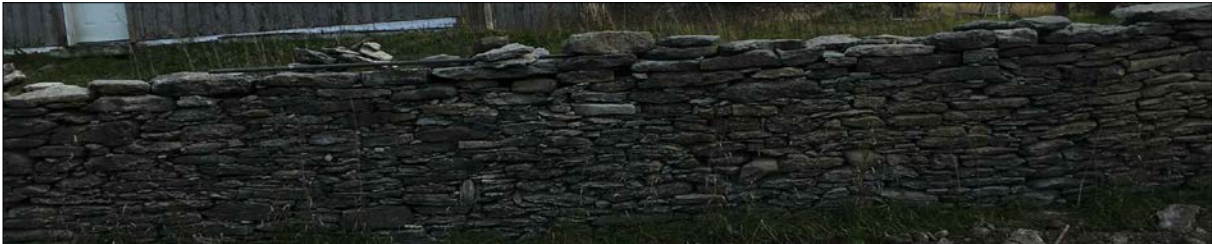
Dry Stone Fence Photo - 20m to 25m

Laid in traditional manner, changes in stone color and texture at mid section, the right end appears less tight than the left end, note occasional large thick pieces.

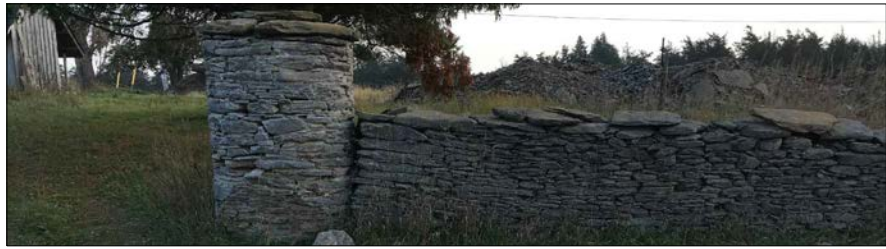
Dry Stone Fence Photo - 30m to 35m

Pillar was constructed with mortar joint inconsistent with dry stacked stone system. Apparent discoloration and loss of mortar at pillar. the wall was constructed in traditional manner but is not tied to the pillar, also change in pattern and tightness apparent towards right (32-35m).

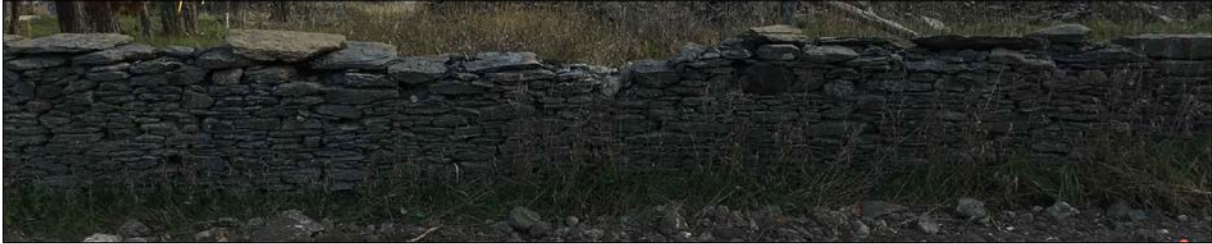
Dry Stone Fence Photo - 35m to 40m

Laid in traditional manner, change of pattern, tightness and height at mid section, note large thick piece at top.

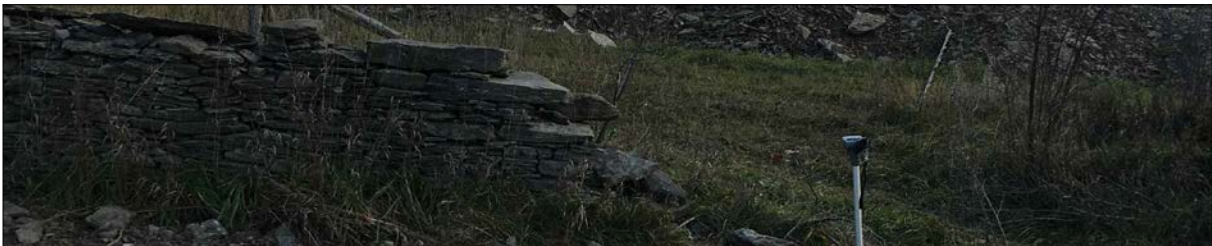
Dry Stone Fence Photo - 40m to 42.7m

Laid in traditional manner but change in pattern, tightness towards the end. Note large pieces at the end.
