**Municipal Roads  
Geotechnical Borehole  
Investigation**

Amherst Island Wind Energy  
Project  
Amherst Island, Ontario

March 9, 2017

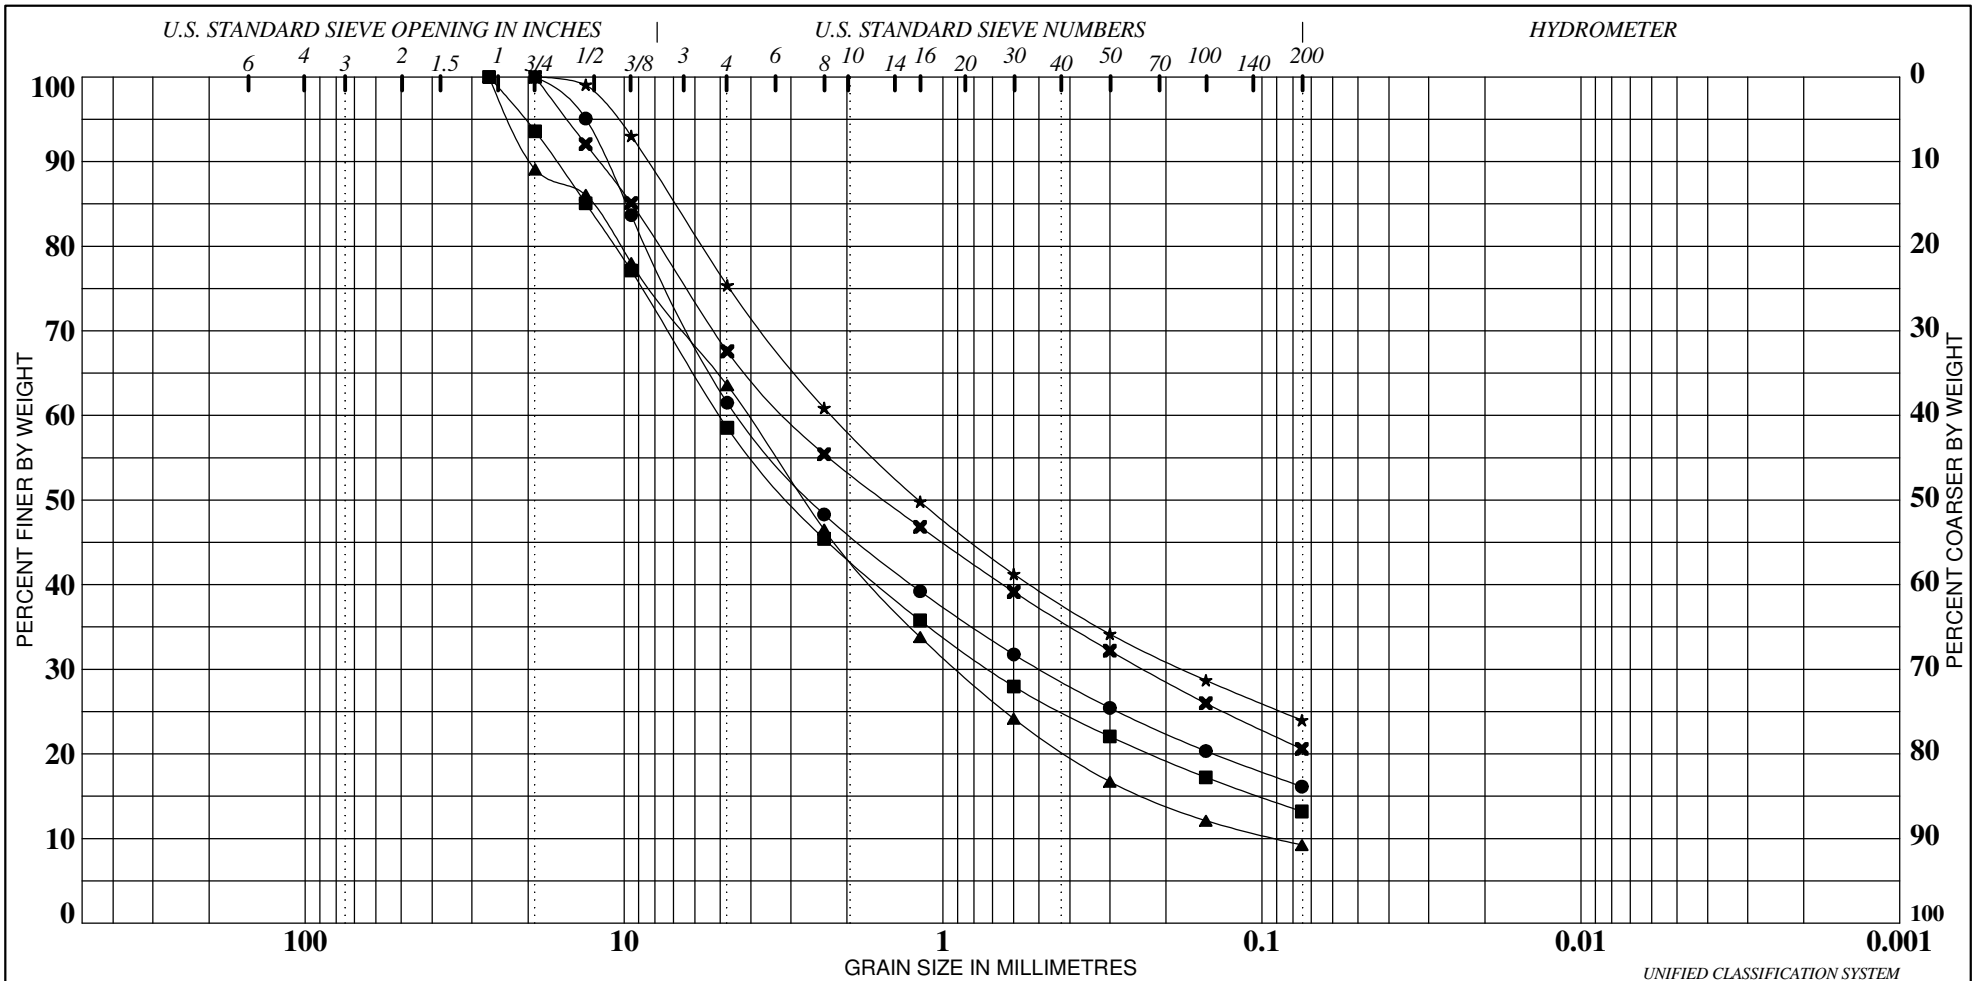
<b>Project:</b> Amherst Island Wind Farm	<b>GRADATION CURVE</b> (ASTM D422) <b>Figure:</b> 1 <b>Remarks:</b>
	<b>Location:</b> Amherst Island	
	<b>Project No.:</b> 133560104

Sample	Depth (m)	Description	W%	W <sub>L</sub>	W <sub>p</sub>	I <sub>p</sub>	%Gravel	%Sand	%Silt	%Clay
● BH16-01	0.2	SAND and GRAVEL	4				39	45	16	
■ BH16-03	0.3	SAND and GRAVEL	4				41	46	13	
▲ BH16-04	0.3	SAND and GRAVEL	3				36	55	9	
★ BH16-06	0.3	SILTY SAND with GRAVEL	3				25	51	24	
✕ BH16-07	0.3	SILTY SAND with GRAVEL	3				32	47	21

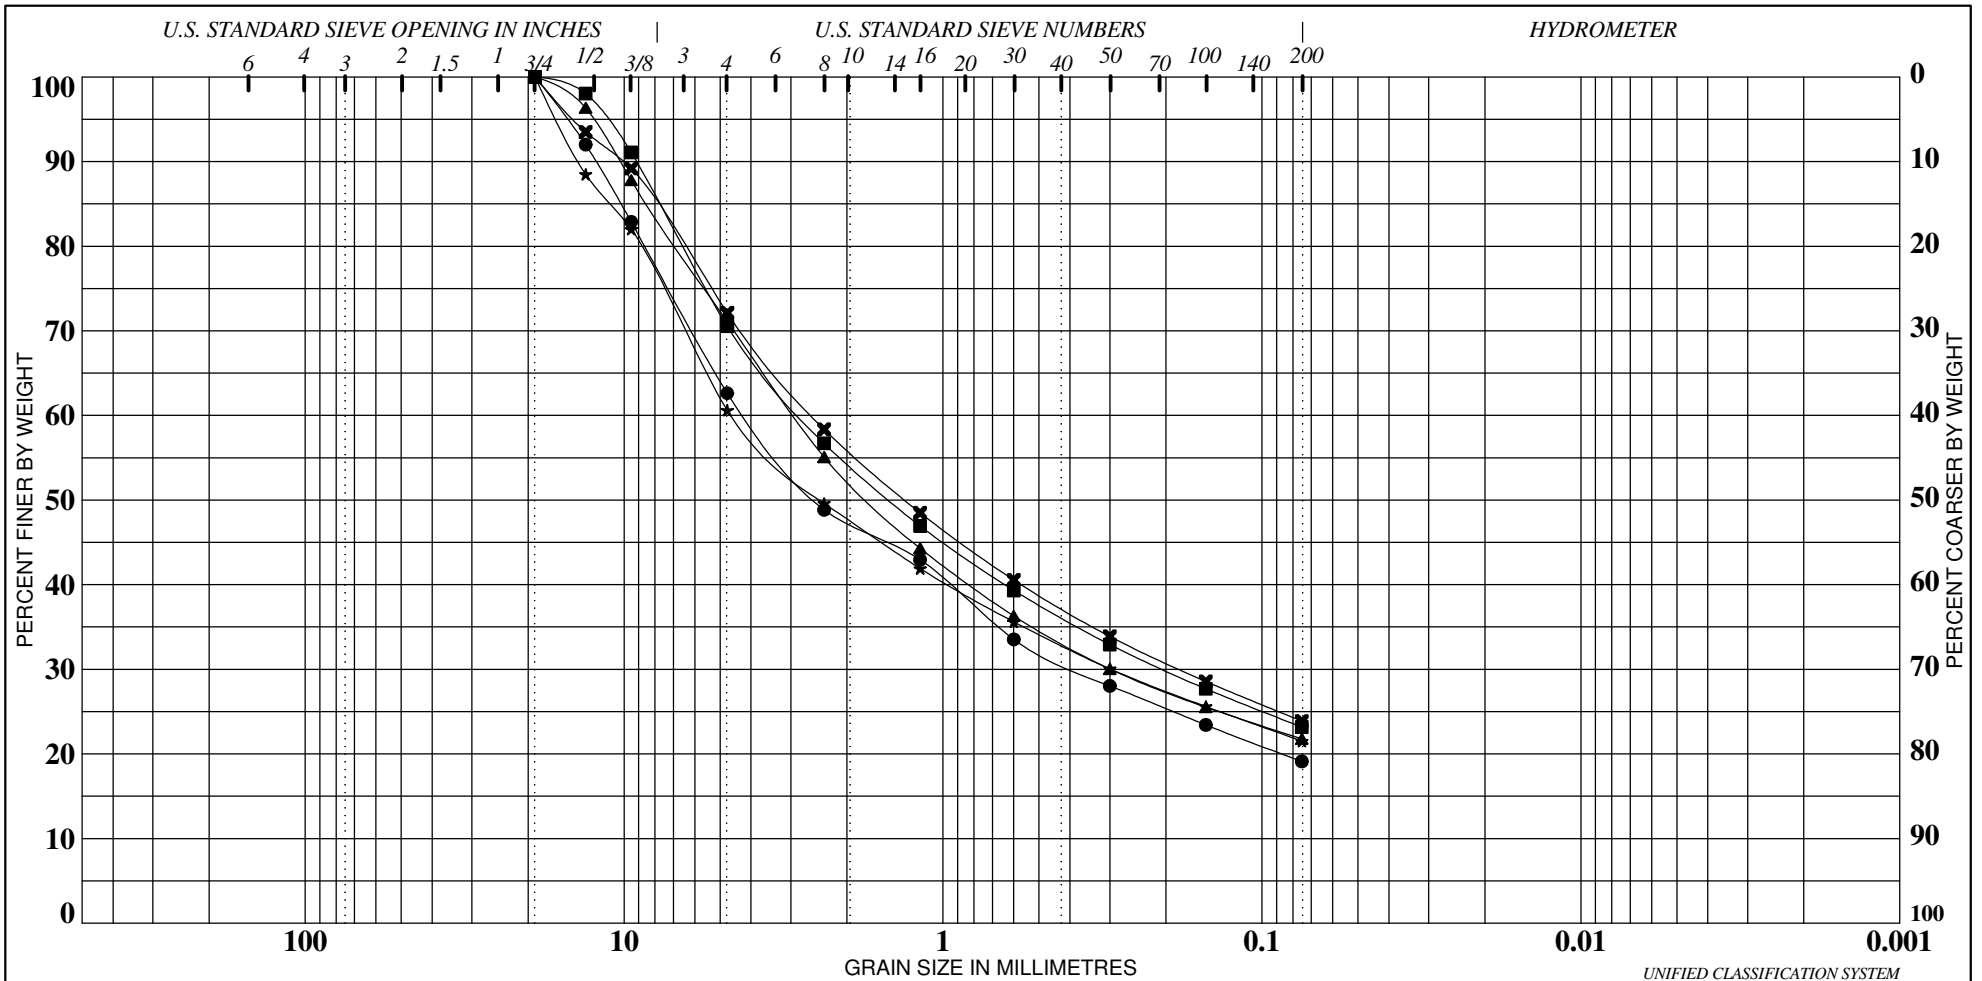
Sample	Depth (m)	Description	W%	W <sub>L</sub>	W <sub>p</sub>	I <sub>p</sub>	%Gravel	%Sand	%Silt	%Clay
● BH16-08	0.3	SILTY SAND with GRAVEL	3				37	44	19	
■ BH16-10	0.3	SILTY SAND with GRAVEL	3				29	48	23	
▲ BH16-12	0.3	SILTY SAND with GRAVEL	3				29	49	22	
★ BH16-13	0.3	SILTY SAND with GRAVEL	3				39	39	22	
✕ BH16-16	0.3	SILTY SAND with GRAVEL	3				28	48	24

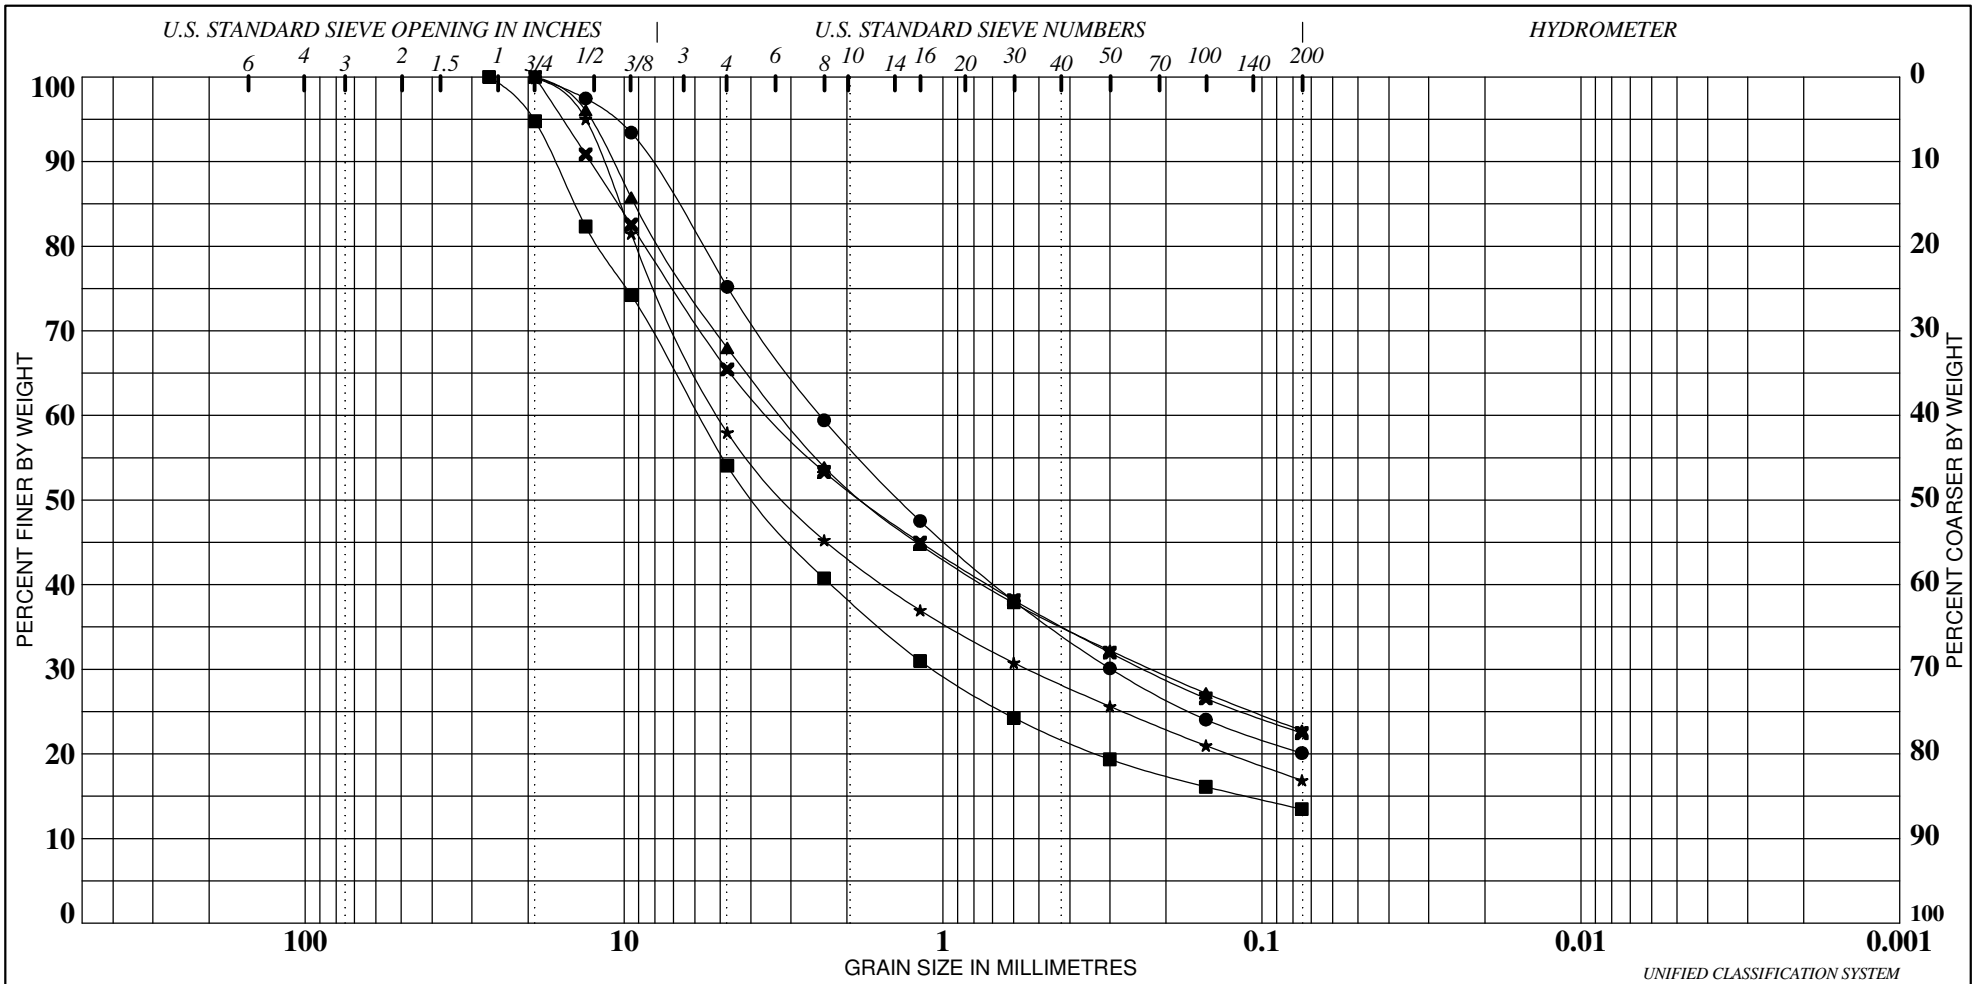
Sample	Depth (m)	Description	W%	W <sub>L</sub>	W <sub>p</sub>	I <sub>p</sub>	%Gravel	%Sand	%Silt	%Clay
● BH16-19	0.3	SILTY SAND with GRAVEL	3				25	55	20	
■ BH16-21	0.3	SILTY SAND with GRAVEL	2				46	41	13	
▲ BH16-22	0.3	SAND and GRAVEL	3				32	45	23	
★ BH16-27	0.3	SILTY SAND with GRAVEL	3				42	41	17	
✕ BH16-28	0.3	SILTY SAND with GRAVEL	3				35	43	22

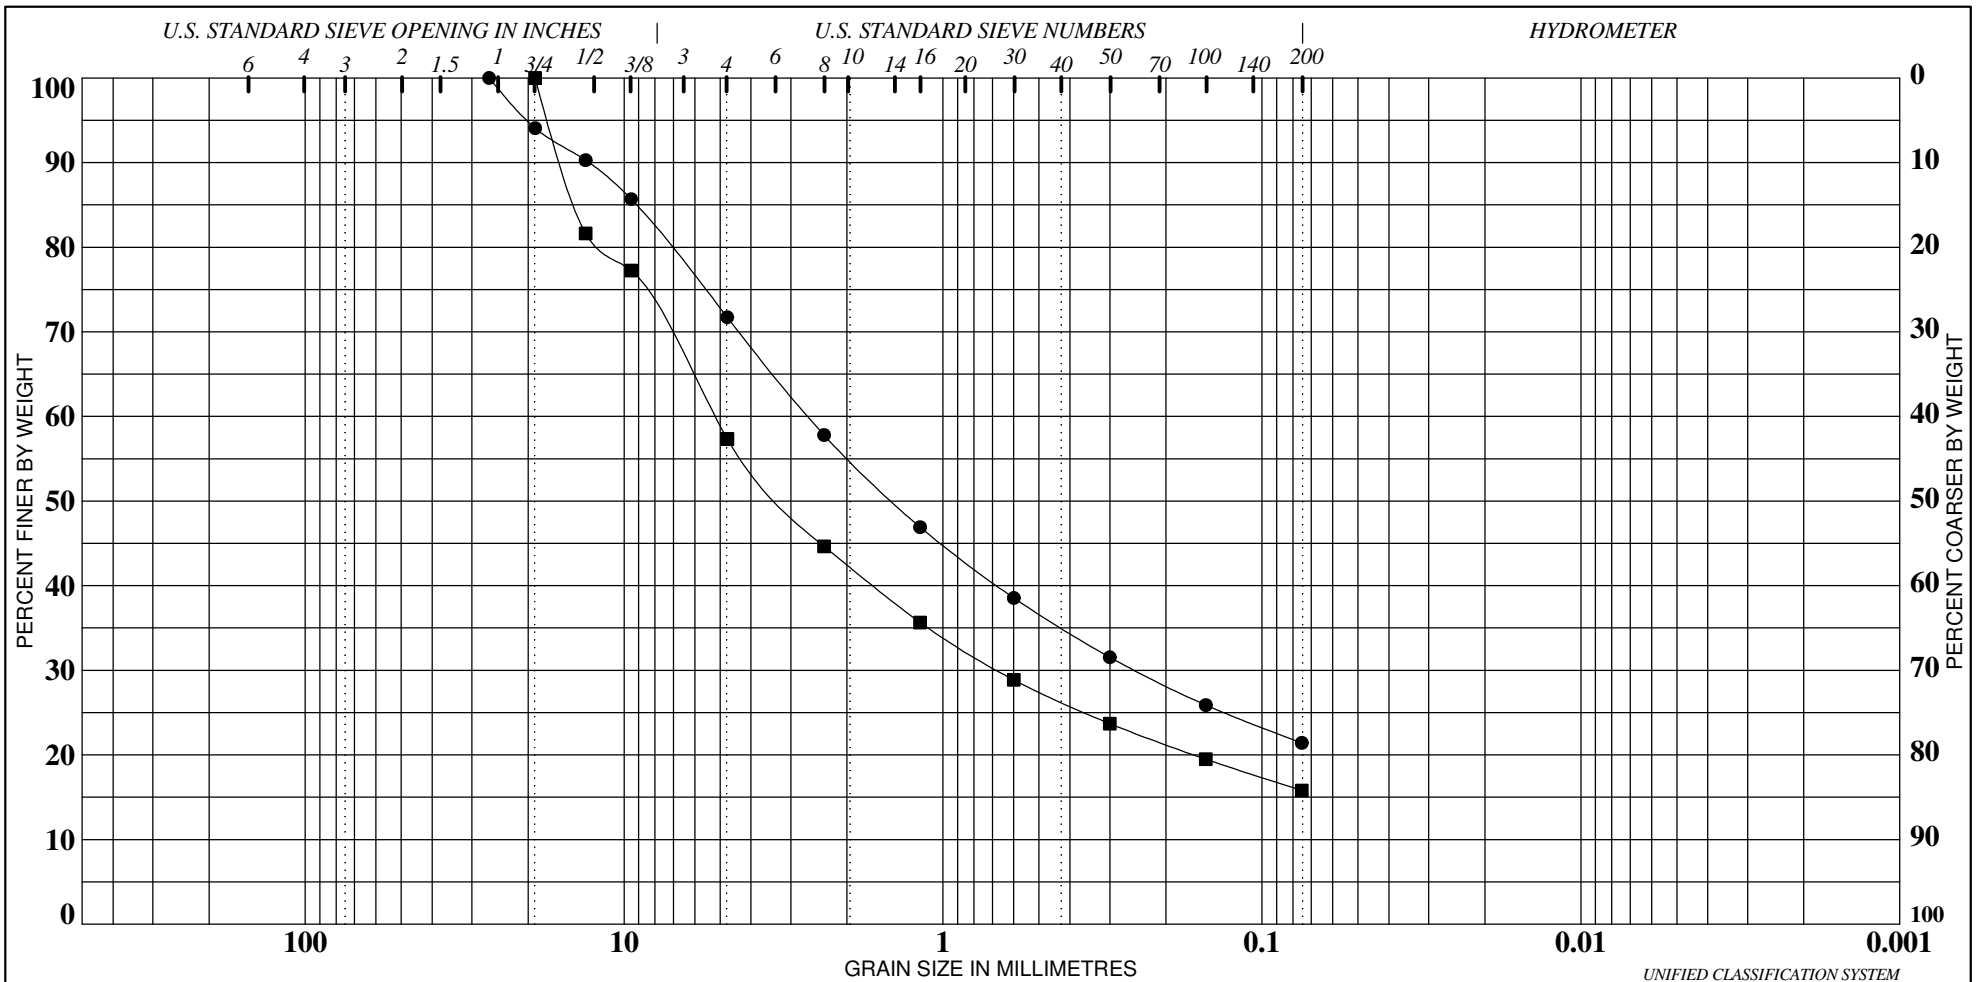
Sample	Depth (m)	Description	W%	W <sub>L</sub>	W <sub>p</sub>	I <sub>p</sub>	%Gravel	%Sand	%Silt	%Clay
● BH16-31	0.3	SILTY SAND with GRAVEL	3				28	51	21	
■ BH16-38	0.3	SAND with GRAVEL	4				43	41	16

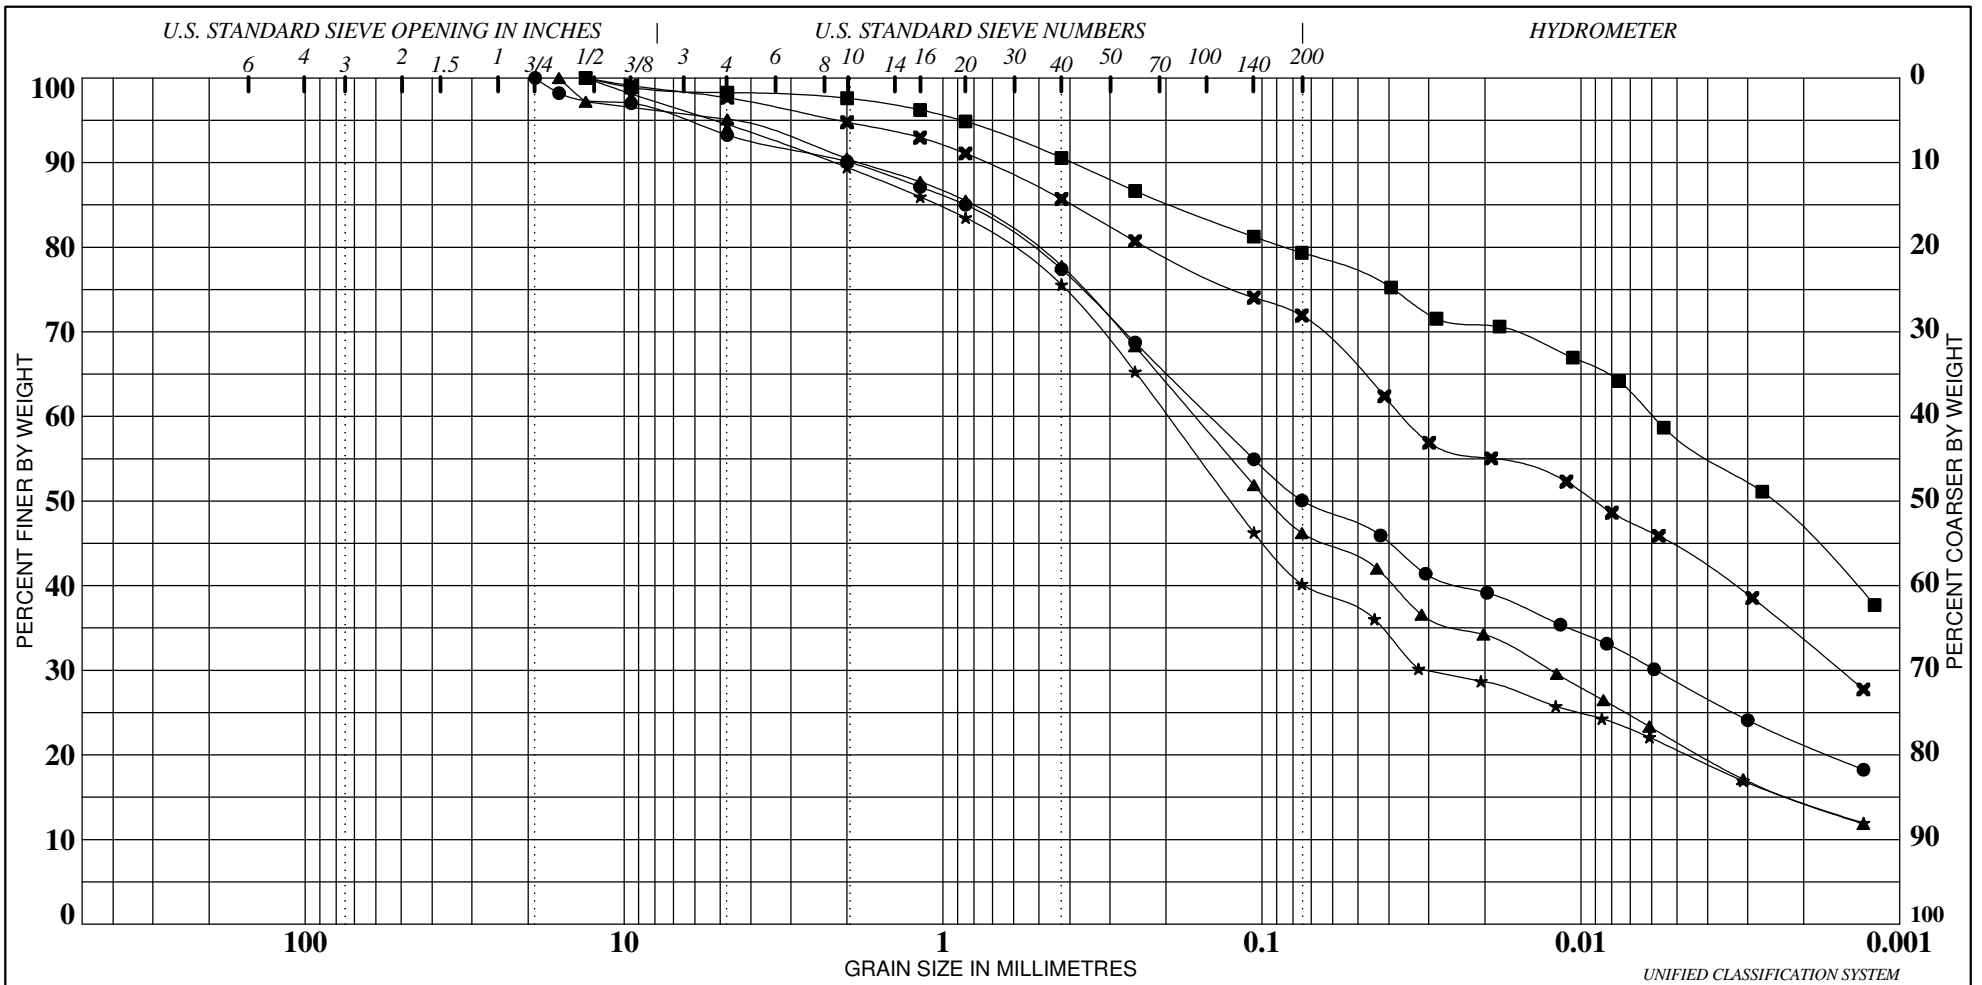
Sample	Depth (m)	Description	W%	W <sub>L</sub>	W <sub>p</sub>	I <sub>p</sub>	%Gravel	%Sand	%Silt	%Clay
● BH16-01	0.3	SANDY CLAY (CL)	17	28	17	11	7	43	29	21
■ BH16-07	1.1	CLAY with SAND (CH)	30	53	27	26	2	19	33	46
▲ BH16-08	1.1	SILTY, CLAYEY SAND (SC-SM)	8	18	13	5	5	49	32	14
★ BH16-10	1.1	SILTY, CLAYEY SAND (SC-SM)	7	15	11	4	5	55	26	14
✕ BH16-16	1.1	CLAY with SAND (CH)	29	55	29	26	2	26	38	34

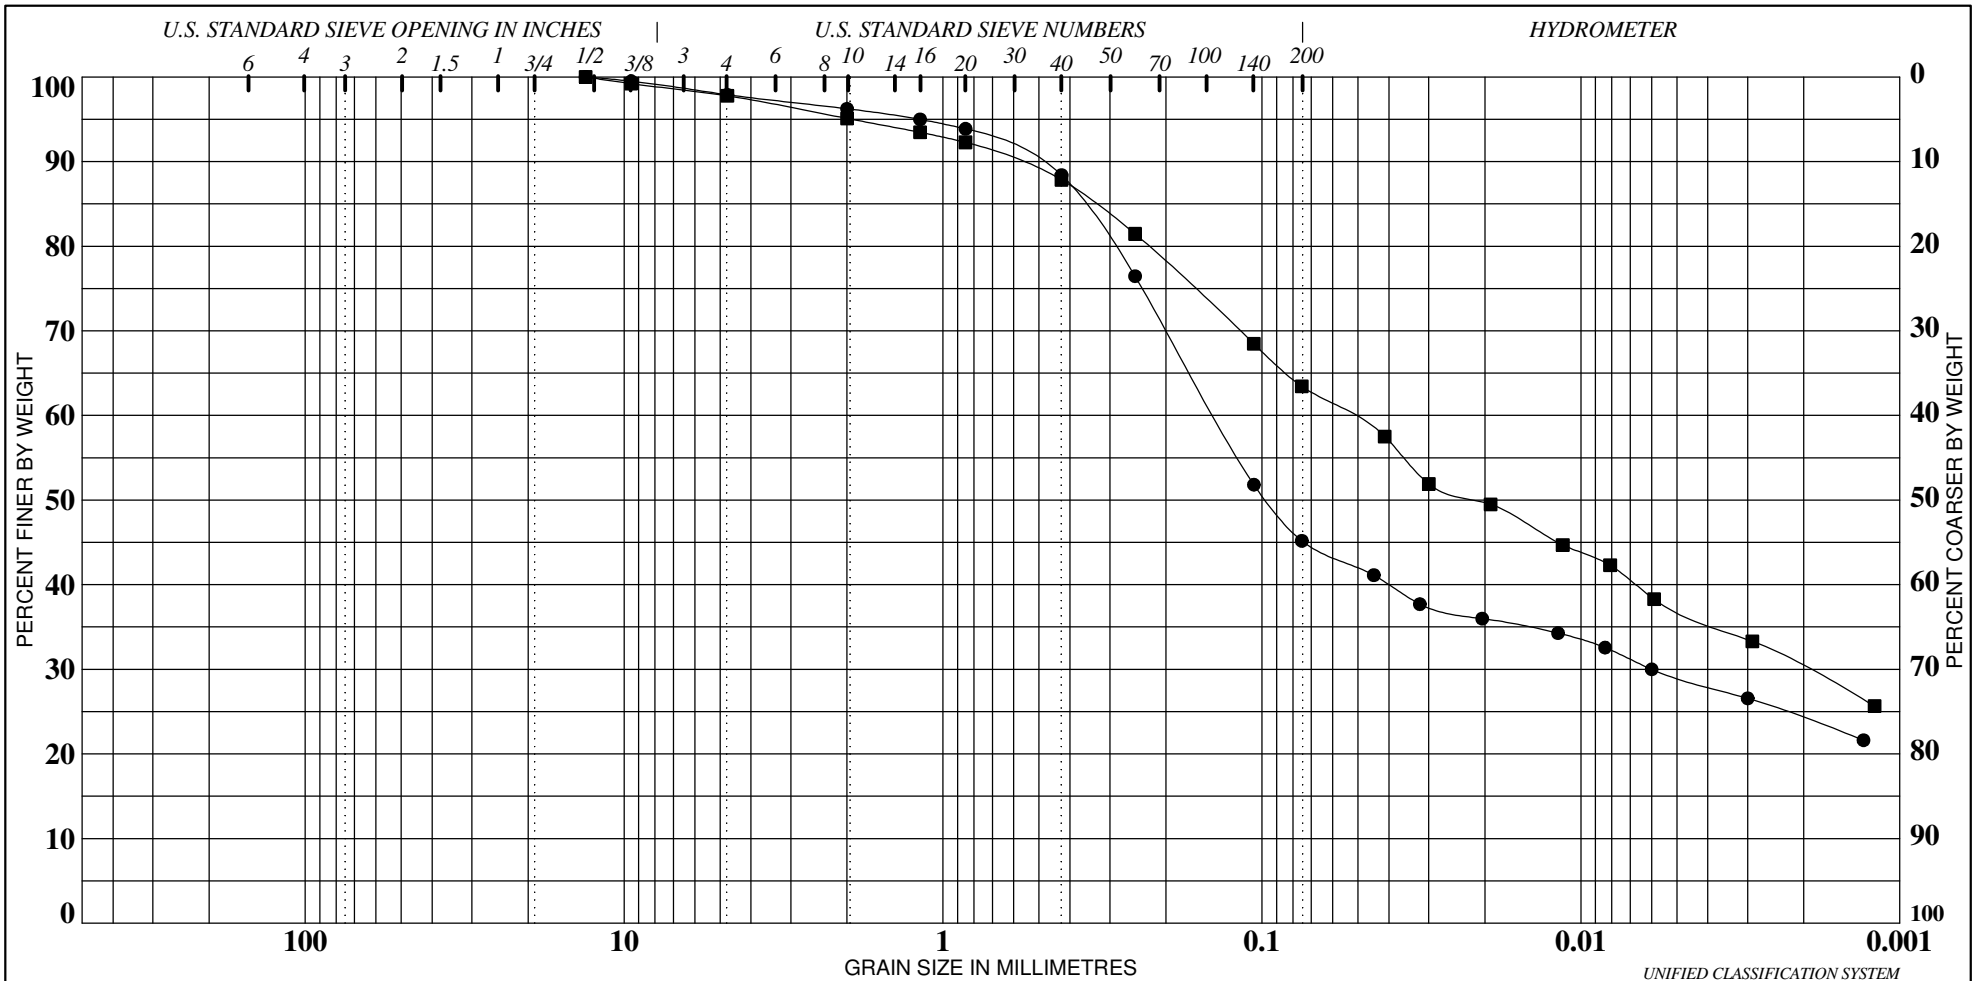
Sample	Depth (m)	Description	W%	W <sub>L</sub>	W <sub>p</sub>	I <sub>p</sub>	%Gravel	%Sand	%Silt	%Clay
● BH16-21	1.0	CLAYEY SAND (SC)	22	24	15	9	2	53	21	24
■ BH16-28	1.1	SANDY CLAY (CL)	21	37	16	21	2	35	33	30

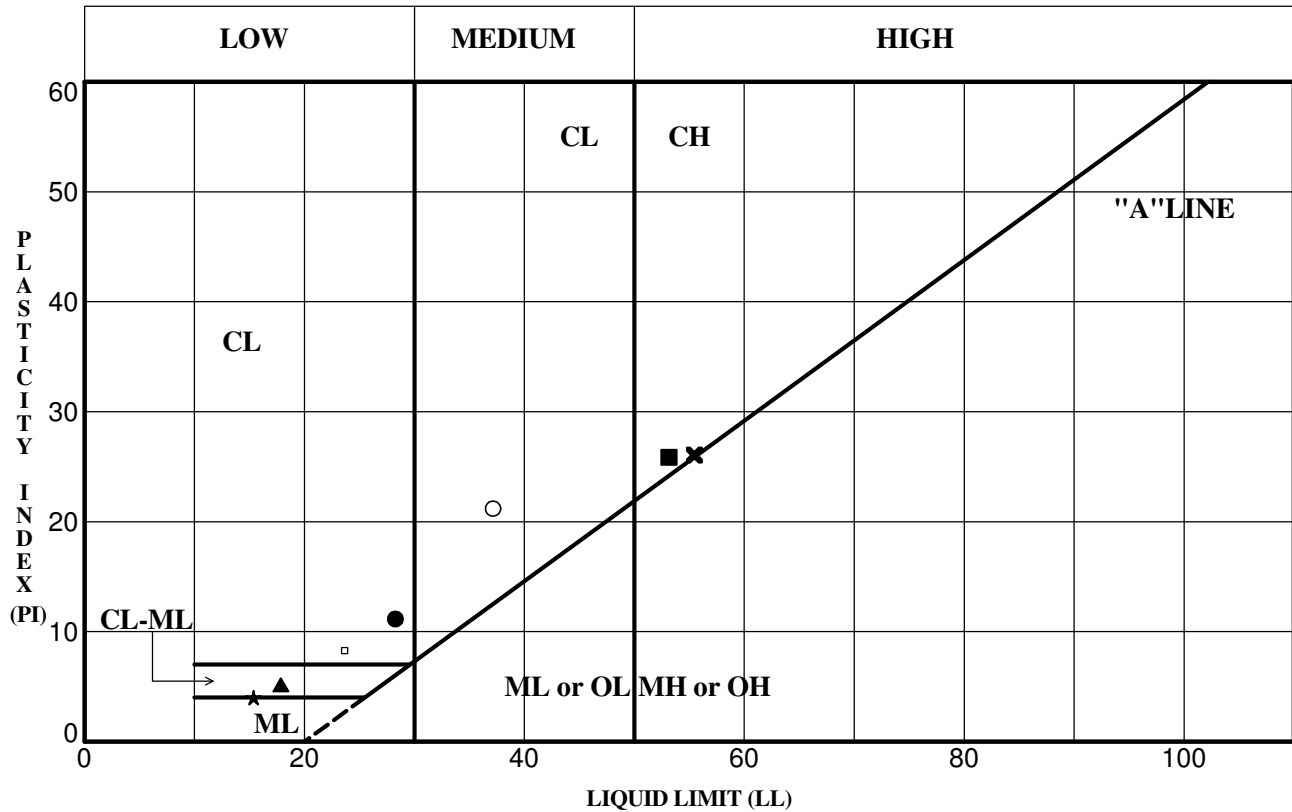
# PLASTICITY CHART

Specimen	Depth (m)	LL	PL	PI	Fines	W%	Classification
● BH16-01	0.3	28	17	11	50	17	SANDY CLAY (CL)
■ BH16-07	1.1	53	27	26	79	30	CLAY with SAND (CH)
▲ BH16-08	1.1	18	13	5	46	8	SILTY, CLAYEY SAND (SC-SM)
★ BH16-10	1.1	15	11	4	40	7	SILTY, CLAYEY SAND (SC-SM)
✕ BH16-16	1.1	55	29	26	72	29	CLAY with SAND (CH)
◻ BH16-21	1.0	24	15	9	45	22	CLAYEY SAND (SC)
○ BH16-28	1.1	37	16	21	63	21	SANDY CLAY (CL)
